THE STITCH
EXISTING UTILITIES EXHIBIT
 Overhead Hanging Utilities with Existing Development

DaVinci
 Development Collaborative, LLC
 Central Atlanta Progress
 Atlanta Downtown Improvement District

THE STITCH
Photograph Sheet

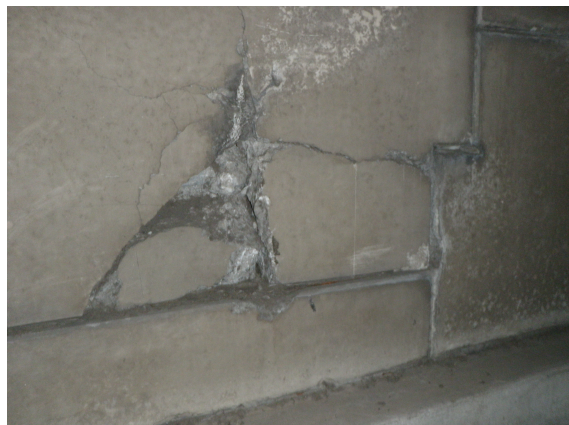
121-0667-0-6.JPG

NBIS Condition 7 - Good Condition **Material:** O. Concrete **Year Painted:** 0000
Paint Type : 0- Not Applicable
 Abutments 1 and 4 are concrete reinforced earth walls.
 Bent 2 and 3 is concrete caps and columns.
 Minor settlement in panels of walls.
 Abutment 4 has minor accident damage (see photo).
 Cracks in panels.

Accident damage on abutment 4 wall.

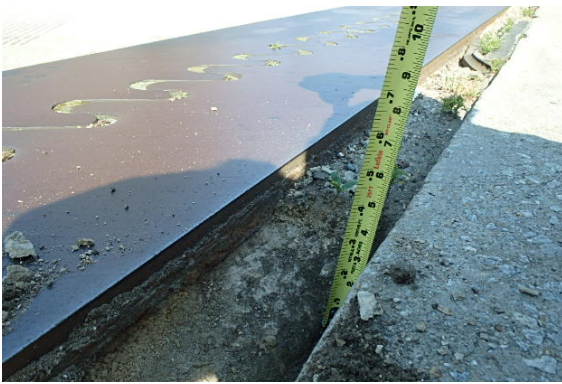
121-0644-0-12.JPG

Deck surface has minor transverse cracking.
Both finger joints are rubbing and full of debris.
Spall abutment 1 header 4sq.ft.
Spall abutment 3 right lane n/b 1'x1' header.
Deck underside has minor transverse cracking up to .008" wide. Some with efflorescence. See photo.
Deck overhang has minor cracking up to .005" wide. Some with efflorescence. See photo.
Spall span1 bottom of deck with exposed rebar bay 4 -1 sq ft.
Span 1 bay 4 has a 4"H x 3"W x 1"D spall with exposed rebar.

Spall at abutment 3 finger joint.

Repairs:
Clean debris from finger joints and repair.
Repair deck spall at abutment 1 and 3 header.
Minor settlement rear approach slab from roadway.
Sidewalk settling rear right.

Activity	Work Quantity	Priority	Location	Inspection Date	Completion Date	Comments
Mntce) ()		B	Beams	05/15/2017		Clean and paint beams.
805 - HEADER JNT RECONST/REPAIR (LINEAR FEET)	2	B	Abutment 3	05/15/2017		Repair spalls

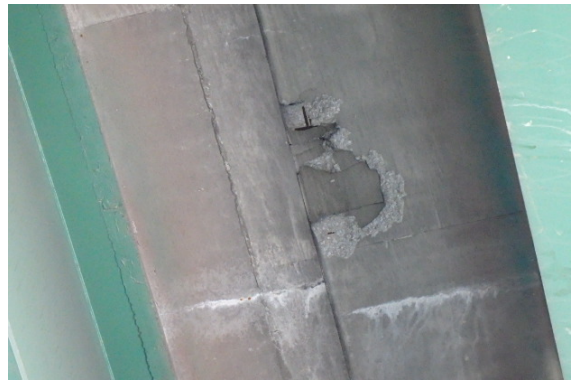
121-0644-0-16.JPG

Spall span #1 bottom of deck with exposed rebar bay #4 -1 sq ft.

Deck spall span #1bottom

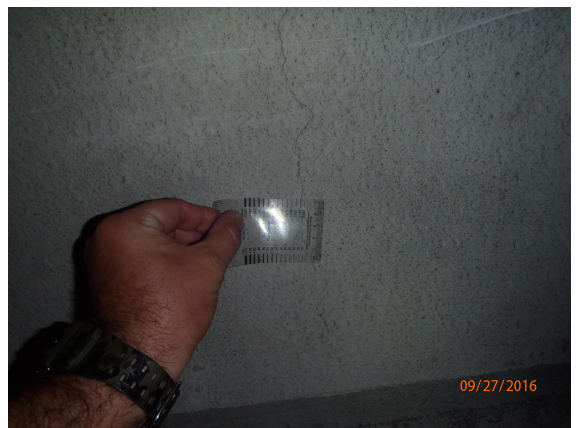
P9270025.JPG

Concrete columns have minor cracking up to .006" wide. See photo.

Team C 9-27-16, Cracking in columns up to .006" wide

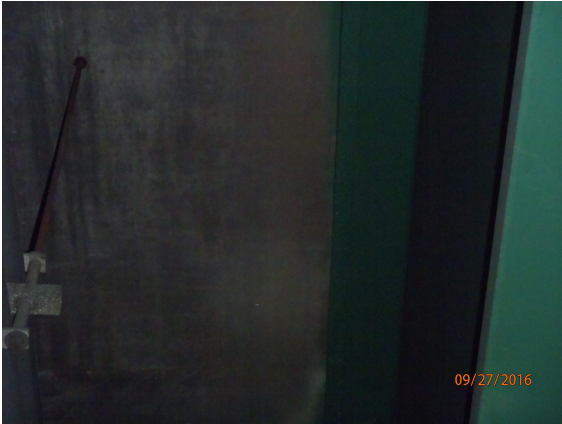
P9270033.JPG

Deck underside has minor transverse cracking up to .008" wide. Some with efflorescence. See photo.

Team C 9-27-16, Cracking in deck underside up to .008" wide with efflorescence

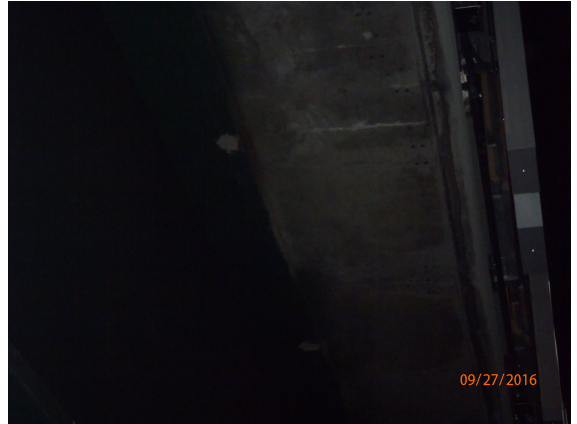
P9270028.JPG

Deck overhang has minor cracking up to .005" wide. Some with efflorescence. See photo.

Team C 9-27-16, Cracking in deck overhang up to .005" wide

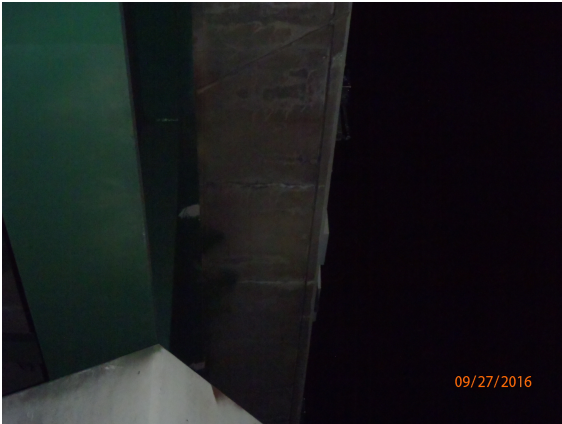
P9270036.JPG

Team C 9-27-16, Cracking in deck overhang up to .005" wide

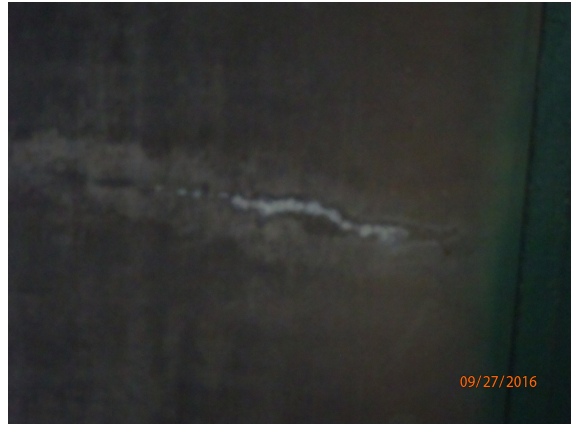
P9270032.JPG

Team C 9-27-16, Cracking in deck underside up to .008" wide with efflorescence

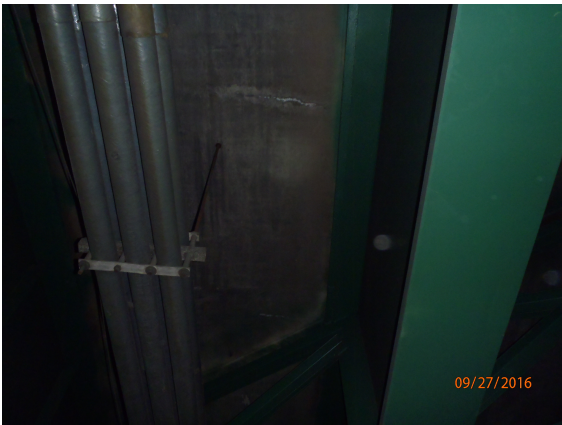
P9270034.JPG

Team C 9-27-16, Cracking in deck underside up to .008" wide with efflorescence

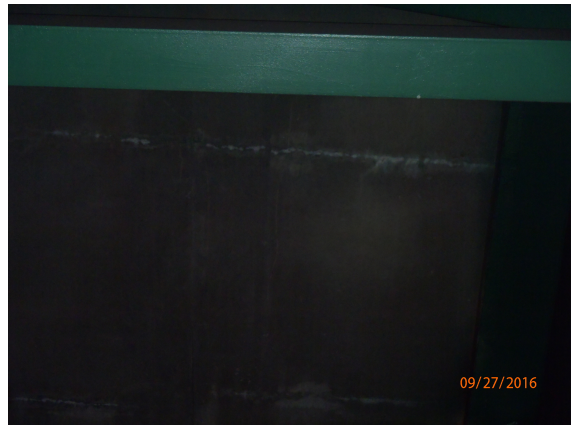
P9270035.JPG

Team C 9-27-16, Cracking in deck underside up to .008" wide with efflorescence

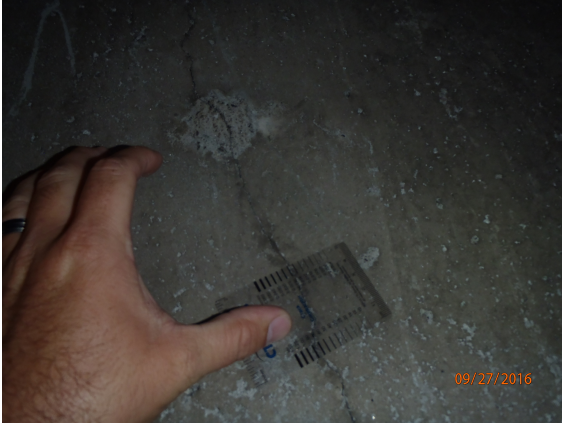
P9270020.JPG

Team C 9-26-16, Vertical cracking in pier wall 2 up to .025" wide

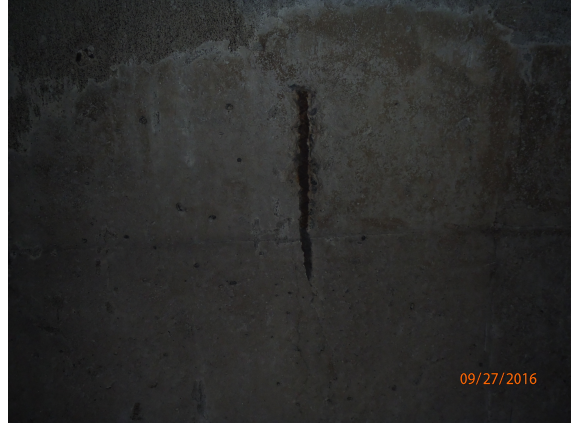
P9270021.JPG

Team C 9-26-16, Pier wall 2 spall with exposed rebar

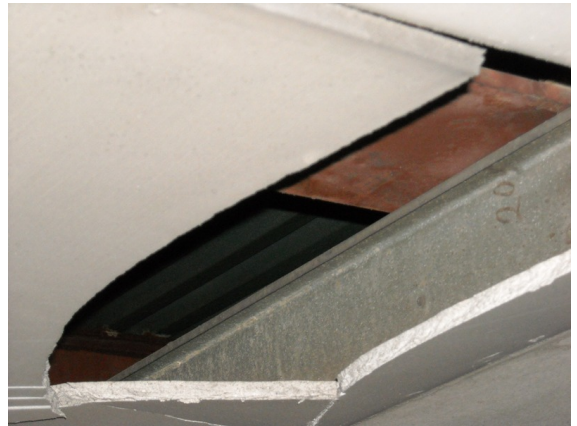
121-0414-0-55.JPG

Broken panels span 2, collision damage.

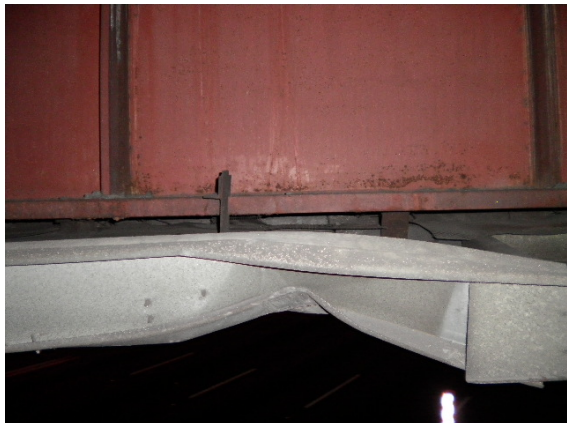
121-0414-0-56.JPG

Collision damage span 1 over right lane, broken panels and panel supports (Beam 3-5).

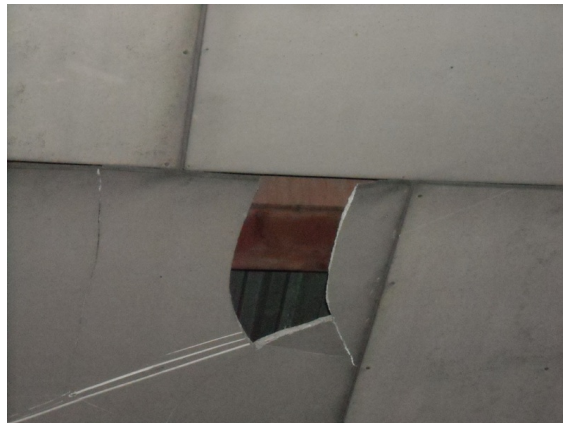
121-0414-0-54.JPG

Broken panels span 2, collision damage.
