124 NEWSROOM

118-124 Monroe Avenue

Development Loan Application

Re: Condition Survey
122 Monroe Avenue
Memphis, Tennessee 38103
CAS No. 2009.15

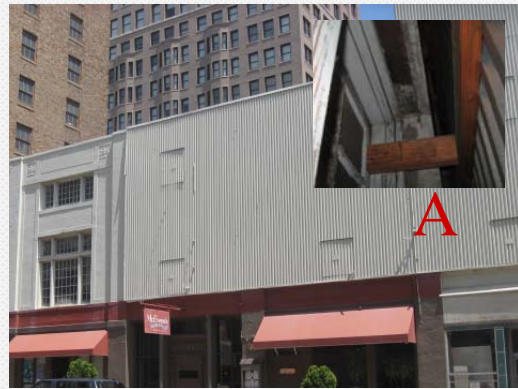
1	The second floors of Bays 2, 3 and 4 and the third floor of Bay 4 are covered with corrugated metal that is anchored to the exterior wall with 2 in. by 4 in. wood framing. See insert photo A	
Remedy	The system appears to be well attached and can remain in place until facade renovation is anticipated.	
2	Some cracks were observed in the stucco on the front elevation of Bay 1. However, the stucco appears to be in good condition. The stucco appears to be 1-1/4 in. thick. See photo inset A.	
Remedy	A delamination survey of the facade is required to determine if it is feasible to repair the existing stucco versus complete replacement of the stucco. See repair options in the cost estimate section of this report.	
3	Large cracks were observed in the stucco on the west elevation that has resulted in complete delamination of the stucco from the brick surface.	
Remedy	Since this wall is located along a public way the stucco should be removed immediately.

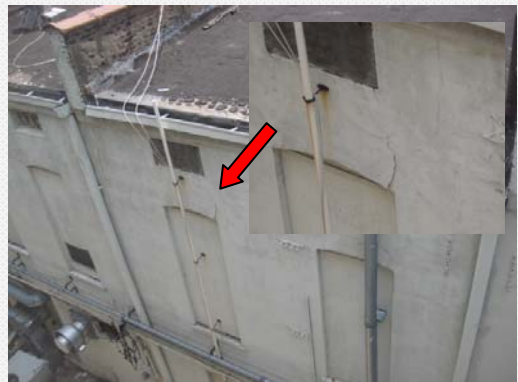
4	Several cracks were also observed in the stucco on the back or north elevation at the tops of door and window openings. The door and window openings not in use are closed up.	
Remedy	Same as Item 2 above.

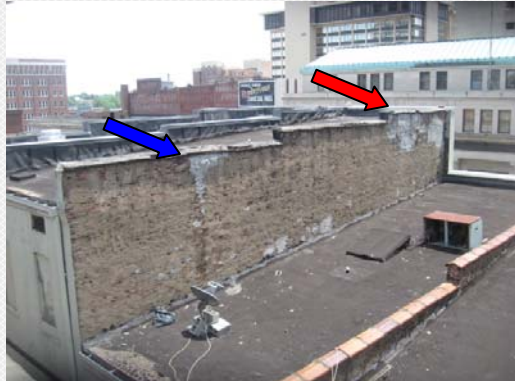
5	The upper part of the west wall of Bay 4 is in poor condition around the chimney openings in the parapet.		5

Remedy	Repair options include remove and replace outer wythe of damaged brick and recoat the wall with elastomeric coating or install new metal panels on hat channels to brick surface.		6

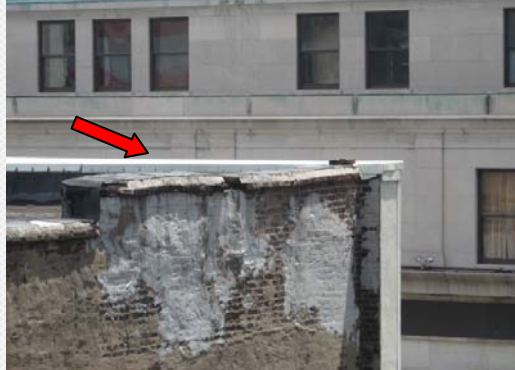
6	Close-up of Item 5 above. Note how brick surface is uneven. Also top course of brick masonry on the parapet is in poor condition.		7

Remedy	Same as Item 5 above.		8

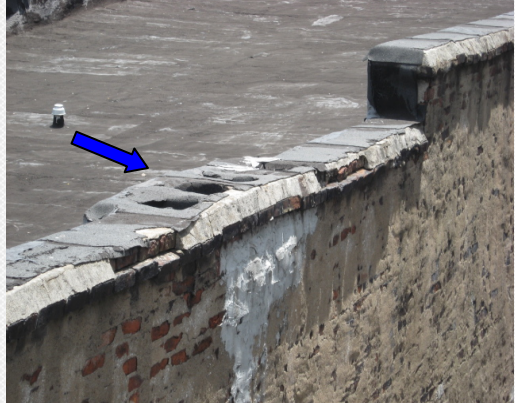
7	Close-up of Item 5 above.		8

Remedy	Same as Item 5 above.			
8	View of Bay 1 and 2 roofs. Moisture relief vents in center of roofs likely indicates a cap sheet has been added over the top of at least one roof system. Roof membrane appears to be in fair condition.			
Remedy	Roof replacement advised due to condition of flashings and copings on top of parapet walls, as noted in Item 5 above.

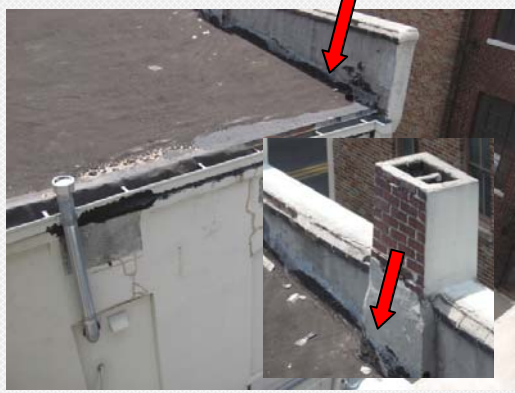
9	Water ponding along gutter on Bay 1. Previous repair evident in this location. Roof flashing at parapet uncertain as it appears to lay-up on wall and are not counter flashed. See arrow.		9

Remedy Remove all roof materials and install new single-ply roof system.		10

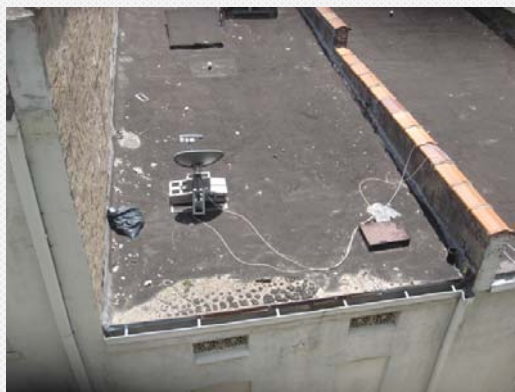
10	Bay 3. Same as Item 9 above.		11

Remedy Same as Item 9 above.		12

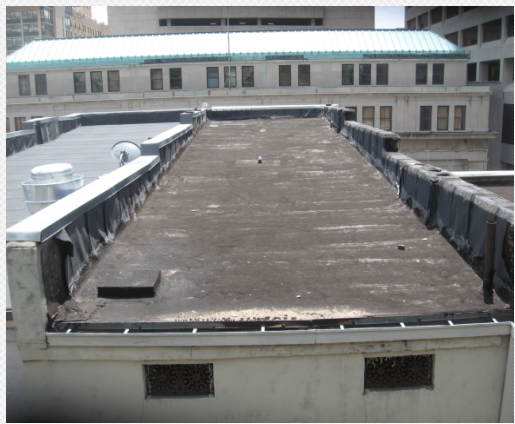
11	Bay 4. Same as Item 9 above. Plus note loose laid membrane over parapet walls.			
	Remedy Same as Item 9 above.			
12	Previous roof leaks are evident by condition of interior ceiling finishes in all Bays. Plaster ceiling of third floor in Bay 4 is severely damaged.			
	Remedy Removed plaster ceiling materials when interior renovation is anticipated.

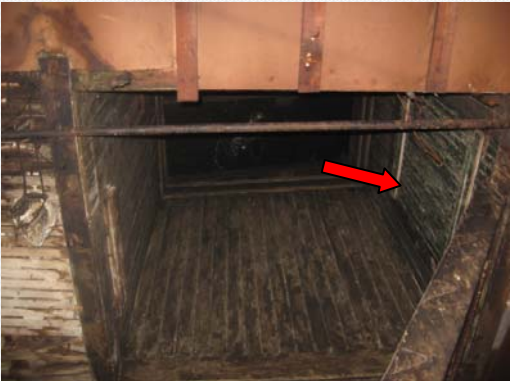
13	Wood ceiling on second floor of Bay 3 is in poor condition from previous roof leaks. Bay 3 has the only attic access via the skylight opening in the roof.		13

Remedy: Remove all ceiling materials when interior renovation is anticipated.			
14	Several roof joists that are adjacent to the skylight in Bay 3 are cracked by the weight of the skylight walls due to improper framing. See Item 15 below..		14

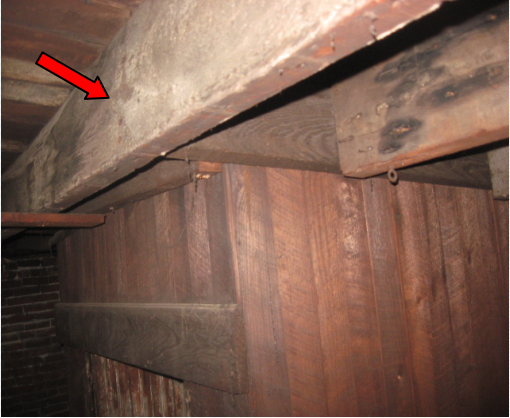
Remedy: Install new 2 x 12 wood joints on each side of cracked wood members. Or, remove skylight and enclose roof opening with new wood framing.			
15	Single roof joist on south side of skylight does not support skylight walls.		15

Remedy: Same as Item 14 above.			
16	Evidence of previous water leakage along the parapet walls of bay 3 is evident. However, wood roof joists appear to be in good condition.		16

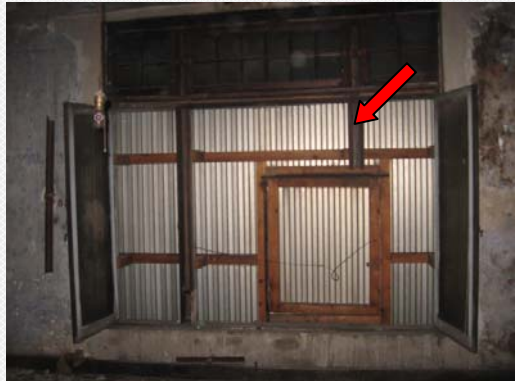
17	Wood window on front elevation of Bay 4 is in poor condition with center section of window missing. Windows have single-pane glazing.		17

Remedy	Replace window with new wood clad windows to match size and profile of existing as part of the facade renovation work.			
18	Masonry openings on the front elevation typically have steel lintels.		18

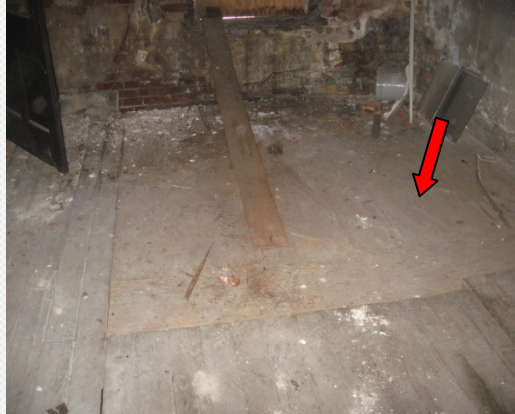
Remedy	Scrape, prime and paint existing lintel as part of facade renovation work.			
19	New floor structure has been added in the northeast corners of floors 1 thru 3 in Bay 4. Opening likely the location of a mechanical lift that has since been removed.		19

Remedy	Ideal location for mechanical chase or elevator.			
20	Windows have been removed and plywood installed at all masonry openings adjacent to the mechanical lift depicted in Item 19 above. Masonry openings have wood lintel		20

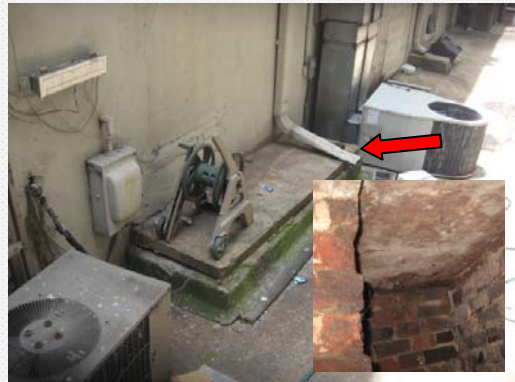
21 Downspout from roof of Bay 4 appears to be the source of water infiltration into basement. The downspout is located on top of a raised slab that covers a light well form the basement.

Remedy Seal perimeter of slab with expandable foam and extend or relocate downspout away from raised slab.

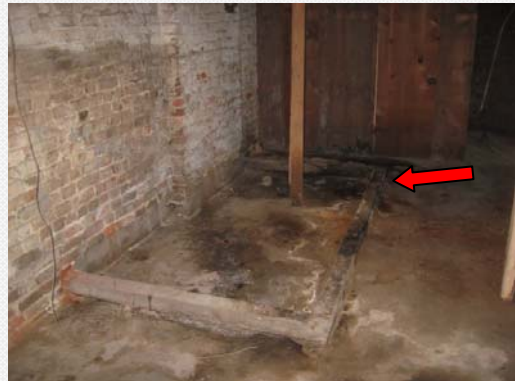
22 Damp basement adjacent to light well depicted in Item 21 above.

Remedy Same as Item 21 above.

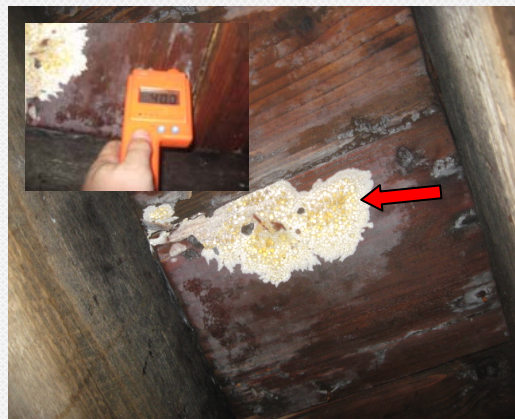
23 Underside of first floor wood decking in Bay 4 as seen from basement has organic matter growing on surface. Moisture reading of wood is 40%. Moisture Content of wood members should not exceed 19%.

Remedy Area of wet wood is localized near the back wall of the basement where water infiltration is occurring. Stop water infiltration and treat affected areas with a bleach solution. Apply forced air ventilation over over wood members until a moisture content of 19% is reached.

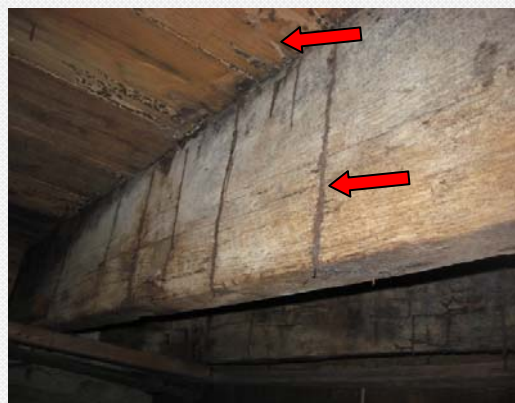
24 Termite shelter tubes were observed on some floor joists near the back wall of the basement of Bay 4. The wood members appear to be structurally sound.

Remedy None.

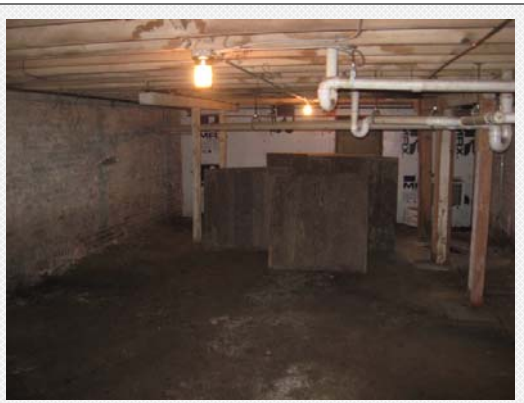
25	Half of basement in Bay 2 has dirt floor. Relative humidity is very high. Three moisture sources were identified: water vapor from dirt floor, hvac condensate, and plumbing leak under bar.		25

Remedy Install vapor retarder over dirt surface and place 4 inches of concrete over top of vapor retarder. Install ventilation or HVAC system. See also Items 26 and 25 below

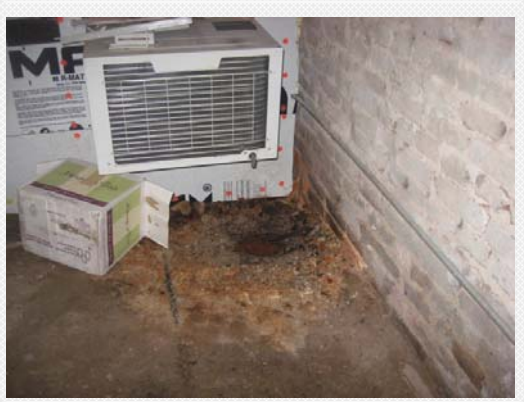
26	Condensate from HVAC unit located under stairs that provides conditioned air to the Wine Cellar drains onto dirt surface.		26

Remedy Install a condensate pump with drain connected to drain under bar area.			
27	An active plumbing leak was observed under the bar at a drain.		27

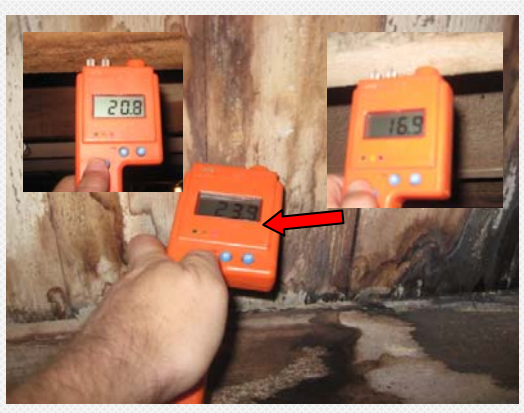
Remedy Repair leak.			
28	A moisture reading of the wood framing that is adjacent to the plumbing leak was 23.9%. Two other readings were also taken further away from leak location.		28

Remedy See Item 25 above. The moisture reading of 16.9% is an indication the RH in the room is too high.
