Property Condition Assessment

**100 North Main
100 North Main Street
Memphis, TN 38103**

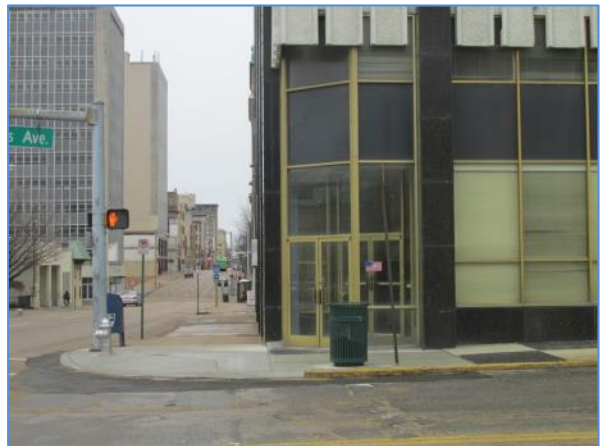
Downward slope to the south viewed looking south across from northeast property corner

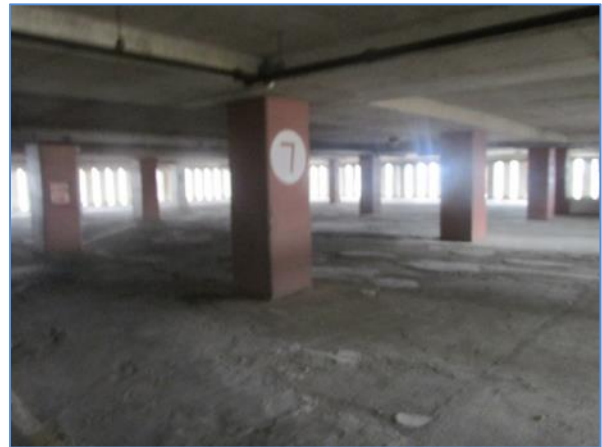
Deteriorated pavement conditions at level 7 of the parking garage

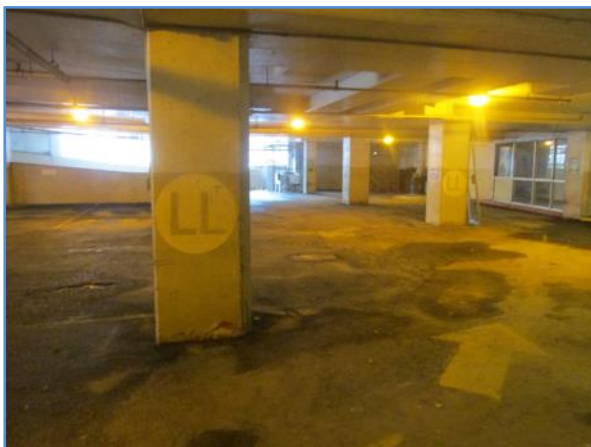
Deteriorated pavement conditions at the lower lobby level of the parking garage

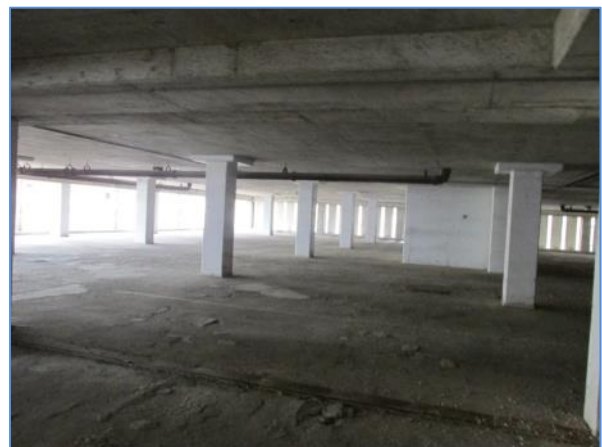
Deteriorated pavement conditions at level 7 of the parking garage

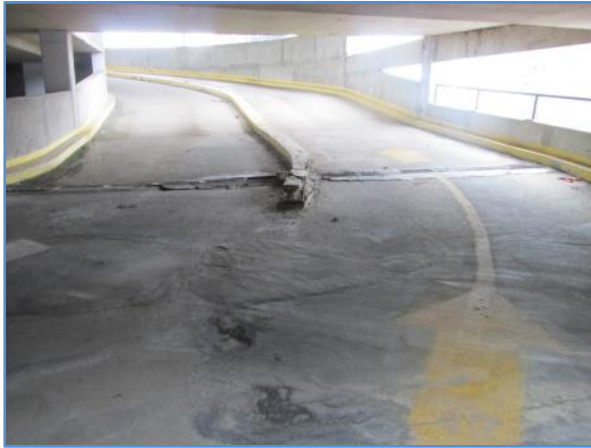
Deteriorated pavement conditions and concrete curbing (center) at the upper garage level ramp

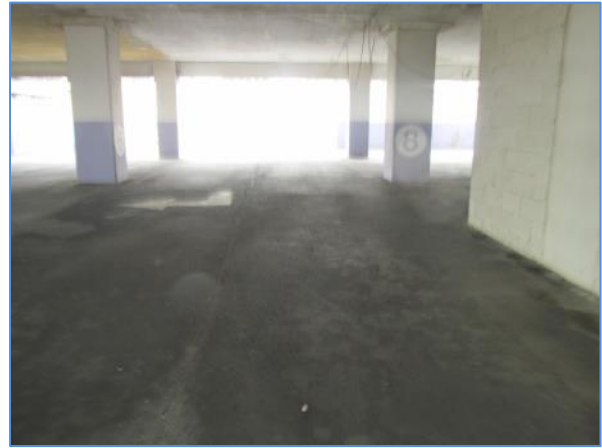
Pavement conditions at level 8 of the parking garage

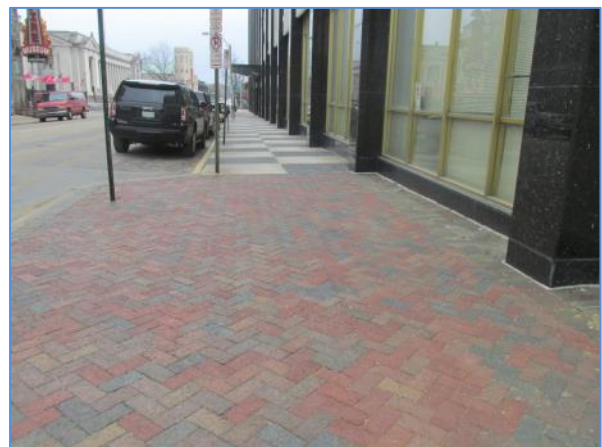
Brick and black and white aggregate sidewalk, north side of the building, looking east

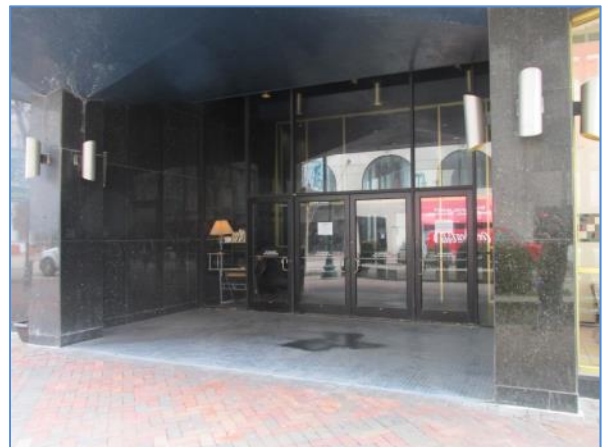
Building-mounted lighting fixtures at pedestrian entrance along Main Street

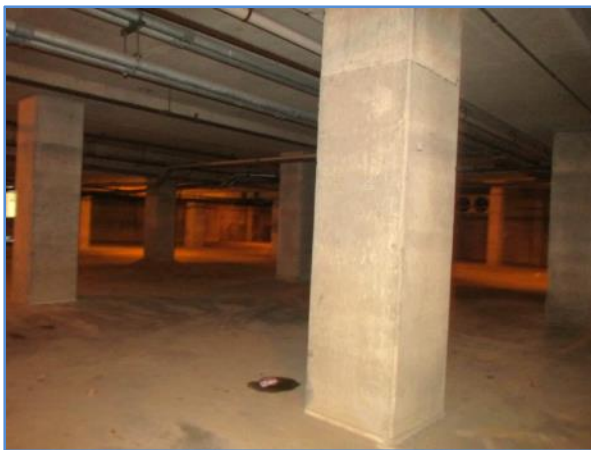
Reinforced concrete columns and floor in the lower level of the parking garage/basement

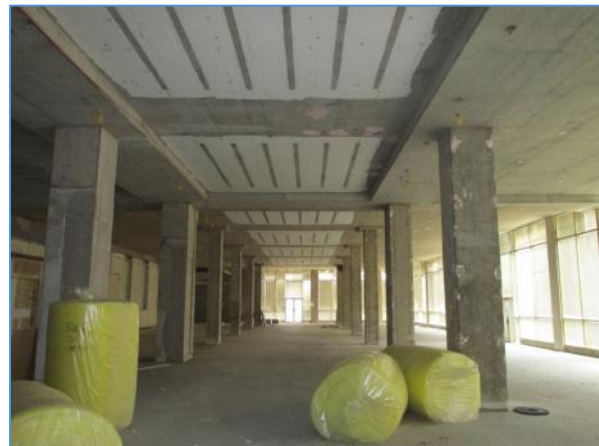
Vacant area on the first floor showing reinforced concrete floors and columns

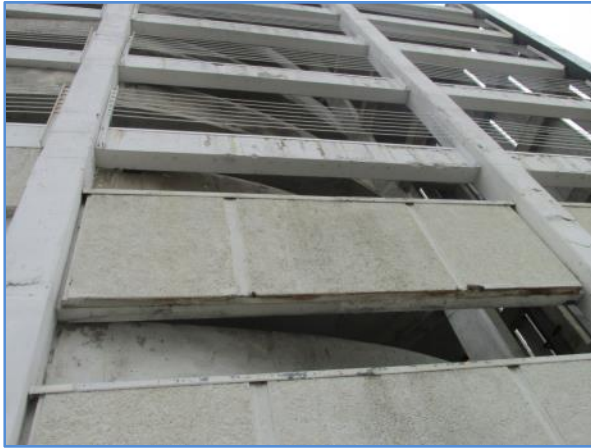
Façade conditions at the south side of the building at the parking garage

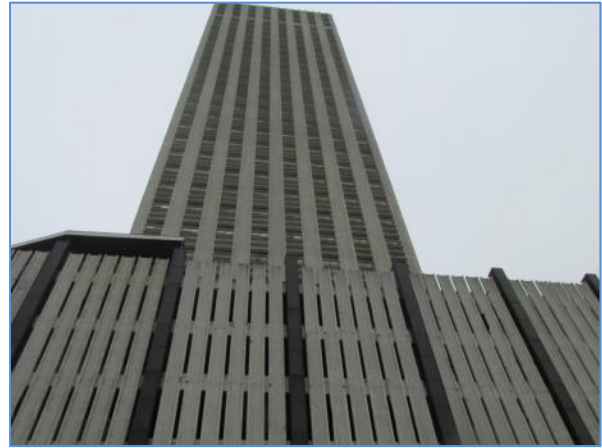
The concrete façade on the east side of the building; note marble panels on the lower level

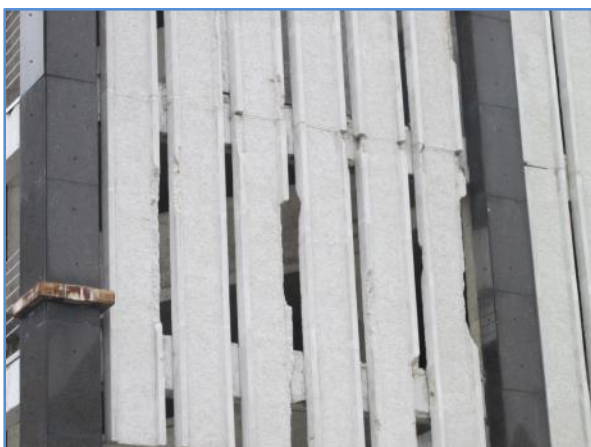
Close up view of damaged concrete tiers on the southeast corner of the building parking garage

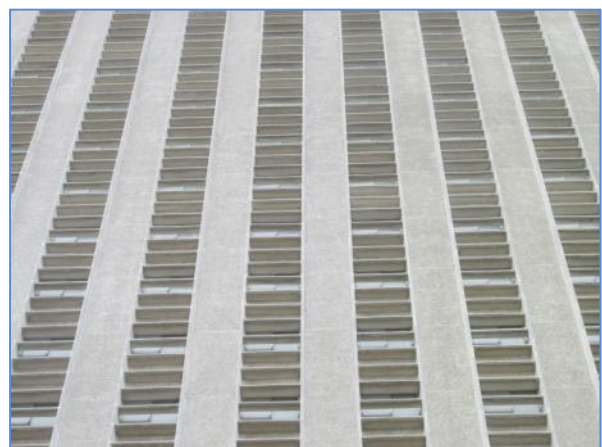
Close up view of the upper level facades on the north side of the building

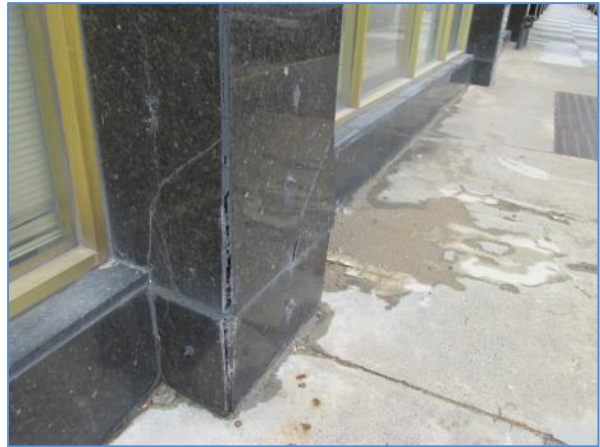
Damage to marble cladding on the lower north facade

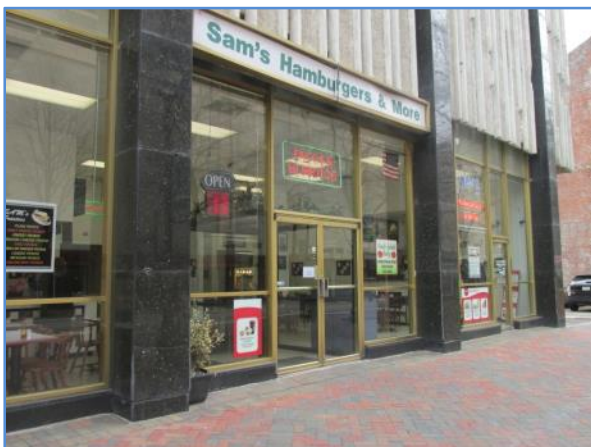
Storefront windows and doors at restaurant on southwest corner of building

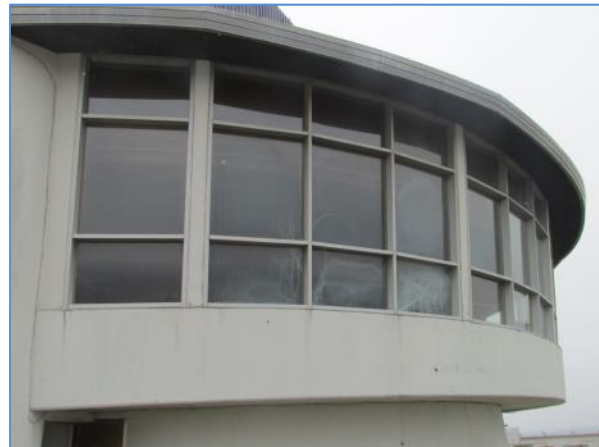
Close up view of the windows and façade at the rotating restaurant/lounge on the roof

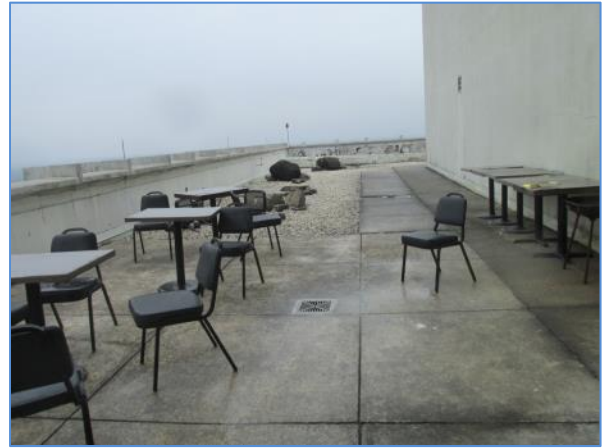
Another view of the concrete pavers and outdoor seating area for the rooftop lounge

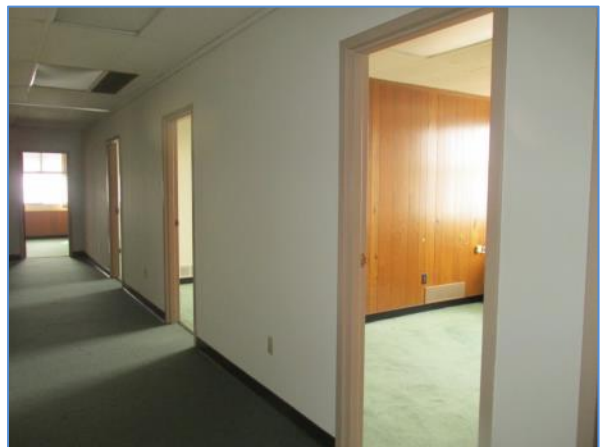
Another representative office space

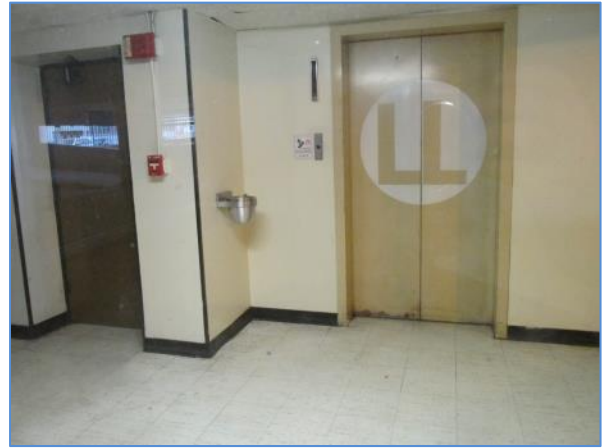
Elevator lobby at the lower lobby level

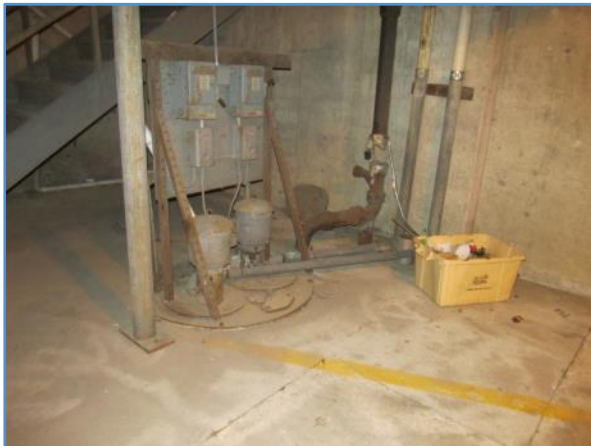
Basement sump area in the parking garage

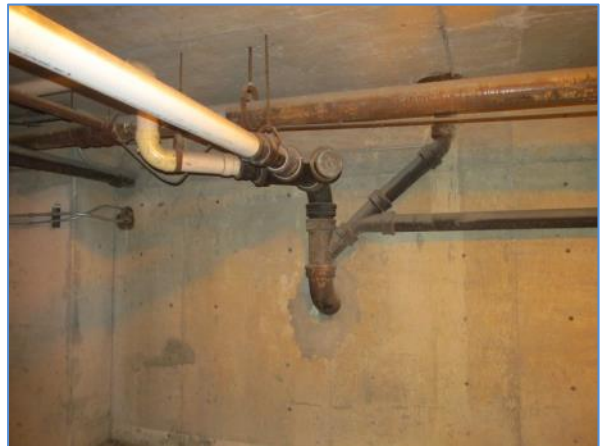
Waste lines in the basement parking garage; note PVC replacement piping

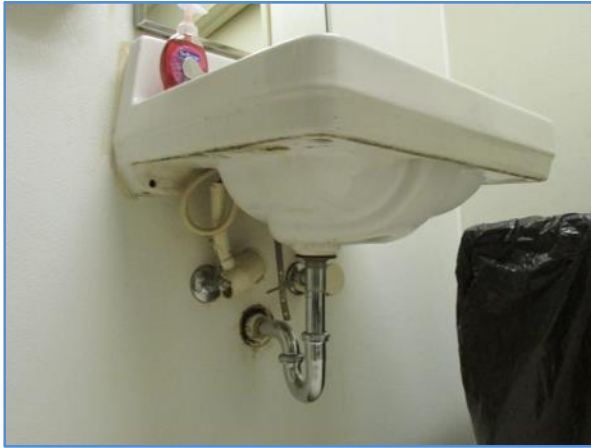
Typical piping beneath a restroom sink

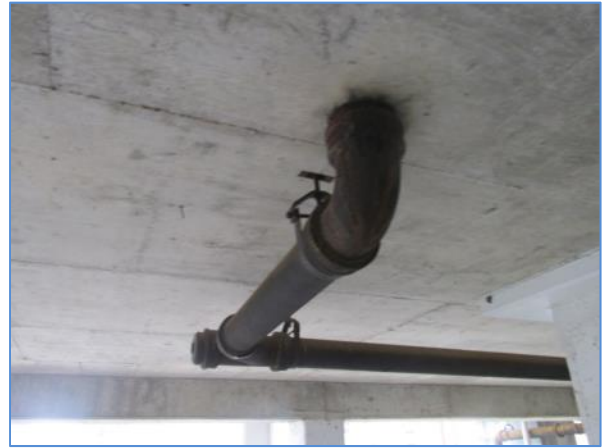
Cast iron drain line at the 7th floor of the parking garage

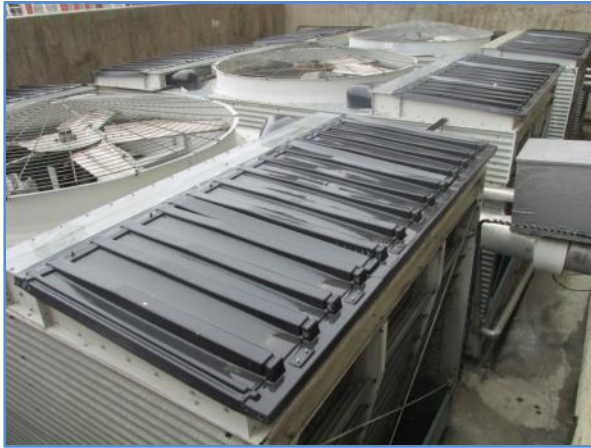
Three of the cooling towers as viewed from the 8th floor parking deck

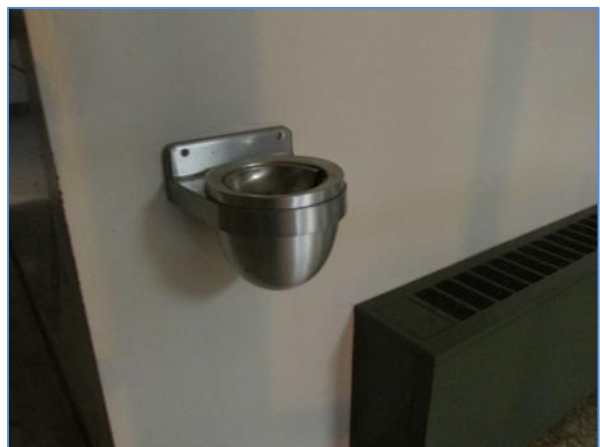
Floor mounted radiator unit in the lobby

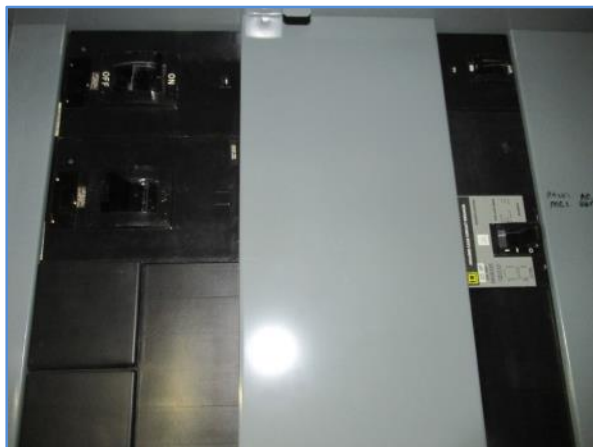
Typical electrical panel in the basement electrical room

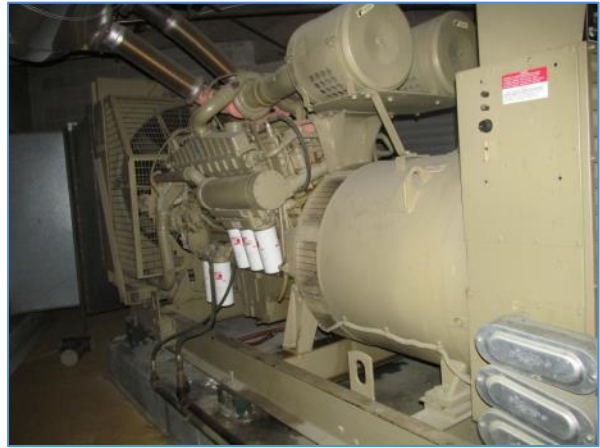
The inactive emergency generator in the basement level of the parking garage

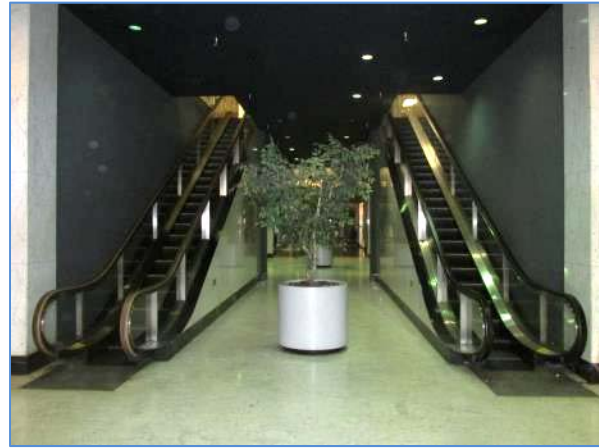
Escalators on the ground floor

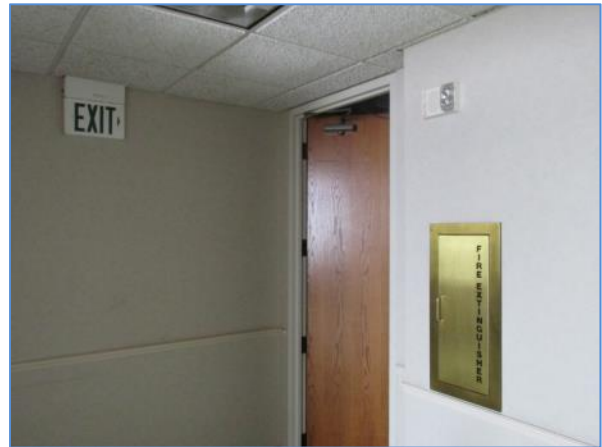
Exit signage, strobe and fire hose in a wall mounted cabinet on the 34th floor

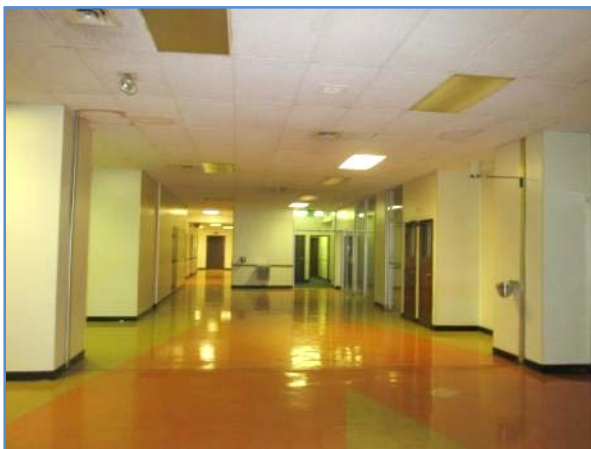
Stained ceiling tiles in the 4th floor common corridor

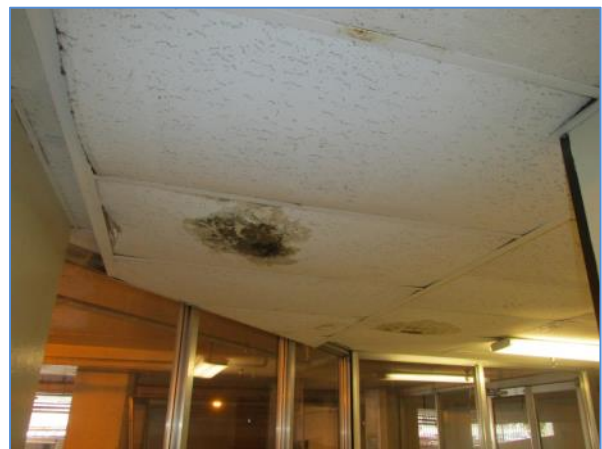
Stained ceiling tile in the lower lobby common corridor

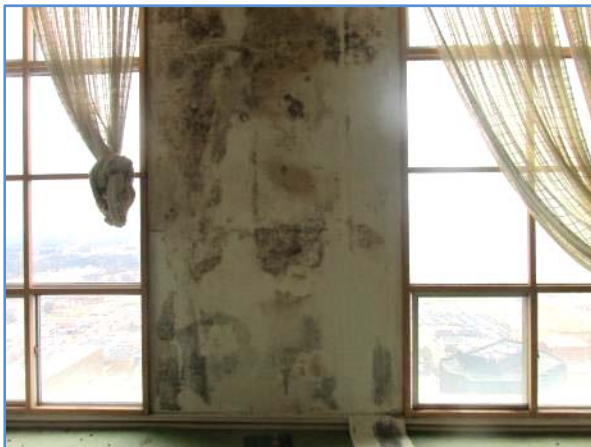
Suspected water damage due to window leaks on the 34th floor

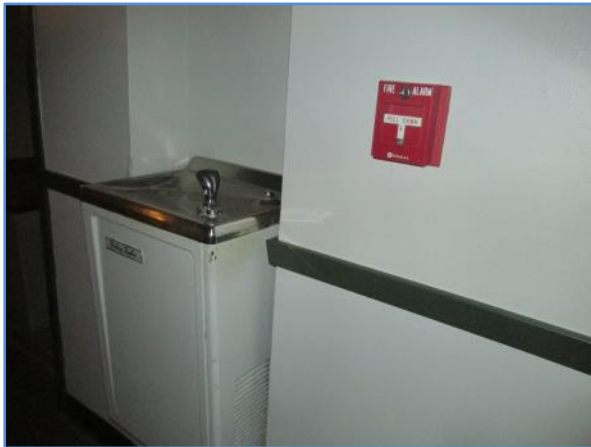
Non-compliant water fountain in a common hallway on an upper floor
