# Downtown Houston Pedestrian Lighting

Existing Conditions Lighting Analysis Report

[www.arup.com/lighting](http://www.arup.com/lighting)  
[www.arup.com/night\\_time](http://www.arup.com/night_time)  
Downtown Houston Pedestrian Lighting - Existing Conditions Lighting Analysis Report | January 2024

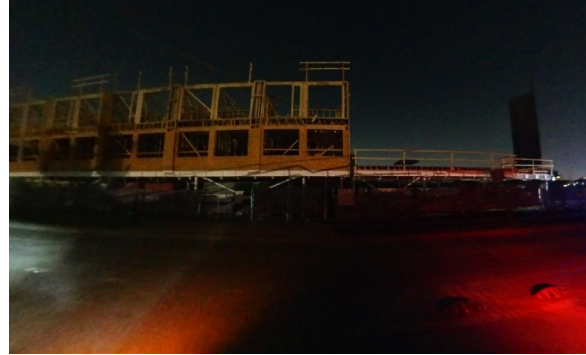
Many areas of Downtown have minimal to no lighting at night, creating dark and unfriendly feeling spaces.

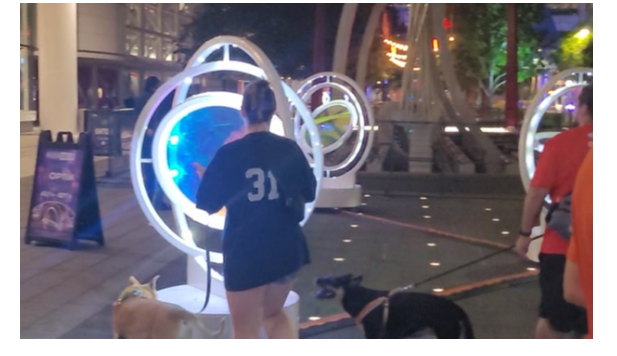
Underpasses tend to gather groups of the unhoused community. The Bagby Street Underpass (shown) is brightly illuminated with art pieces, whereas other underpasses around the outskirts of Downtown Houston are illuminated with 1-2 luminaires.

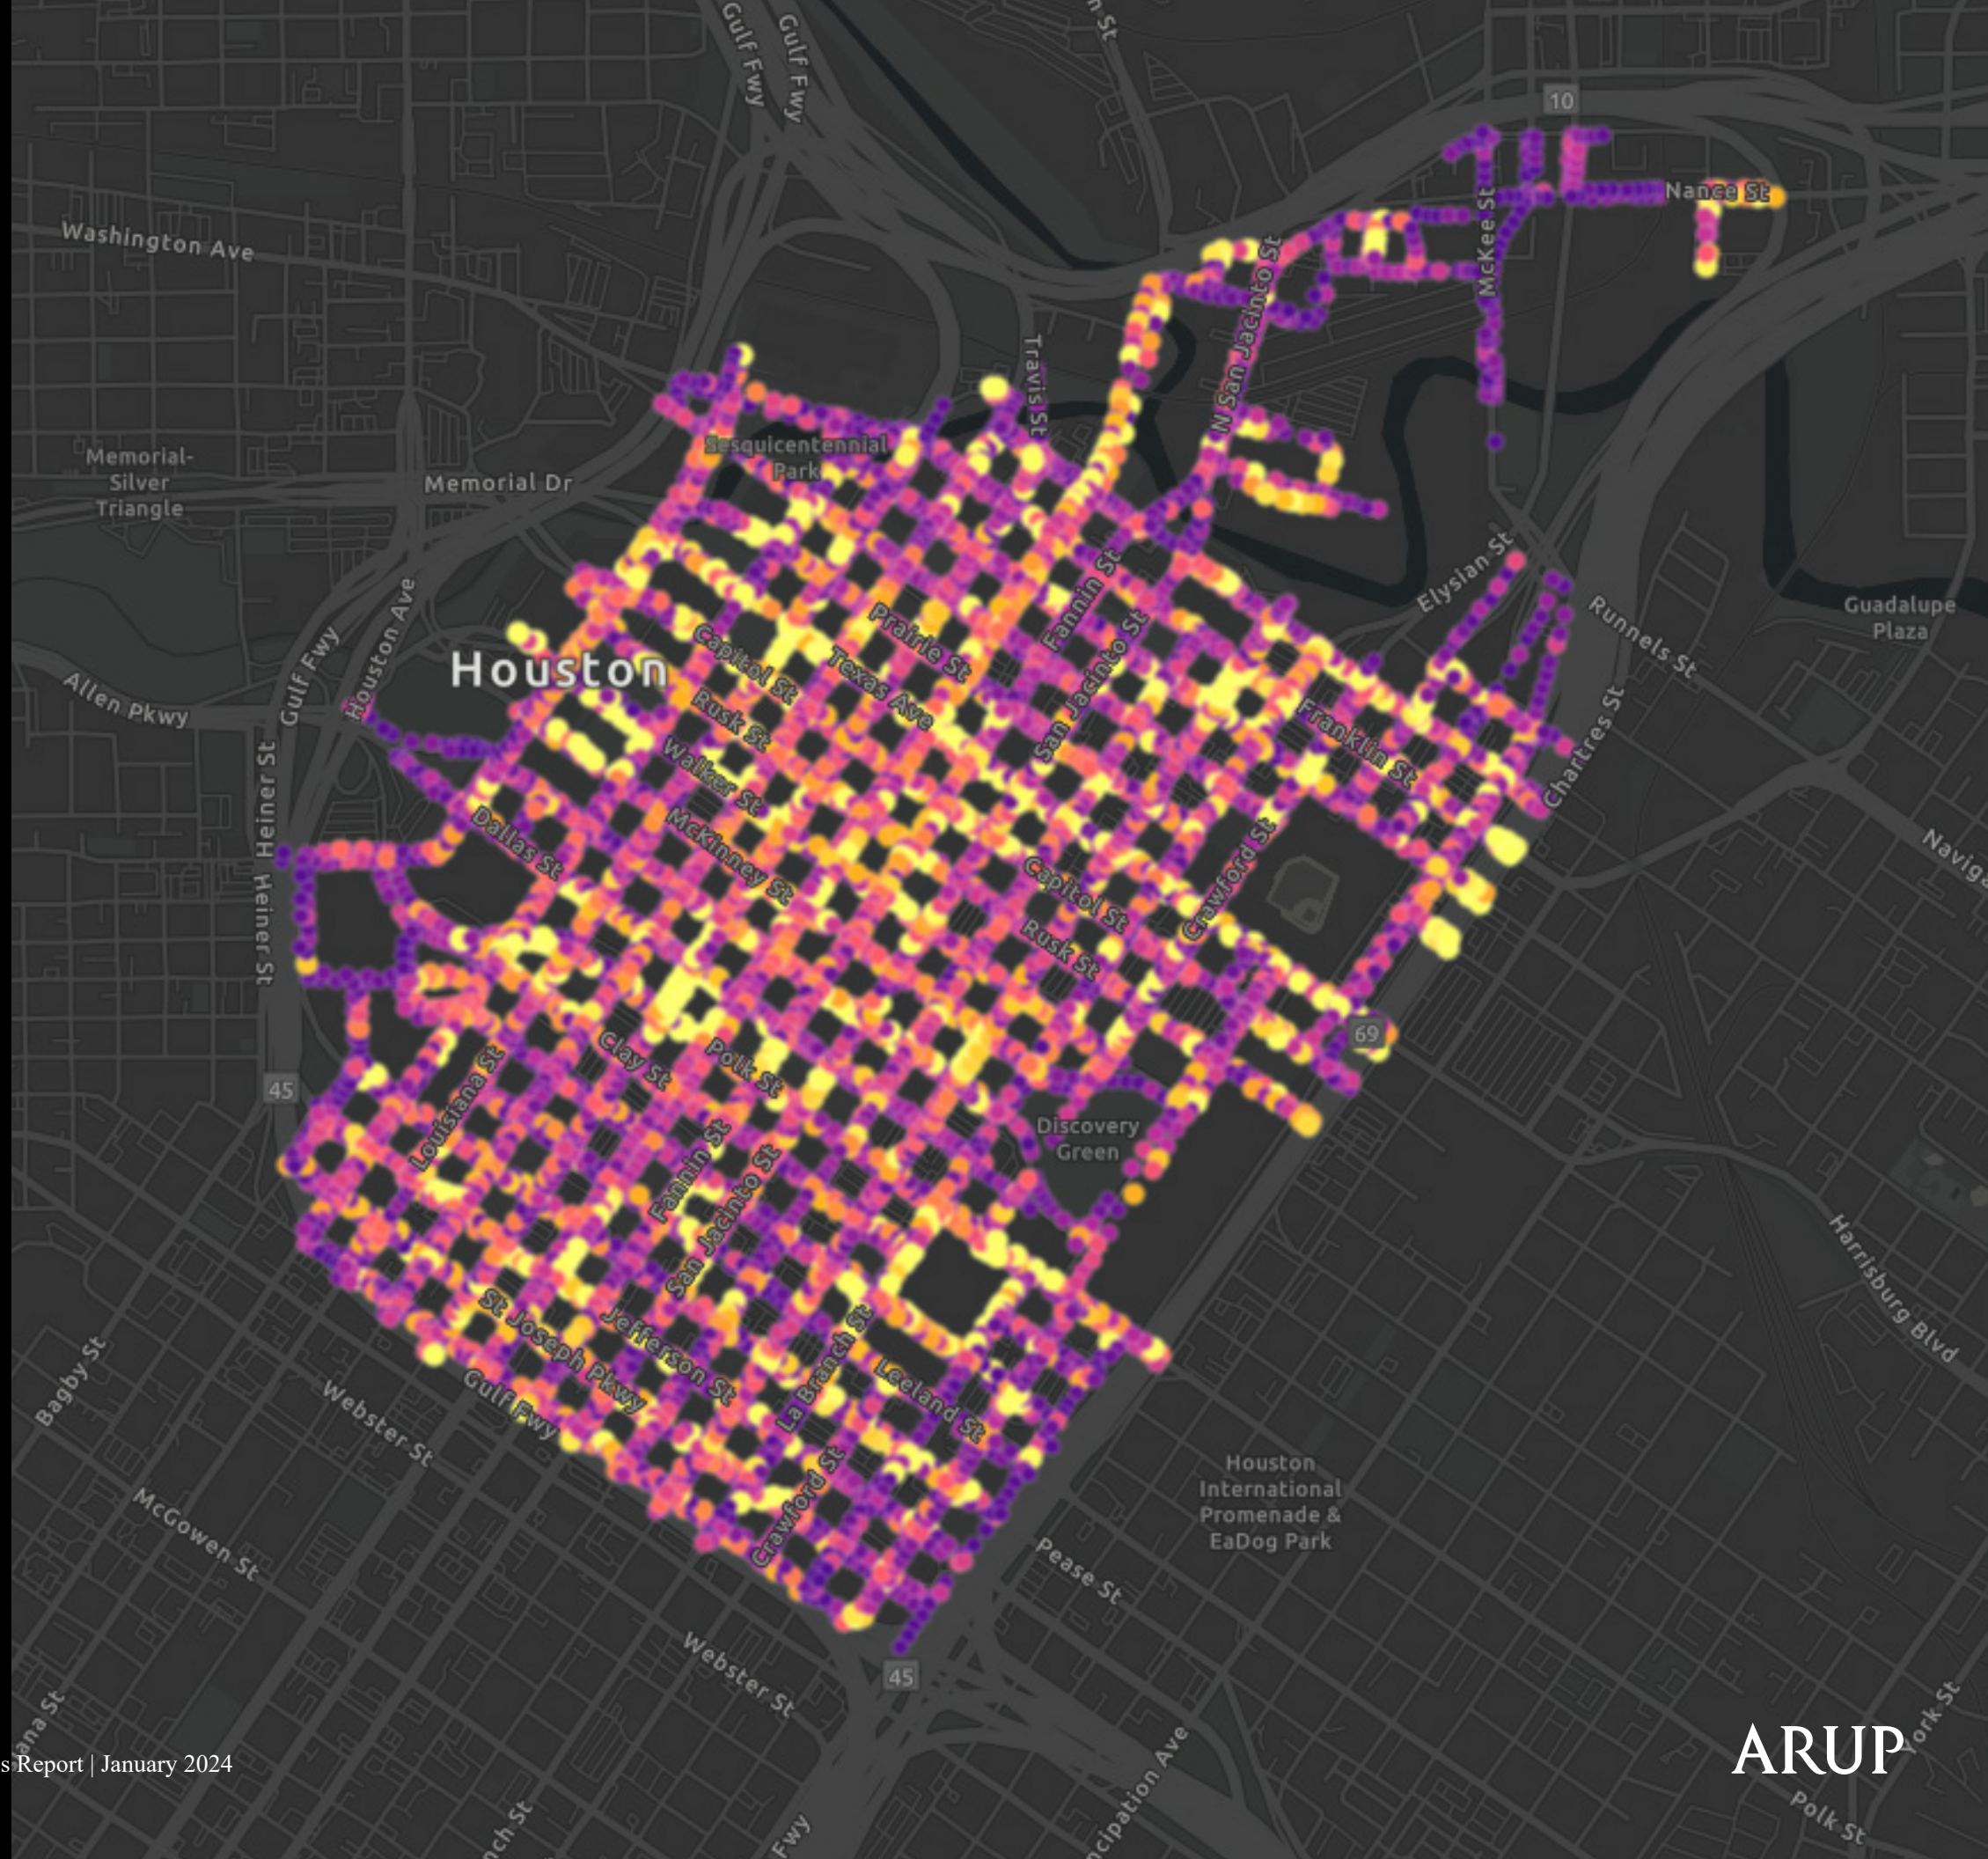
Over 6550 points were taken, generating the heat map located to the right. 2fc is an industry reference for outdoor lighting levels. A higher fc measurement indicates that the location is more brightly lit. The darker purples and pinks are measurements below 2fc, the brighter pink is around the 2fc level, and the orange and the yellow are above the 2fc level.

Brighter than 2fc can cause glare to those walking through the space. This can create a spotlighting effect, where the user is brightly illuminated and unable to see those coming towards them from a darker space.

Darker than 2fc can cause a reduced perception of safety, due to users being unable to see what and who is around them.

Ideally we would like consistency in the colors across the entire map. Fluctuating light levels across an area can contribute to a sense of insecurity, as there are pockets of too much or too little visibility.

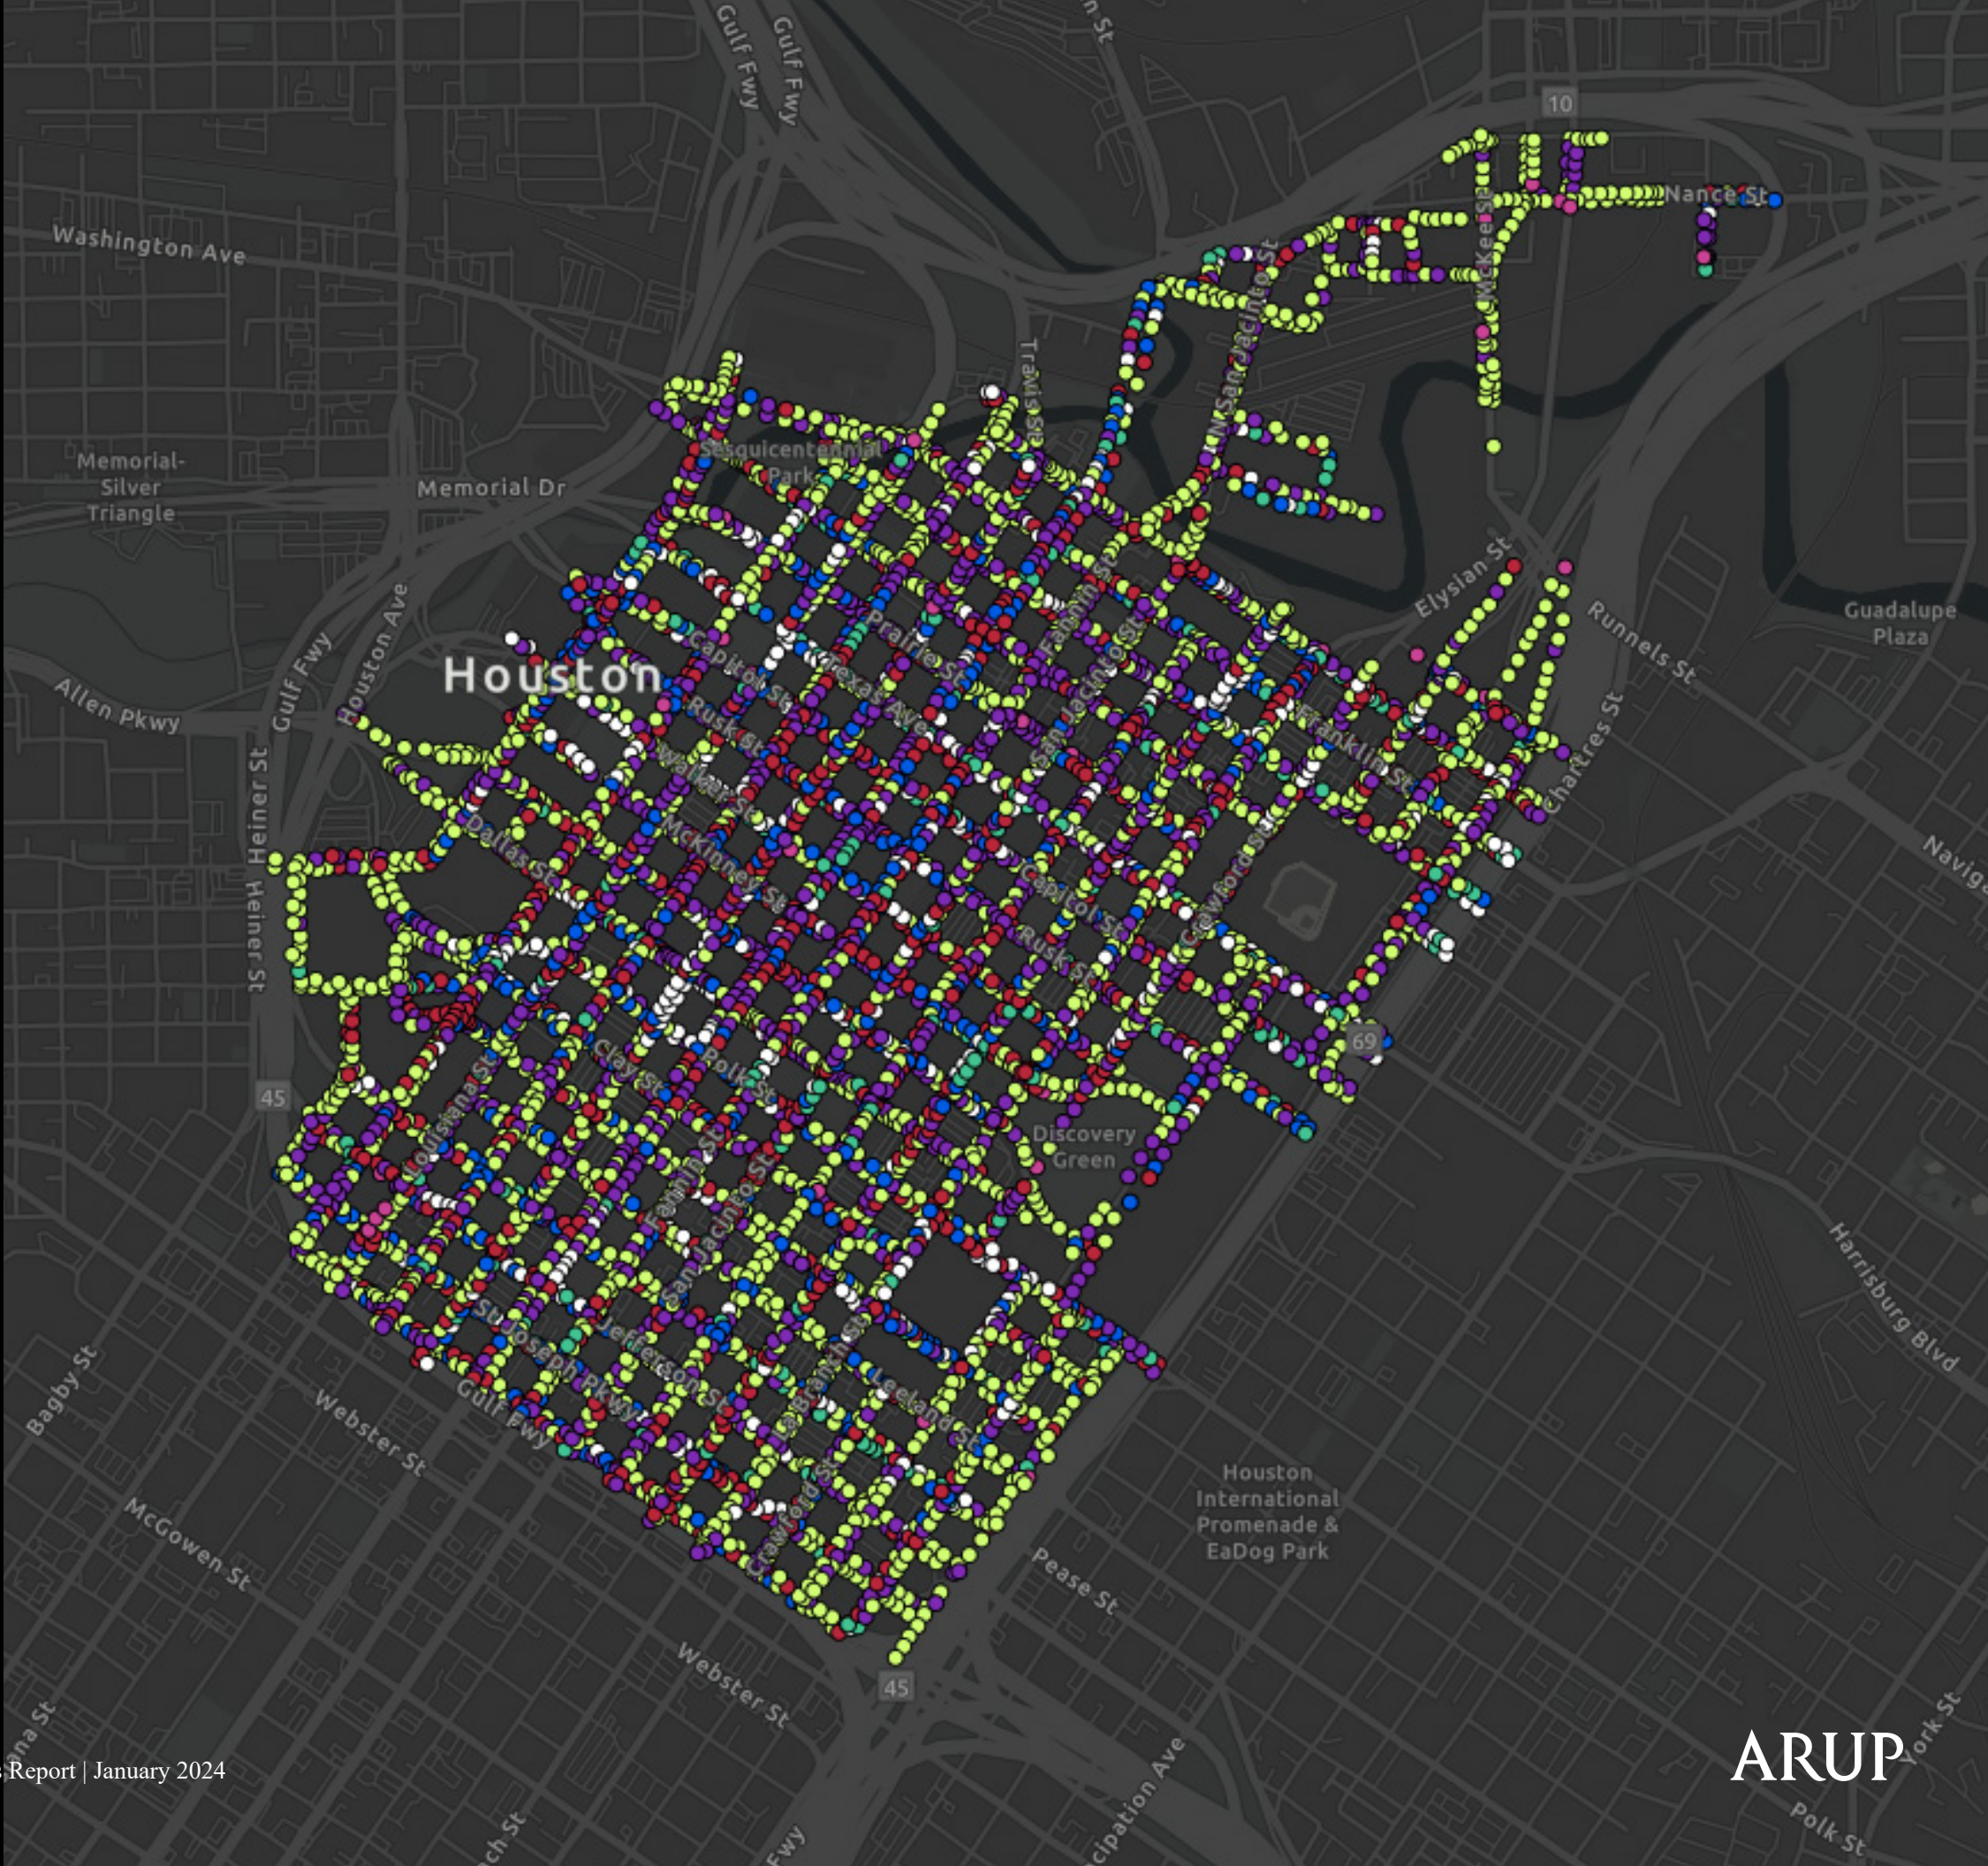
Another way to visualise this map is through each point showing its value in foot candles. All the areas in the light green are those that have potential for improvement.

It is to be noted that 2fc is the aimed for standard, however, between 1 and 4 footcandles can be acceptable, depending on the surrounding conditions, such as areas under canopies or front store of an active retail. As mentioned on the previous page, too high or too low a variation from 2fc can reduce the perception of safety.

Anything that is too high (white in colour) can be a problem, due to the high contrast.

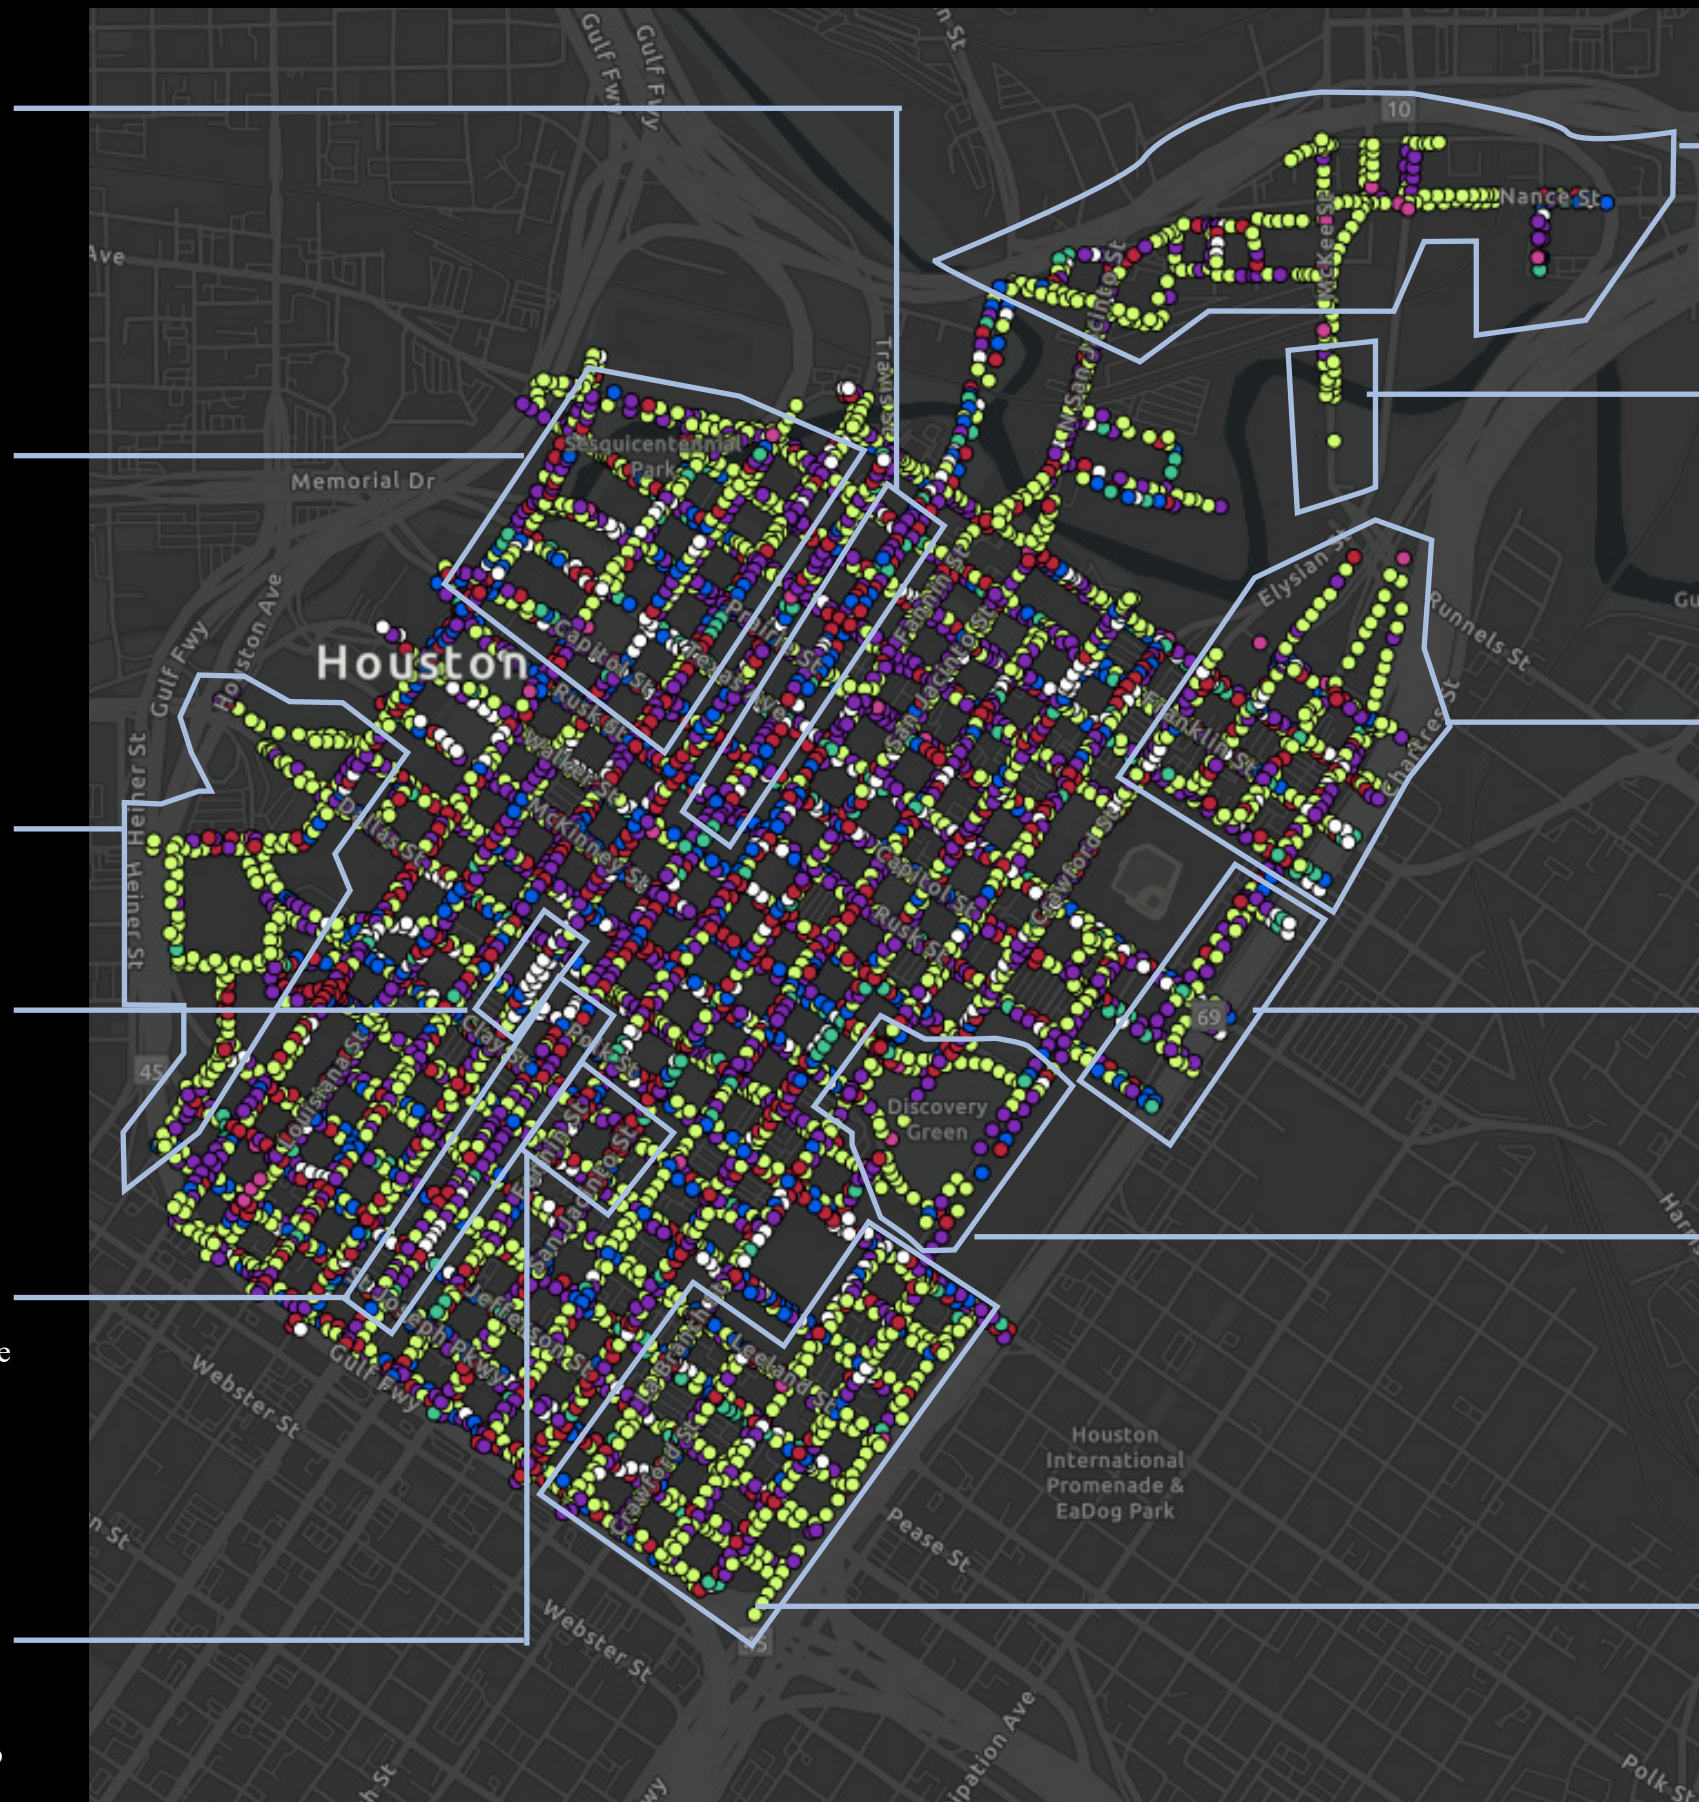
The Warehouse district has a consistently low illumination level with active construction work blocking some of the sidewalks. This reduces feelings of safety and both physical and visual transparency.

Here, there is a lack of public pedestrian lighting with social-economic issues which drive the location to feel very unsafe for any user walking through.

The typical condition of the underpass are 1-2 floodlights, which although they provide illuminance, they lack quality. It generates glare and is not inviting for pedestrians.

The combination of low lighting levels, empty parking lots and no pedestrian presence, makes the space feels unsafe.

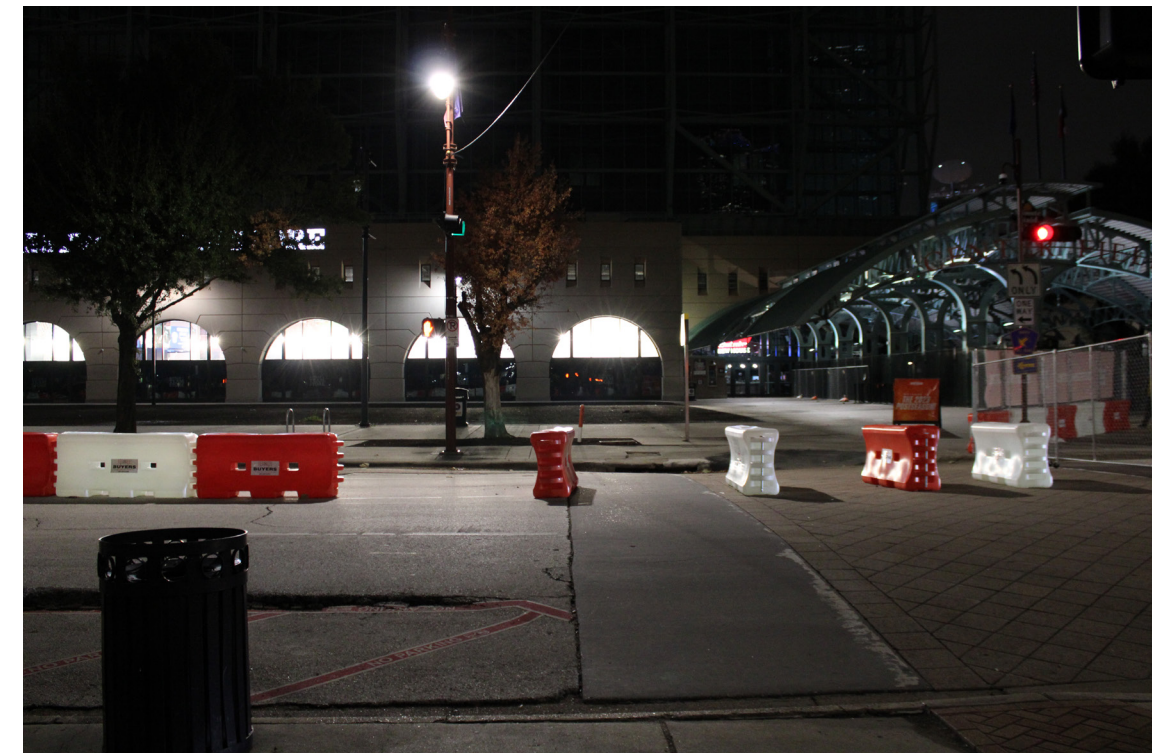
# Texas / Caroline

This location is missing human scale elements - there is a flat, dark parking lot which contrasts with the large lit façade of the prison. This contrast in scale and surface reflectance raises the vulnerability score, tipping it over into the medium score. As with a range of locations across Downtown, many of the trees have grown over the street lighting, making the sidewalks much darker than they were originally designed to be. Introducing activation of the parking lot at night, and bringing more lighting into the trees will improve the feeling of this area.

Key Opportunities for this site are listed below and are expanded upon at the end of the location overview section

- Illuminate foliage
- Activate empty parking lots

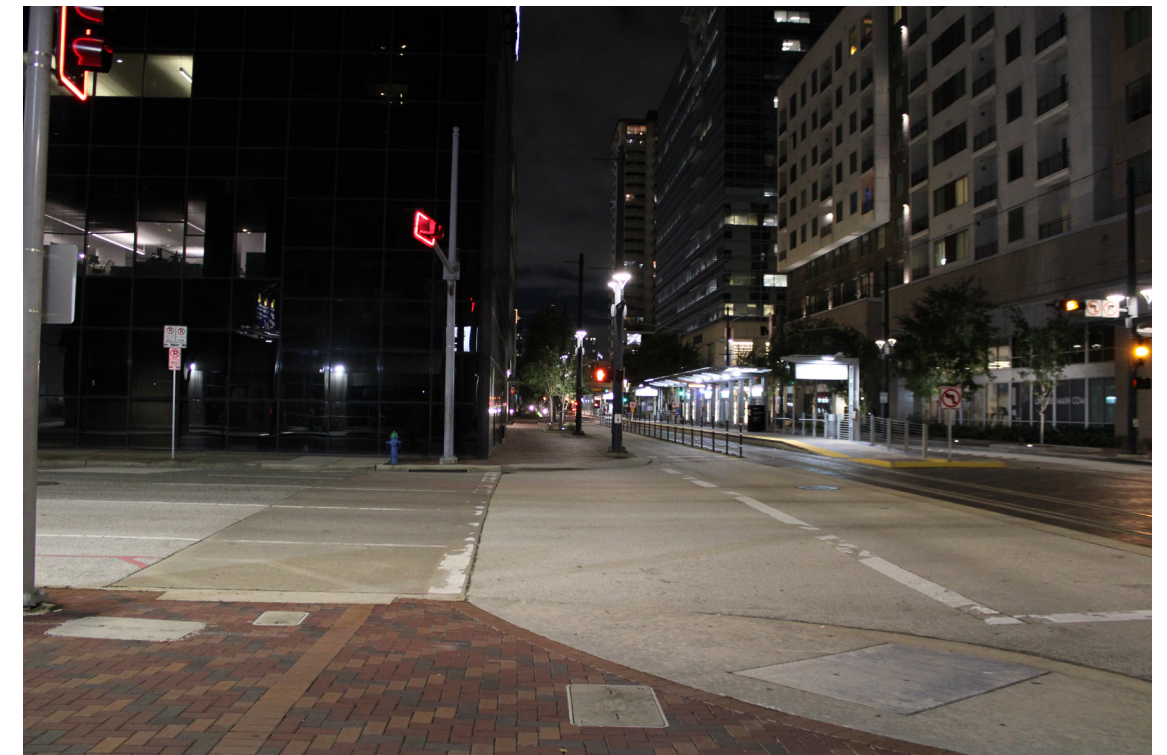
# Pease / San Jacinto

A lot of traffic and car noise, but no foot traffic. A lot of dark walls that make the space feel enclosed with broken sidewalks. It looks and feels disconnected from Downtown.

- Illuminate foliage
