DESIGN REVIEW BOARD APPLICATION

Project Description: This project includes the renovation and restoration of the building's exterior, repair or complete replacement of the roof, accessibility upgrades, the preparation of the interior for a future commercial tenant (TBD), and upper-level apartments.

24 S Main St
Facade Improvements
October 2022

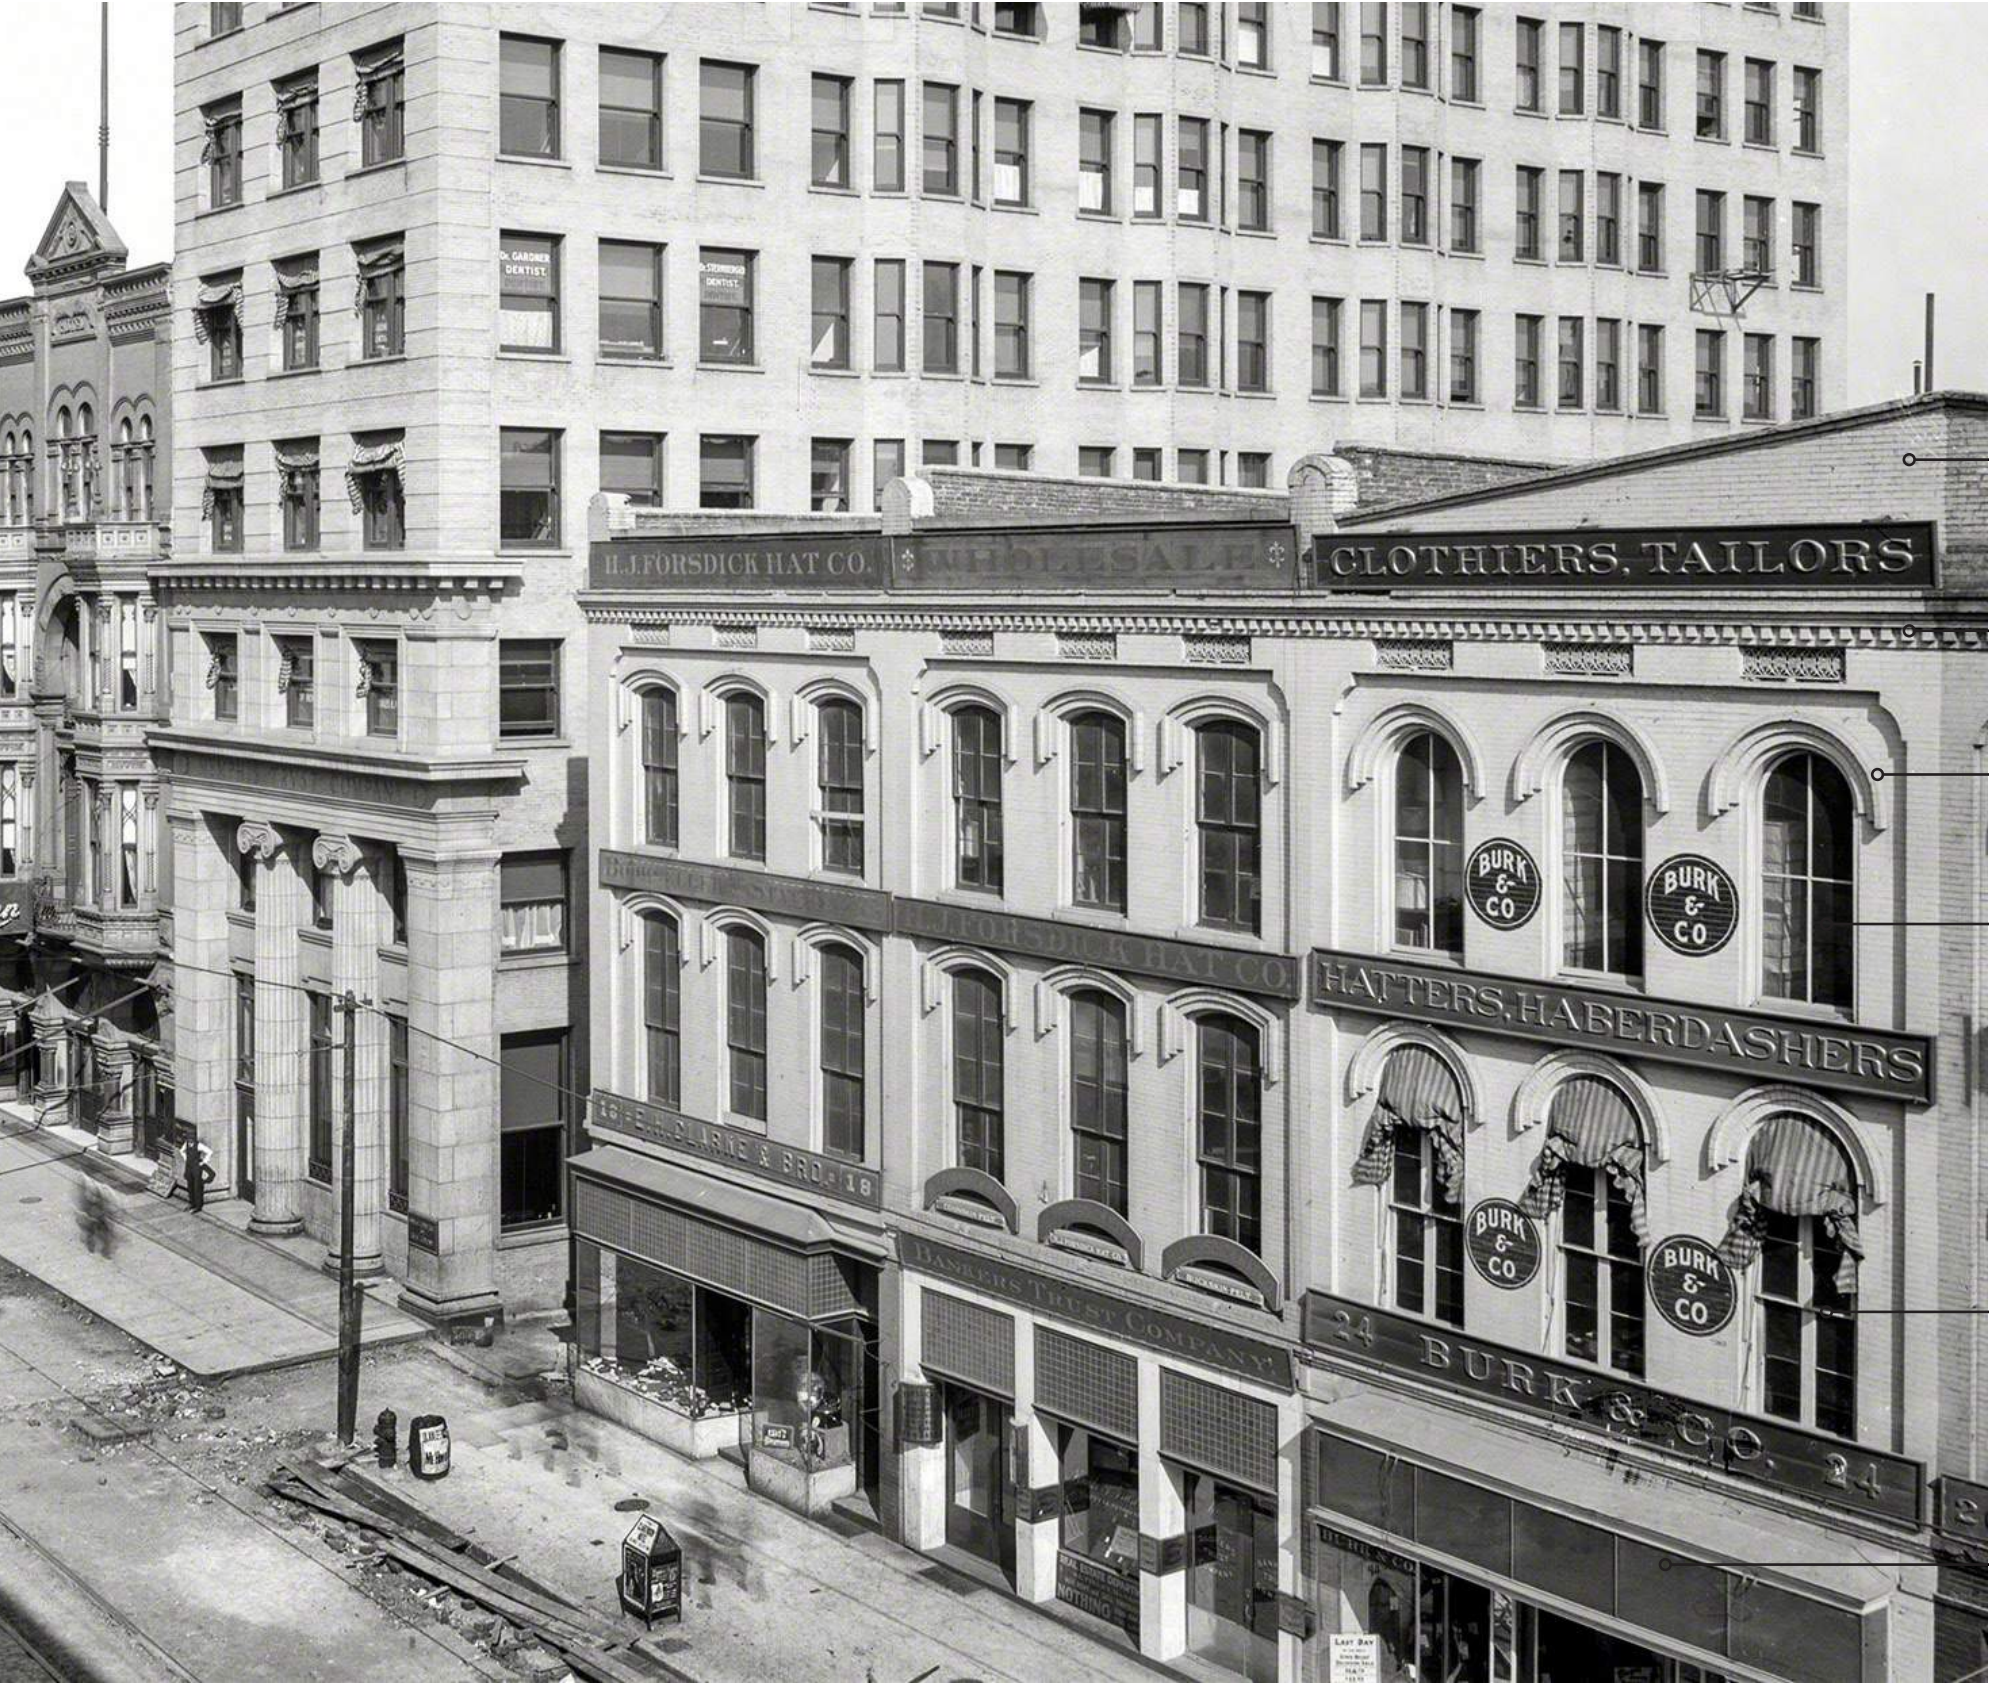
Historic Images

- 1. Historic Western parapet was paired with that of 26 S. Main and mirrored each other with a slope towards their center. Both parapets have since been removed of the slope and are level.
- 2. Corbelled architrave above attic vents was continuous across four buildings, 18-26 S. Main. This feature has since been removed from all four buildings.
- 3. Three projecting courses of arching masonry caps each upper story window. The outter course has since been removed from each to accommodate the existing stucco facade that hides the historic masonry facade seen here.
- 4. Windows at Level 03 appear to be fixed.
- 5. Windows at Level 02 are hung windows and featured exterior cloth shades.
- 6. Projecting storefront canopy with false clerestory covered the ground floor entrance(s).

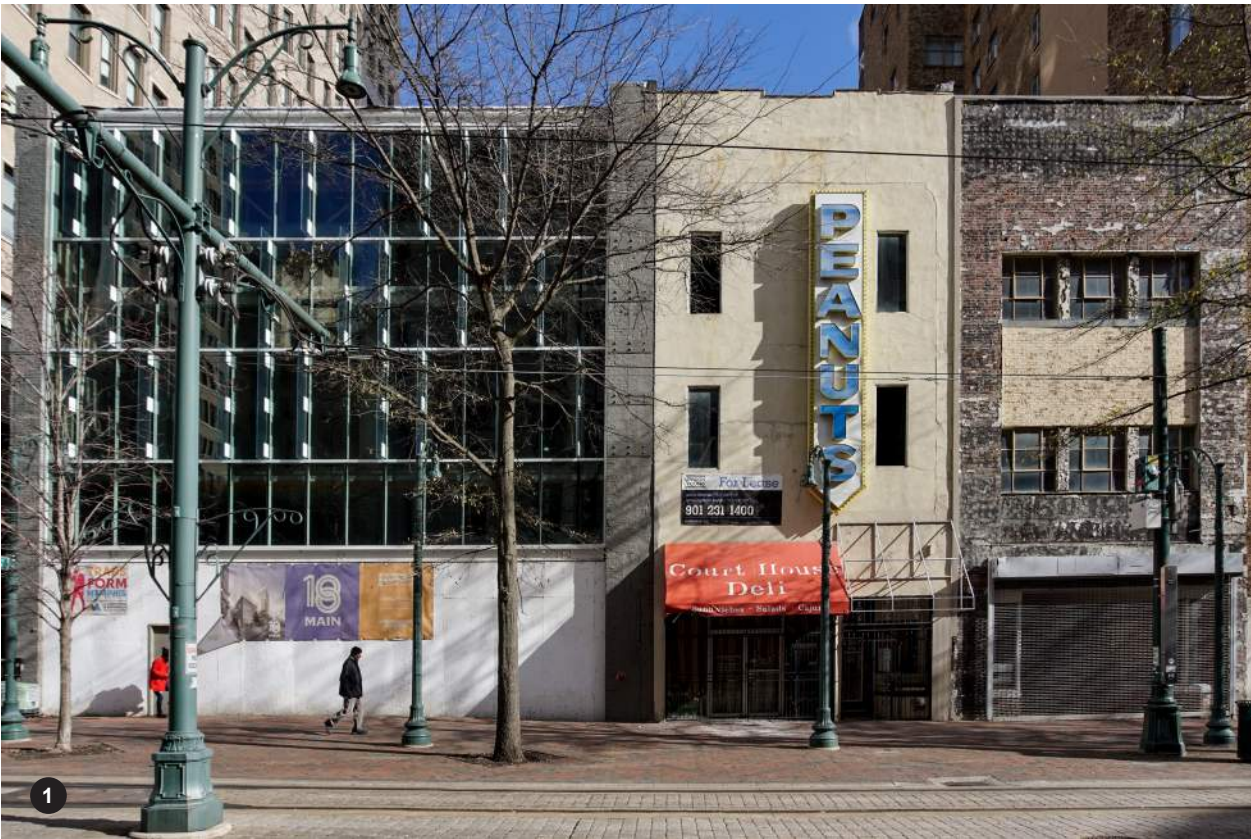
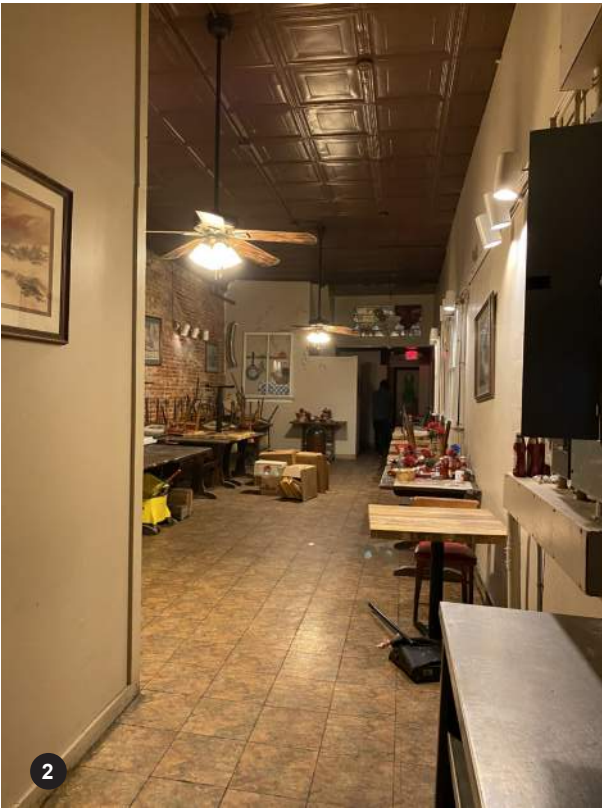
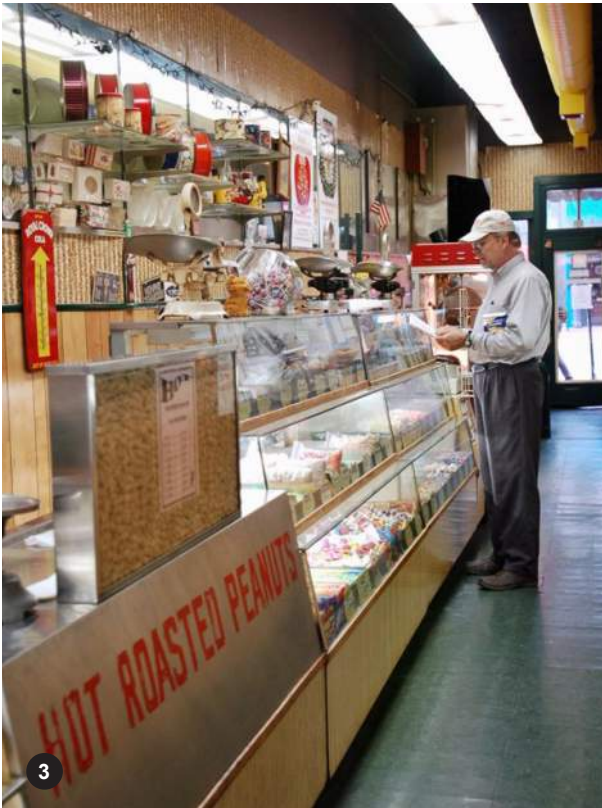
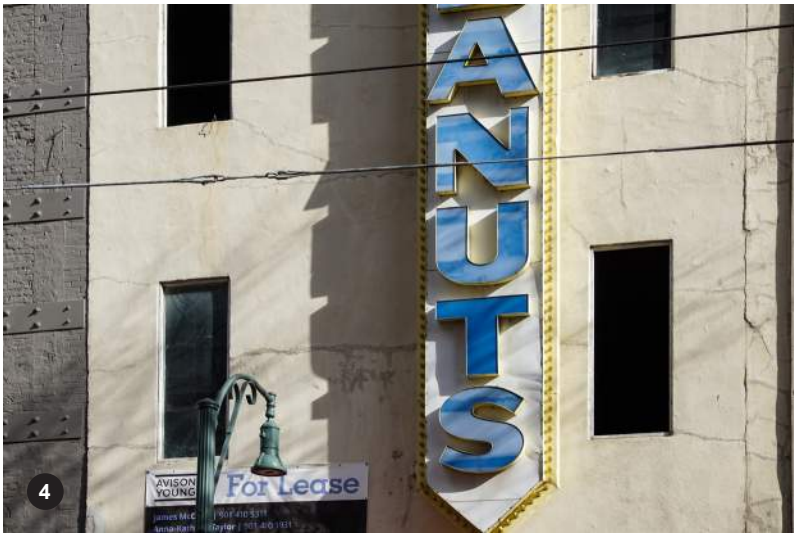
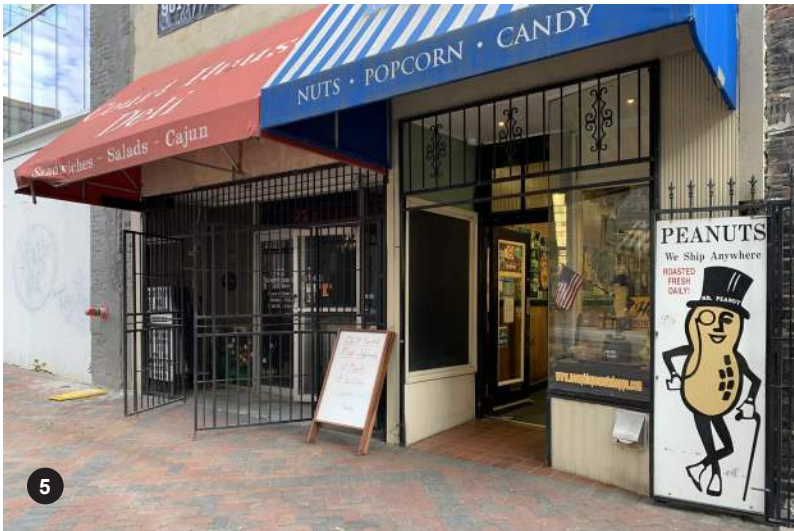
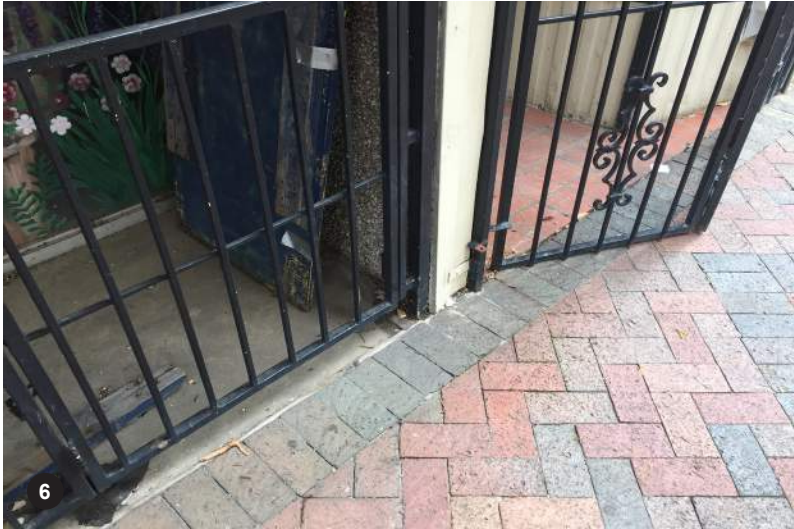
Existing Conditions

- 1. Elevation view of building at 24 S. Main St.
- 2. Dining area towards rear of northern commercial bay on ground level.
- 3. Retail area within narrow southern commercial bay on ground level.
- 4. Detail photo of West facade and signage.
- 5. Streetscape along storefront entrances.
- 6. Detail photo of transitions between street and gated storefront entrances.

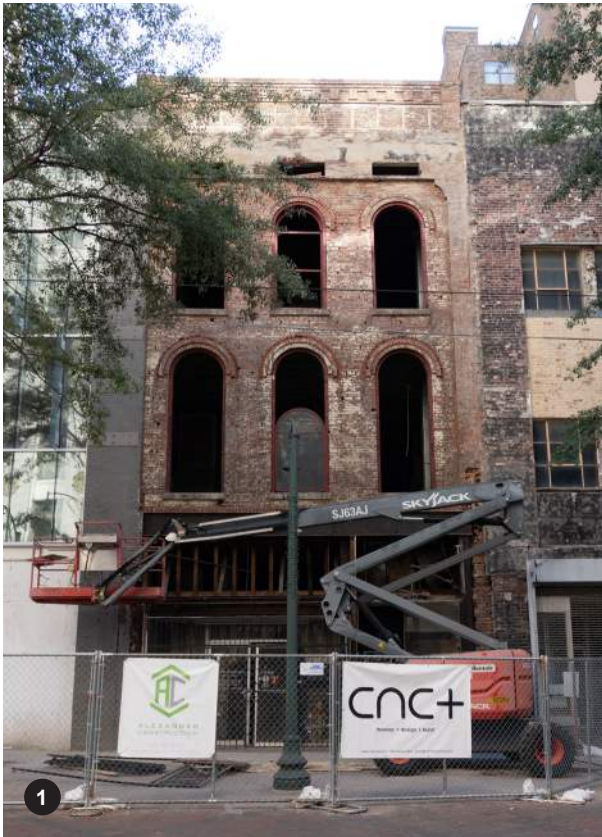
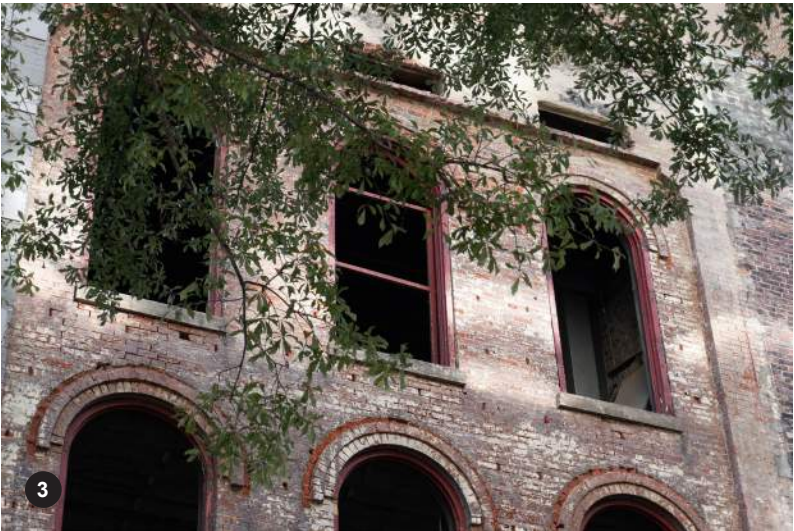
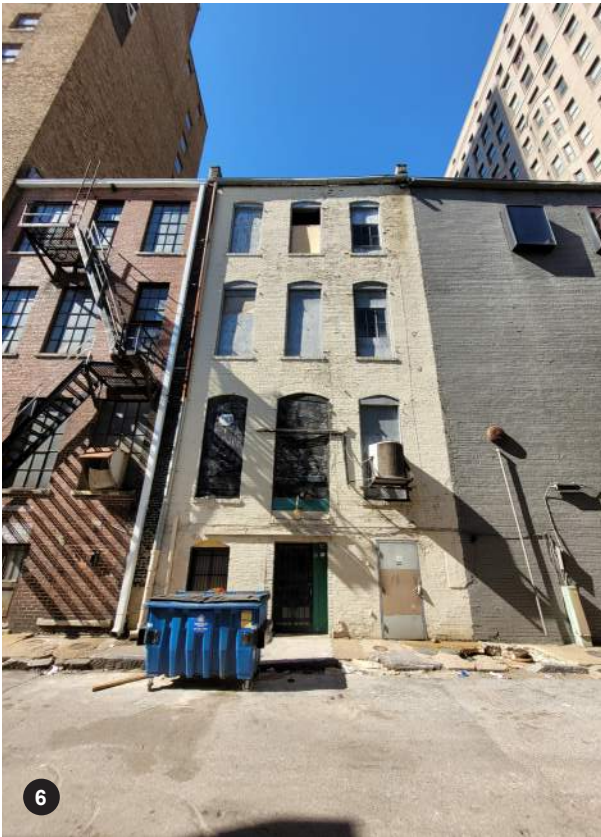
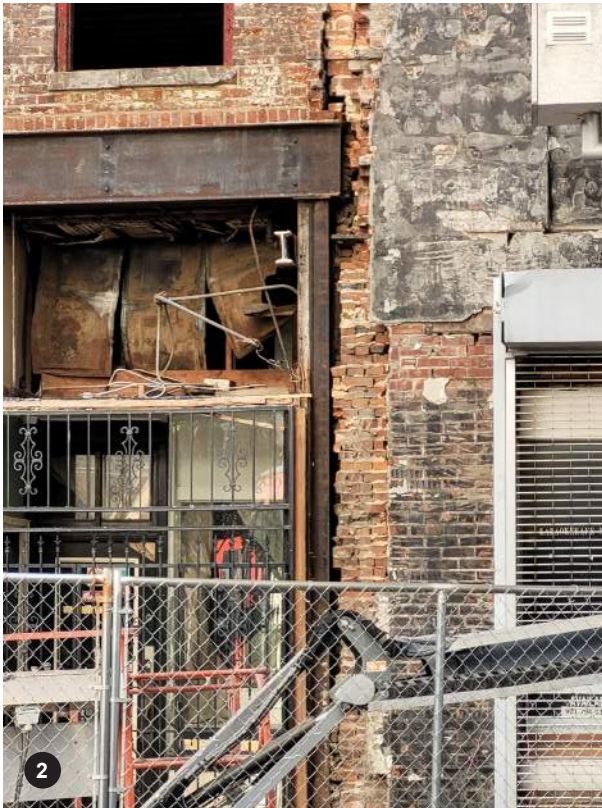
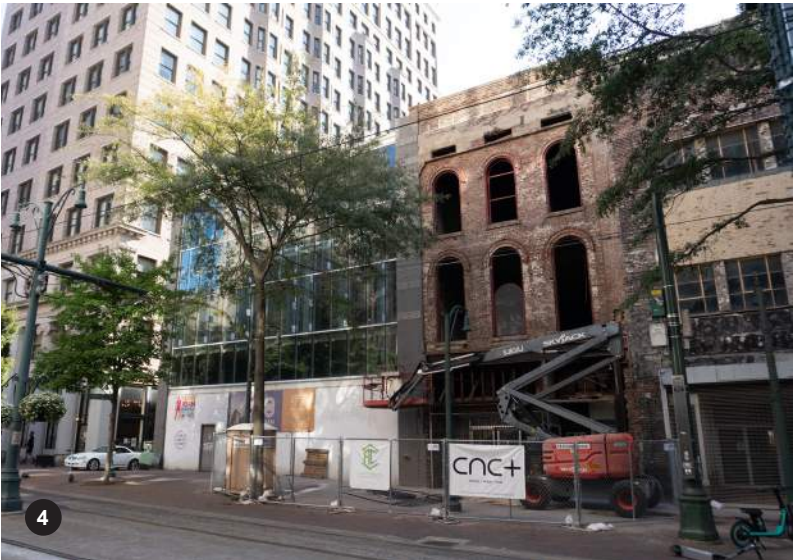
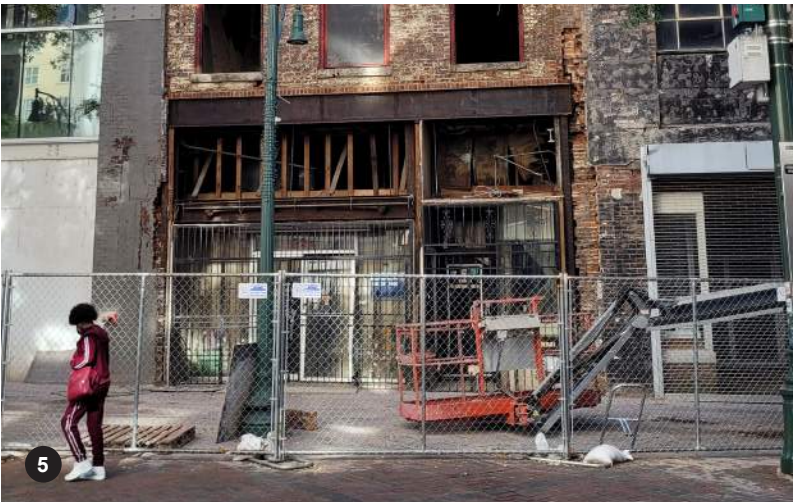
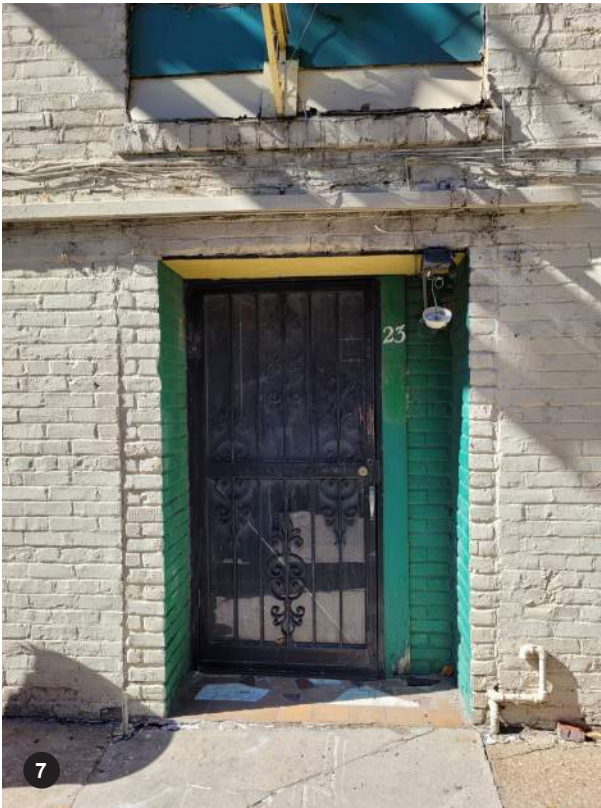
Existing Conditions

- 1. Overall view of exposed West facade after the removal of stucco.
- 2. Existing steel beam and column supporting masonry facade above storefront opening.
- 3. Detail of masonry “eyebrows” above upper level windows, showing third course has been chipped off from facade.
- 4. View looking up recovered facade with adjacent buildings visible for comparison.
- 5. Storefront entrance area exposed to reveal size of opening supported with steel.
- 6. Overall view of East facade.
- 7. Detail of masonry opening around rear basement entrance door.

1. Reconsruction of parapet to be level, incorporating masonry corbelling details from the previously removed architrave.
2. Area of removed architrave, where projecting chipped brick to be grinded smooth and flush with adjacent masonry, and holes grout-filled.

5. Third masonry course at window “eyebrows” to be grinded smooth and flush with adjacent masonry, and holes grout-filled.
6. Existing steel beam to remain exposed, painted to match storefront system finish.

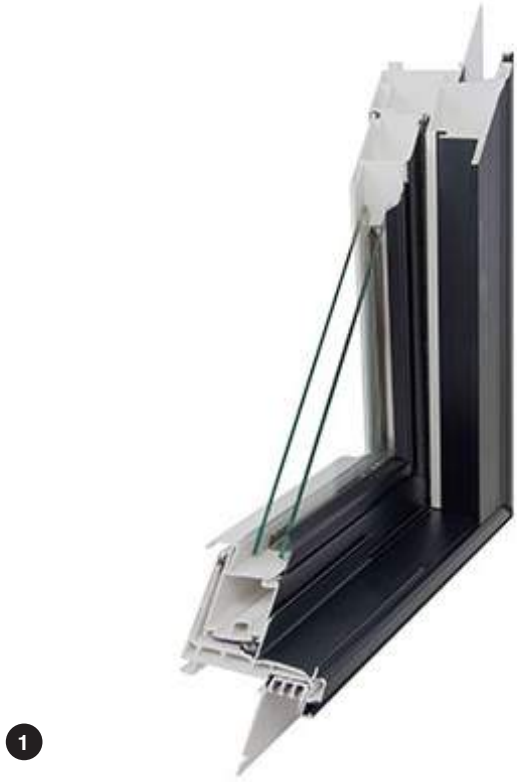
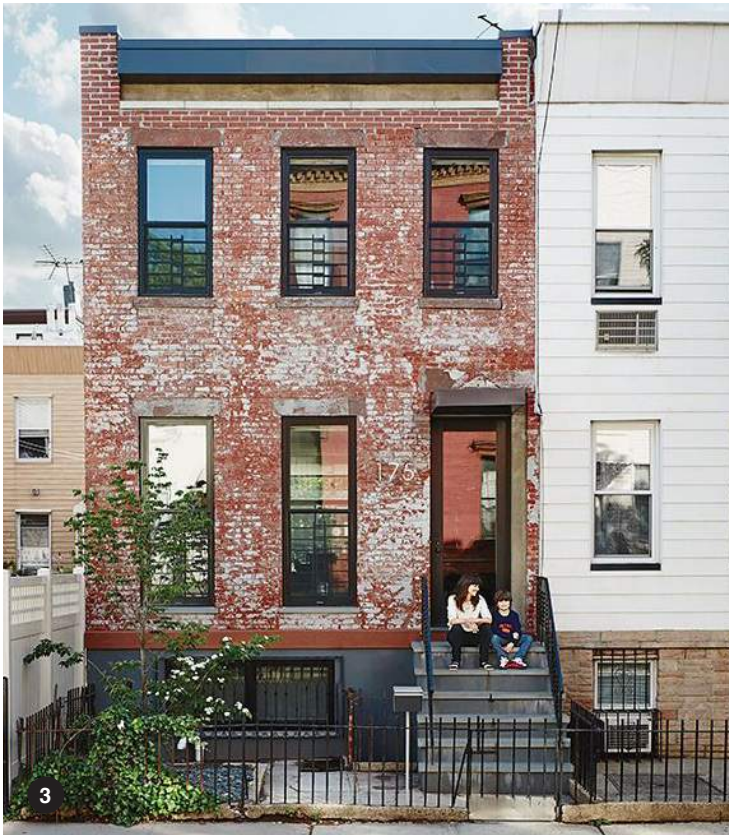
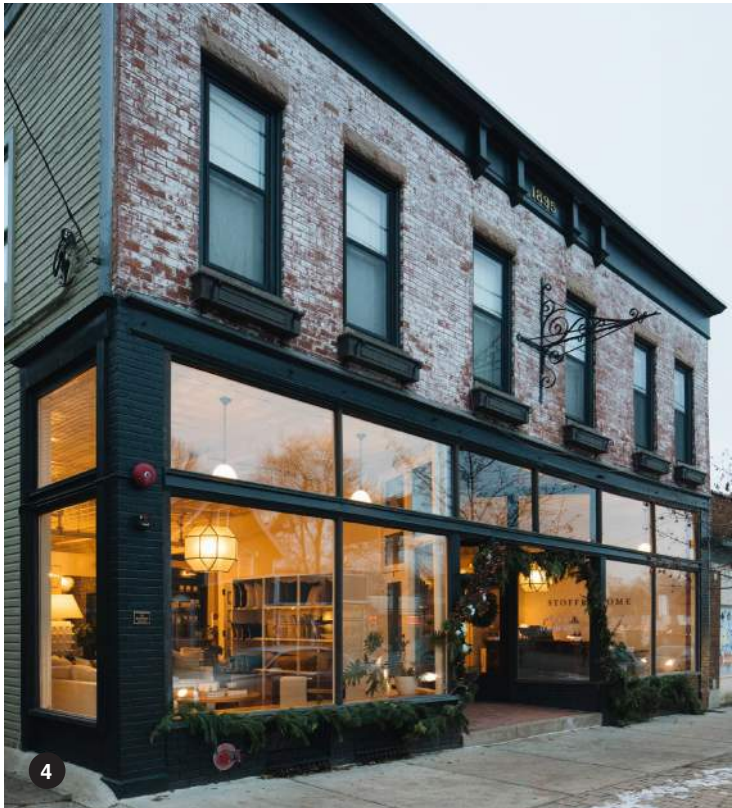
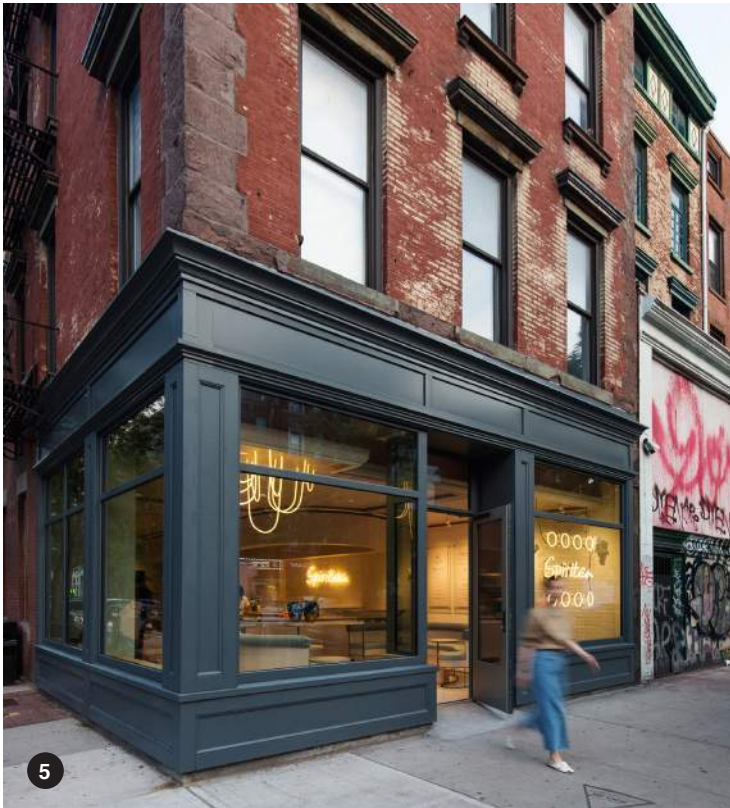
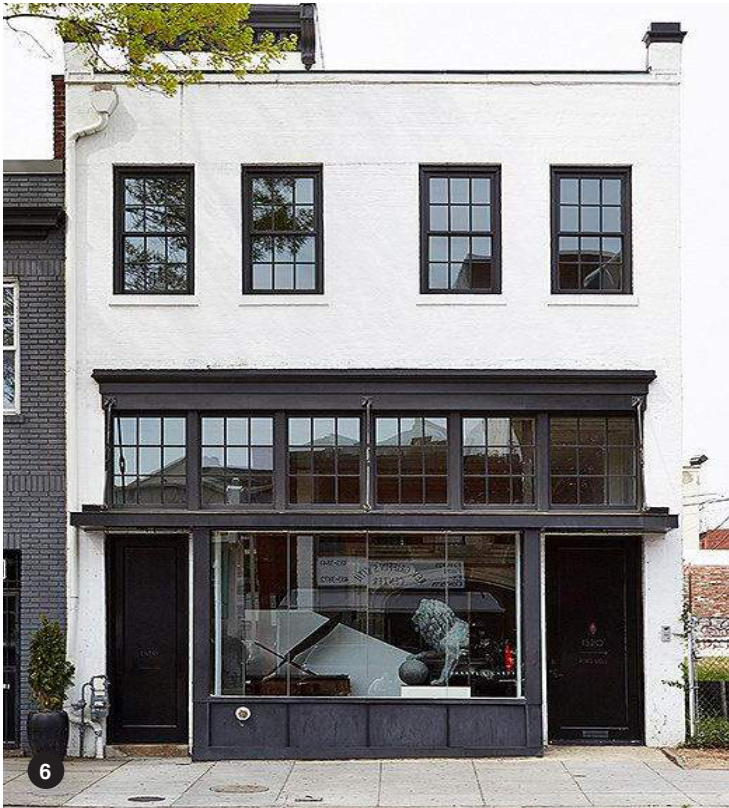
Materials

- 1. Pre-finished aluminum double-pane windows with panning to match historic wood window frames.
- 2. Black paint color for all pre-finished and painted exterior metal, window frames, storefront system frames, and canopy.
- 3. Precedent example of paint-stripped and grout/stucco-marred brick facade.
- 4. Building with paint-stripped brick facade, pre-cast window details, black-painted exposed steel beam, and black storefront system.
- 5. Paint-stripped brick facade with traditional wood storefront details painted black/dark-gray.
- 6. Traditional storefront with exterior canopy and clerestory windows.

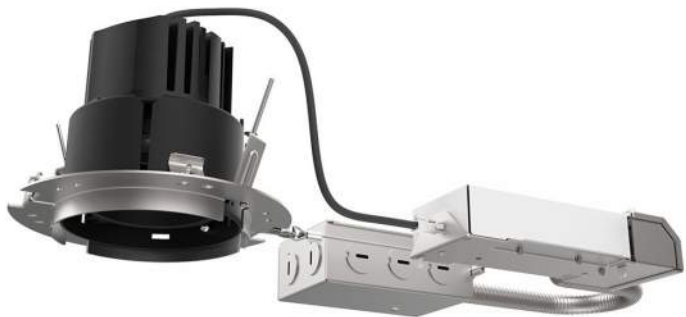
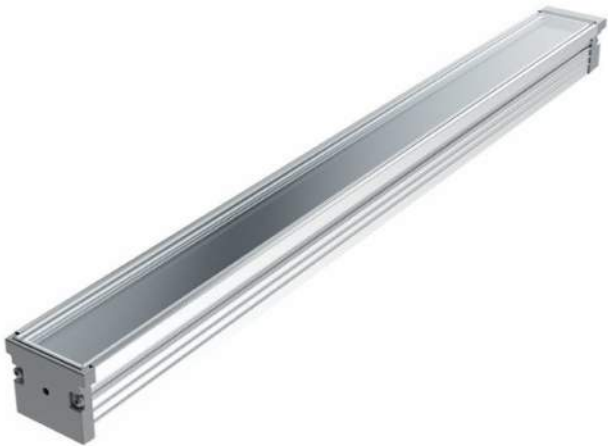
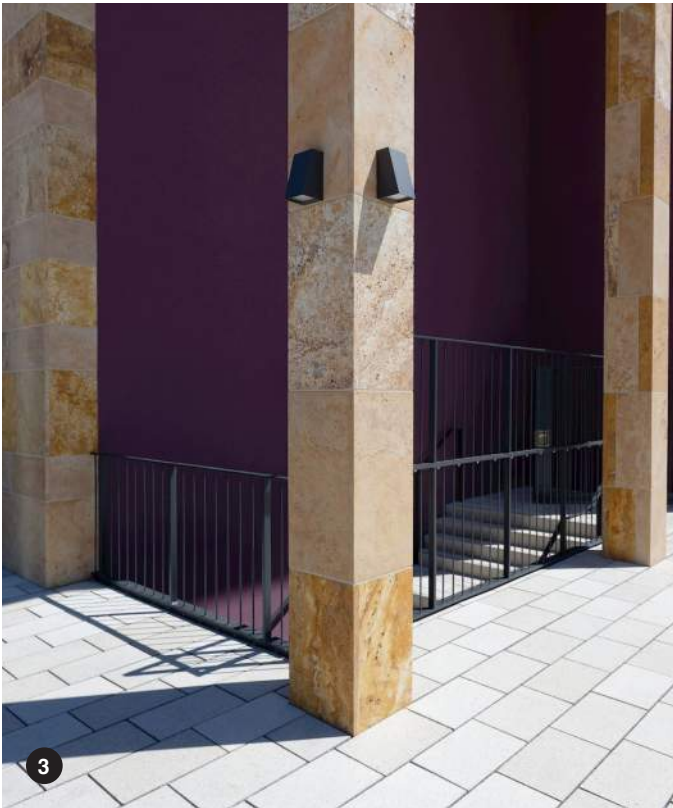
Exterior Lighting

- 1. Recessed-can light fixture: recessed in canopy soffit above storefront entrance (alternate option)
- 2. Compact linear facade floodlight: installed on top of steel canopy, out of view from street level, to highlight the architectural detailing of the historic masonry facade.
- 3. Wall-mounted downlight/wall-washing fixture: installed adjacent to each building entrance.

1. Recessed-can light fixture: recessed in canopy soffit above storefront entrance (alternate option)
2. Compact linear facade floodlight: installed on top of steel canopy, out of view from street level, to highlight the architectural detailing of the historic masonry facade.

3. Wall-mounted downlight/wall-washing fixture: installed adjacent to each building entrance (base design option)
4. Vinyl address numbers located on glazing transoms over entrance doors, color to match storefront system frames.

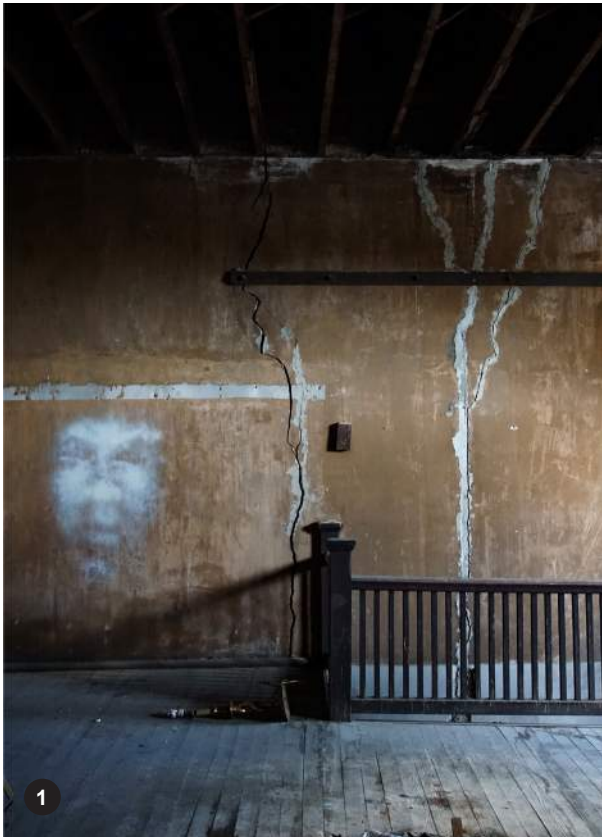
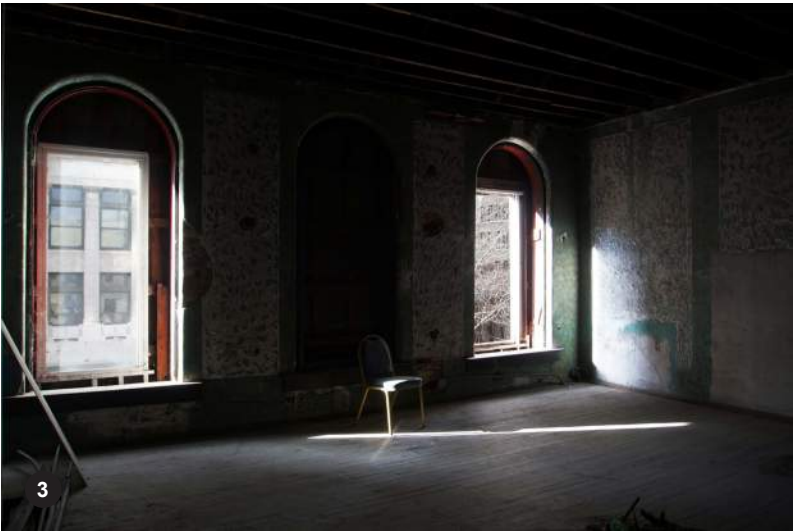
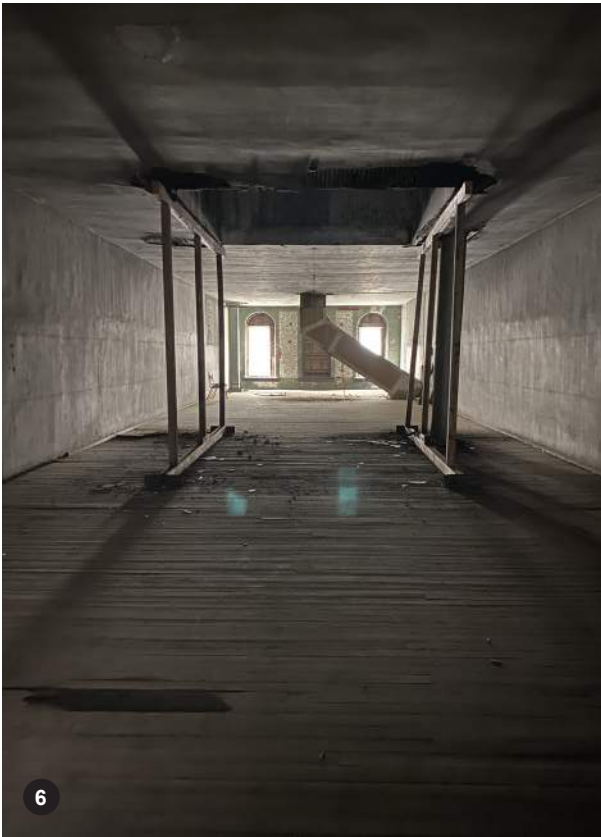
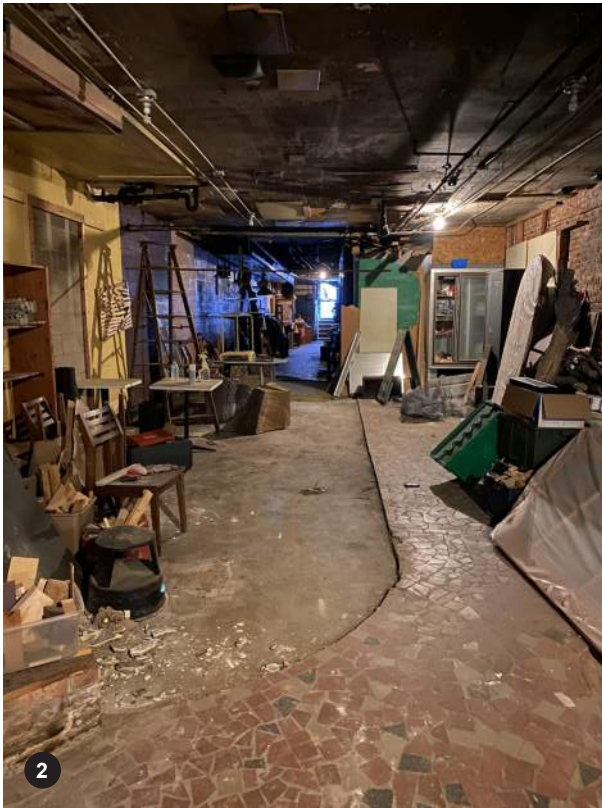
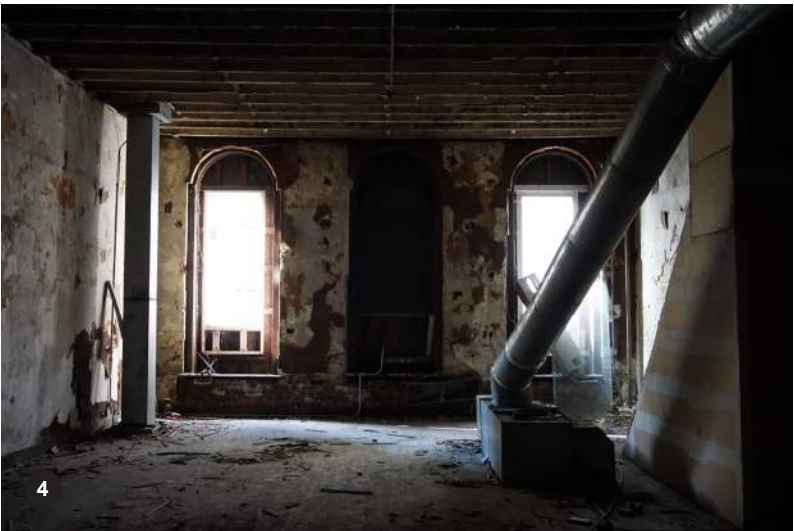
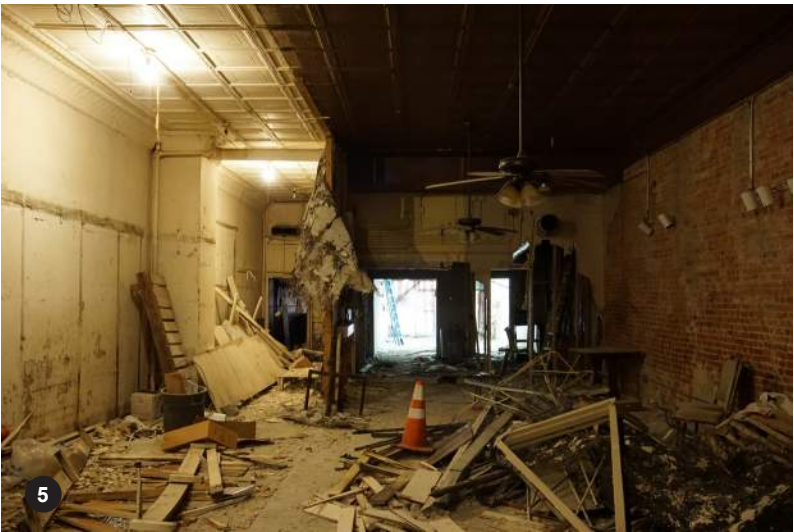
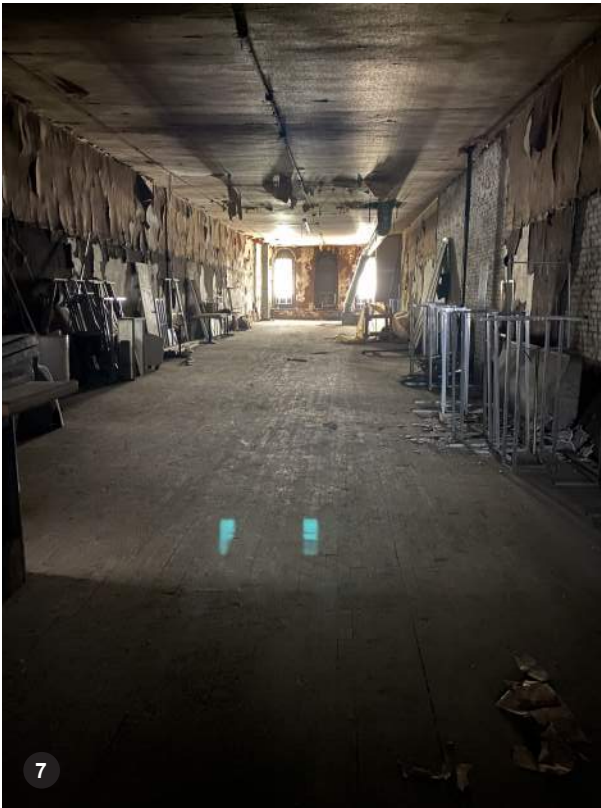
Existing Interiors

- 1. Level 02 South bay looking West
- 2. Level 02 North bay looking West
- 3. Roof behind East parapet
- 4. Level 01 South bay looking West
- 5. Level 01 back of house area
- 6. Basement North bay looking East
- 7. Basement South bay looking East
- 8. Basement concealed stair
