THE STITCH
EXISTING UTILITIES EXHIBIT
 Overhead Hanging Utilities with Existing Development

DaVinci
 Development Collaborative, LLC
 Central Atlanta Progress
 Atlanta Downtown Improvement District

THE STITCH
Photograph Sheet

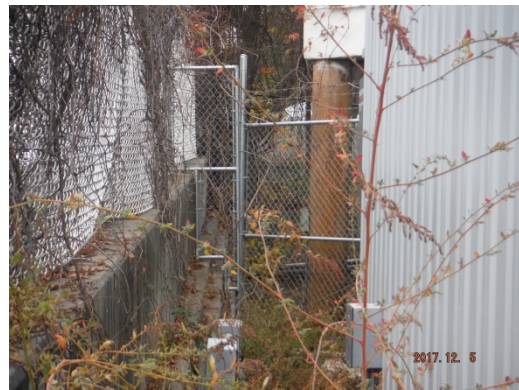
Figure A-4: Proximity of The Old New York 19 Condo Foundation to Wall N

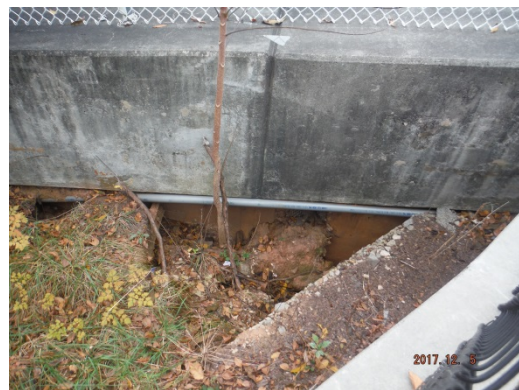
Figure A-6: Soil Erosion Behind Wall N
