124 NEWSROOM

118-124 Monroe Avenue

Development Loan Application

Re: Condition Survey
122 Monroe Avenue
Memphis, Tennessee 38103
CAS No. 2009.15

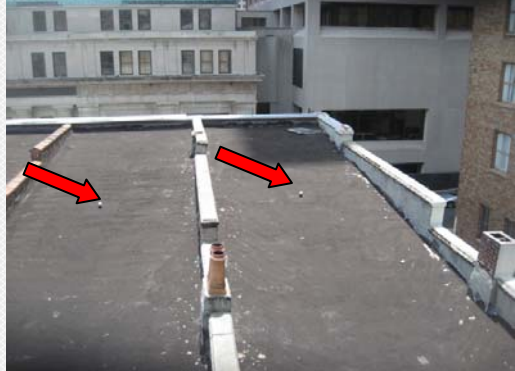
7	Close-up of Item 5 above.		8

Remedy	Same as Item 5 above.			
8	View of Bay 1 and 2 roofs. Moisture relief vents in center of roofs likely indicates a cap sheet has been added over the top of at least one roof system. Roof membrane appears to be in fair condition.			
Remedy	Roof replacement advised due to condition of flashings and copings on top of parapet walls, as noted in Item 5 above.

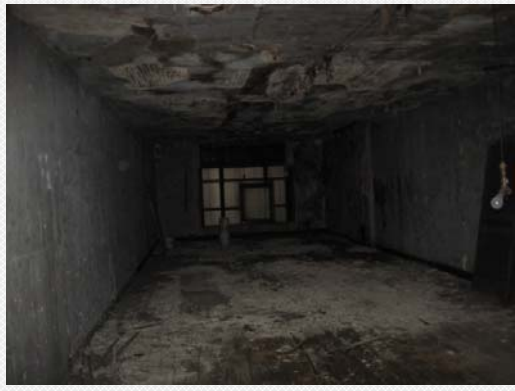
11	Bay 4. Same as Item 9 above. Plus note loose laid membrane over parapet walls.			
	Remedy Same as Item 9 above.			
12	Previous roof leaks are evident by condition of interior ceiling finishes in all Bays. Plaster ceiling of third floor in Bay 4 is severely damaged.			
	Remedy Removed plaster ceiling materials when interior renovation is anticipated.
