# Downtown Houston Pedestrian Lighting

Existing Conditions Lighting Analysis Report

[www.arup.com/lighting](http://www.arup.com/lighting)  
[www.arup.com/night\\_time](http://www.arup.com/night_time)  
Downtown Houston Pedestrian Lighting - Existing Conditions Lighting Analysis Report | January 2024

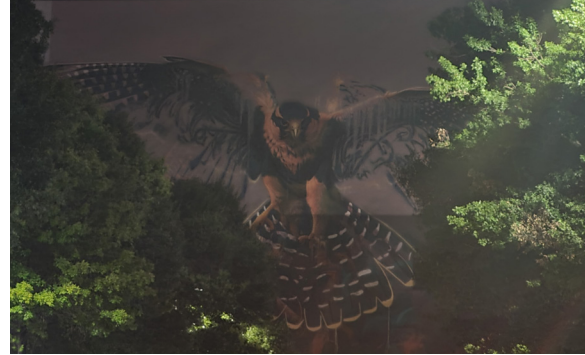
Many of the Downtown Houston artwork is lost to the night, with minimal or no illumination. There are many art pieces across the city with varying levels of illumination.

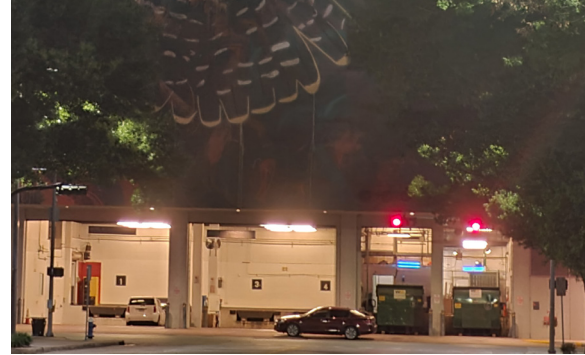
Multiple loading dock entrances leads to disconnects between the areas with high hospitality locations, with the brightly lit loading spaces contrasting with the darker streetscape, causing a 'spotlight' effect.

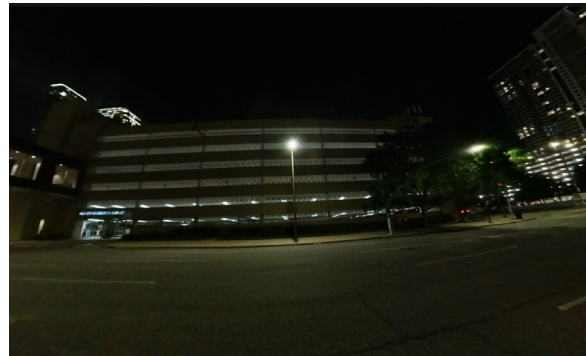
Large amounts of both garage parking and surface parking lots leads to disconnects between the areas with high hospitality locations. Surface parking lots are often unlit or poorly lit at night, creating dark voids next to the sidewalks.

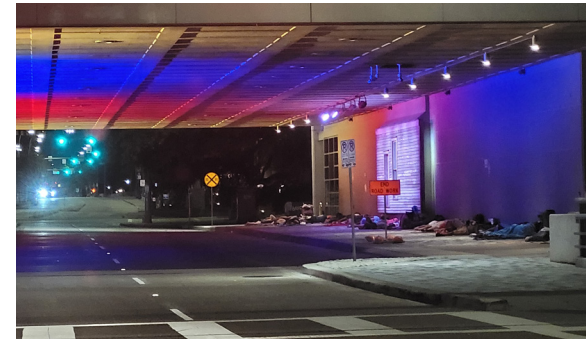
Underpasses tend to gather groups of the unhoused community. The Bagby Street Underpass (shown) is brightly illuminated with art pieces, whereas other underpasses around the outskirts of Downtown Houston are illuminated with 1-2 luminaires.

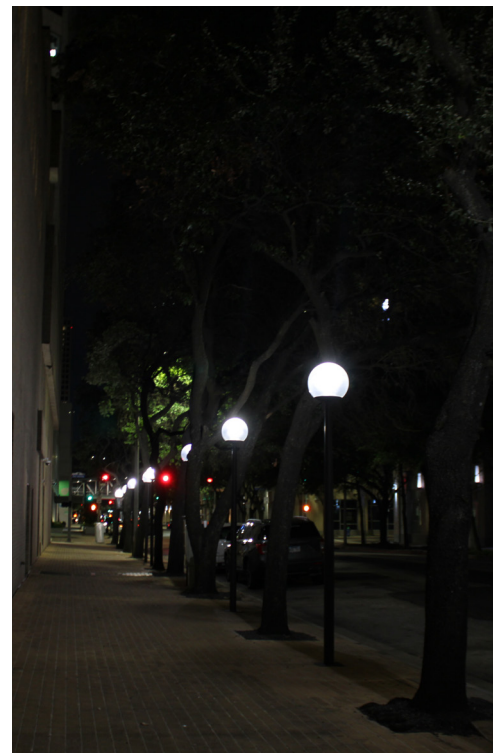
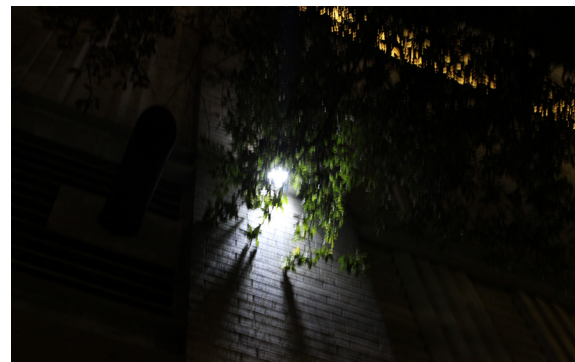
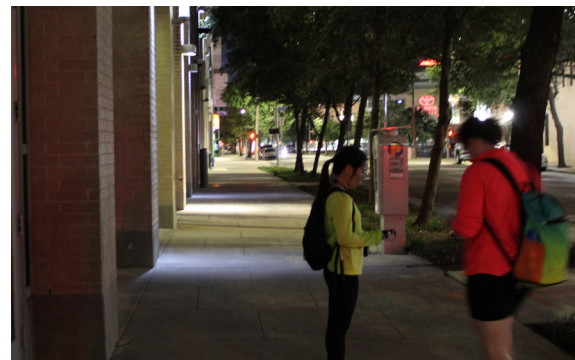
# Dallas / Fannin

Well lit and evenly illuminated through the mixed-use development, the site feels unsecure and dead at night. It is noted it is a Monday - weekends will be much busier with patrons.

Greenstreet has very little foot traffic, although it is to be noted that this site was surveyed on a Monday night. Most of the businesses were closed and had dark storefronts which negatively impacted the score. The site does provide consistent lighting in the underpass which benefits the pedestrian realm. Activating the retail spaces after hours will help improve the visual transparency around this site.

- Activate retail lighting
- Activate Underpasses

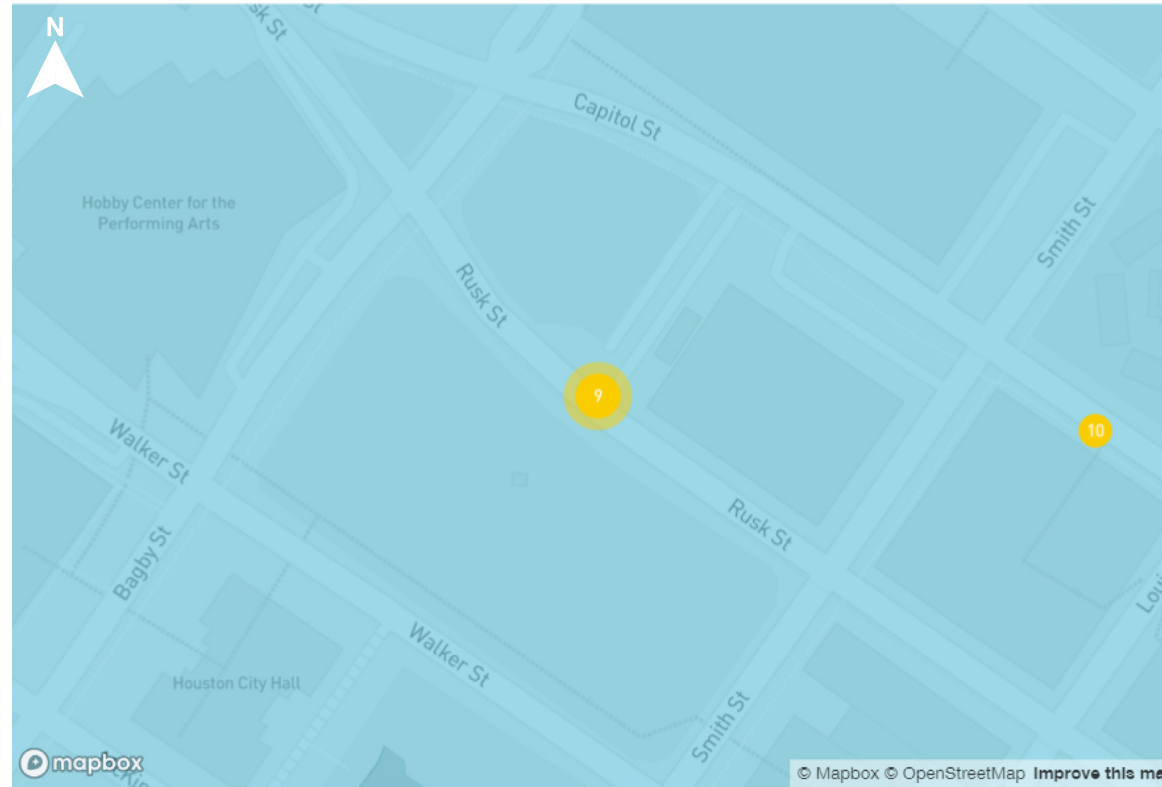
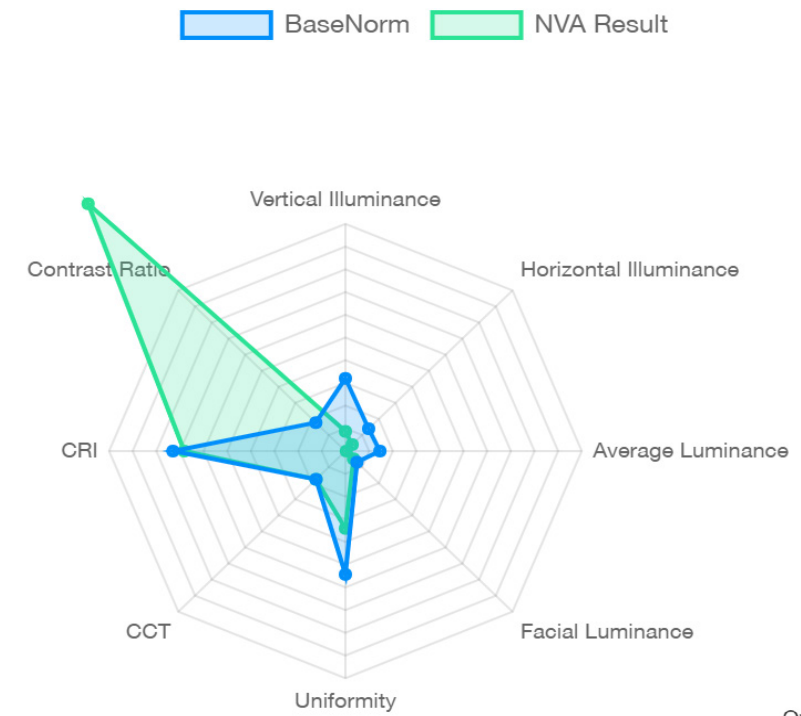
# Rusk / Tranquillity Park

This NVA location has both physical and visual constraints which negatively impact the vulnerability score. High foot traffic across this area with the large amount of the unhoused community resting at the Bagby Street underpass added to a feeling of being unsafe. The park to one side of this junction is very dark, creating a visual void - with the passing light rail's headlights bringing high glare to the opposite side. This mix creates a very disorienting experience to those walking along this route. The foliage blocks any further street lighting, making the facial luminance very low. To improve this, bringing lighting into the trees and across the parkland will allow the area to feel less visually constrained.

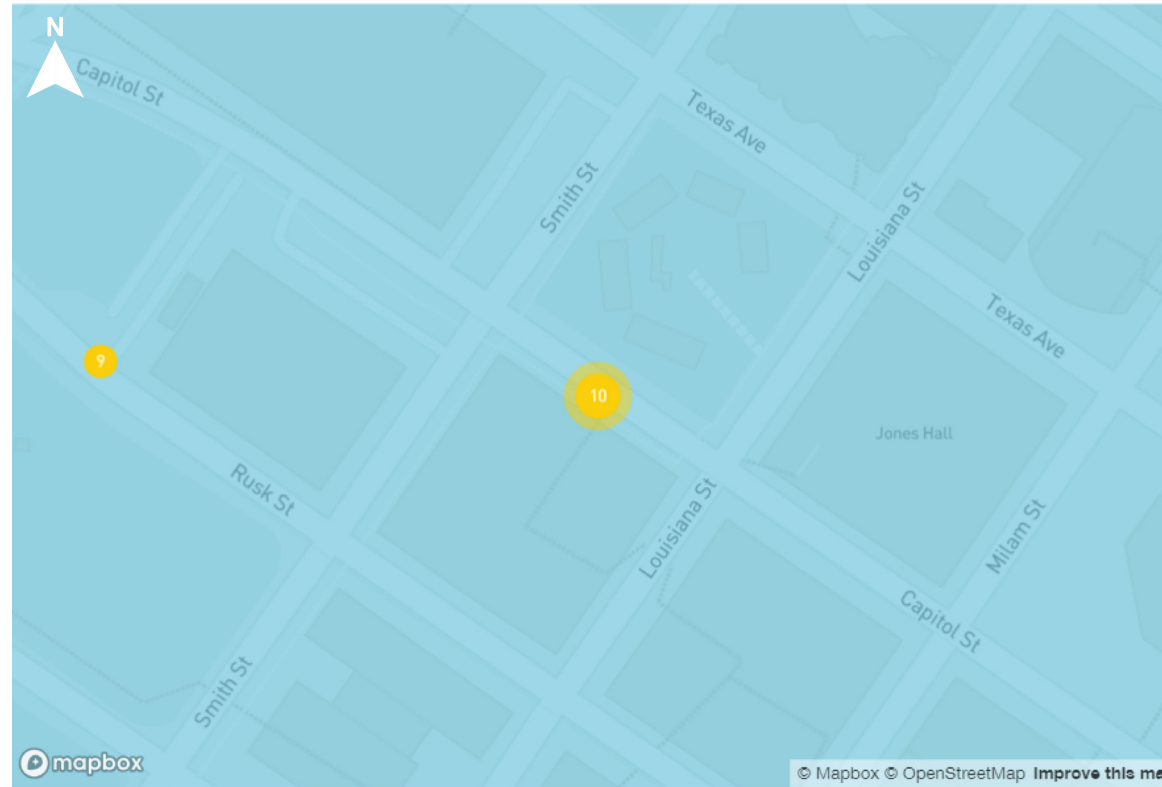
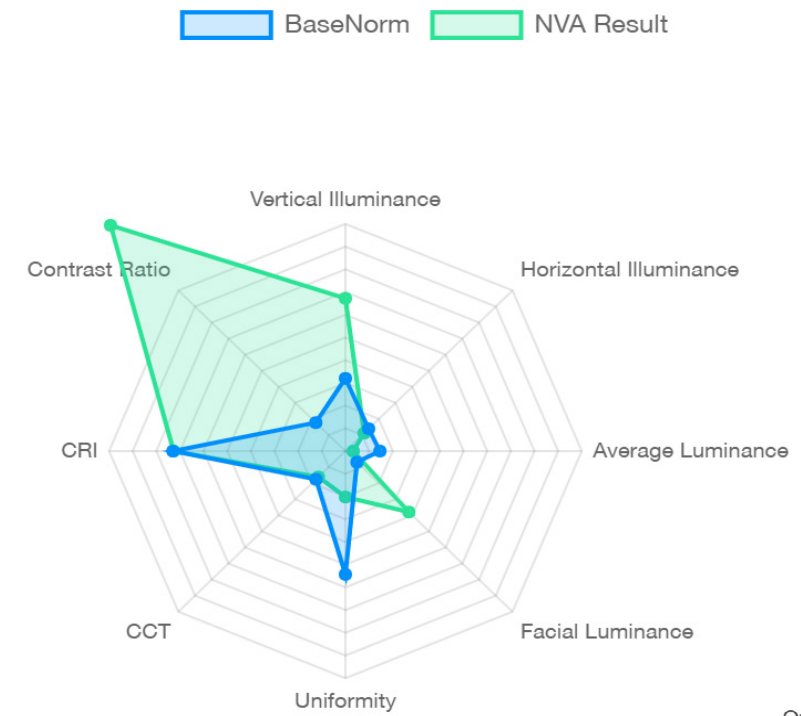
# Capitol / Smith

This location has very dark surfaces throughout, so although there is high illuminance across the site from consistent street lighting, the luminance is very low. The low illuminance is causing a high contrast ratio spike that is impacting the vulnerability score. There was little signage or lighting to indicate this was a Metro stop. There is little in the view of this NVA that is within eye level, causing this location to have a poor scale score. Bringing more lighting to the Metro stop will tie this location into the design of the transport stops across the city.

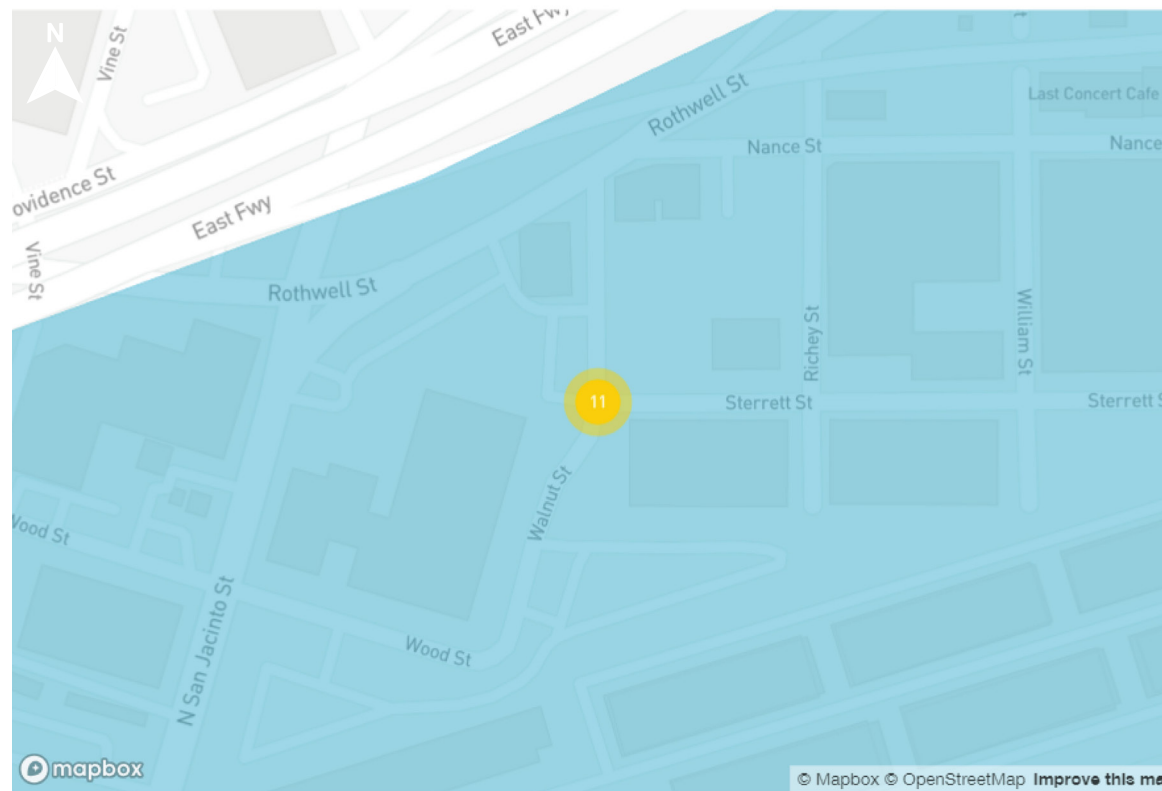
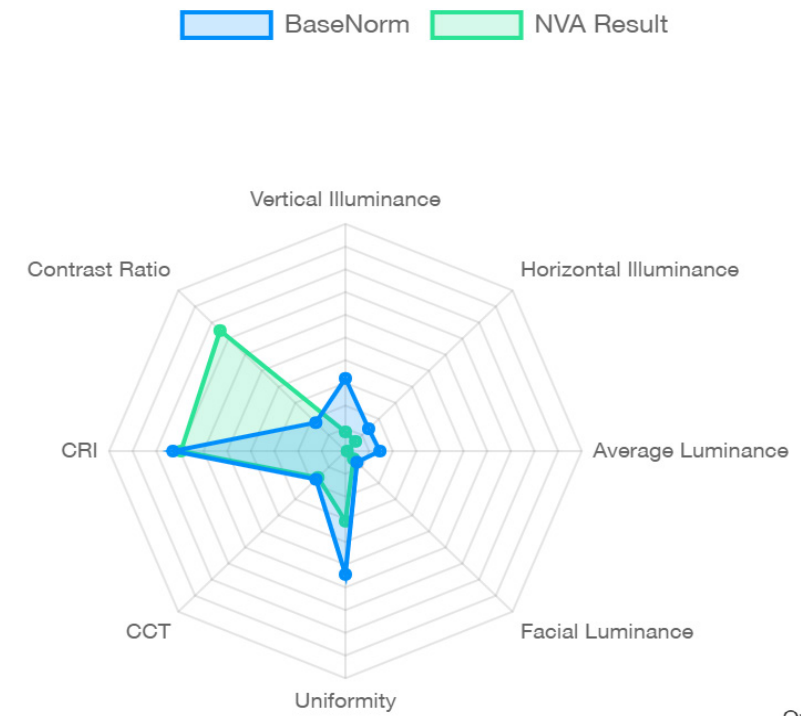
# Walnut / Sterrett

The Warehouse District of Houston is an up and coming area, with a lot of construction actively in progress. This has led to a lot of empty buildings whilst the construction is finishing. This area is very quiet at night, with minimal foot fall, which heightens users' unease. Many of the trees along this street have grown over the street lighting, making it much darker. Bringing illumination to the foliage will improve this. Activating some of the construction sites at night will bring the focal point of the façades down to eye level.

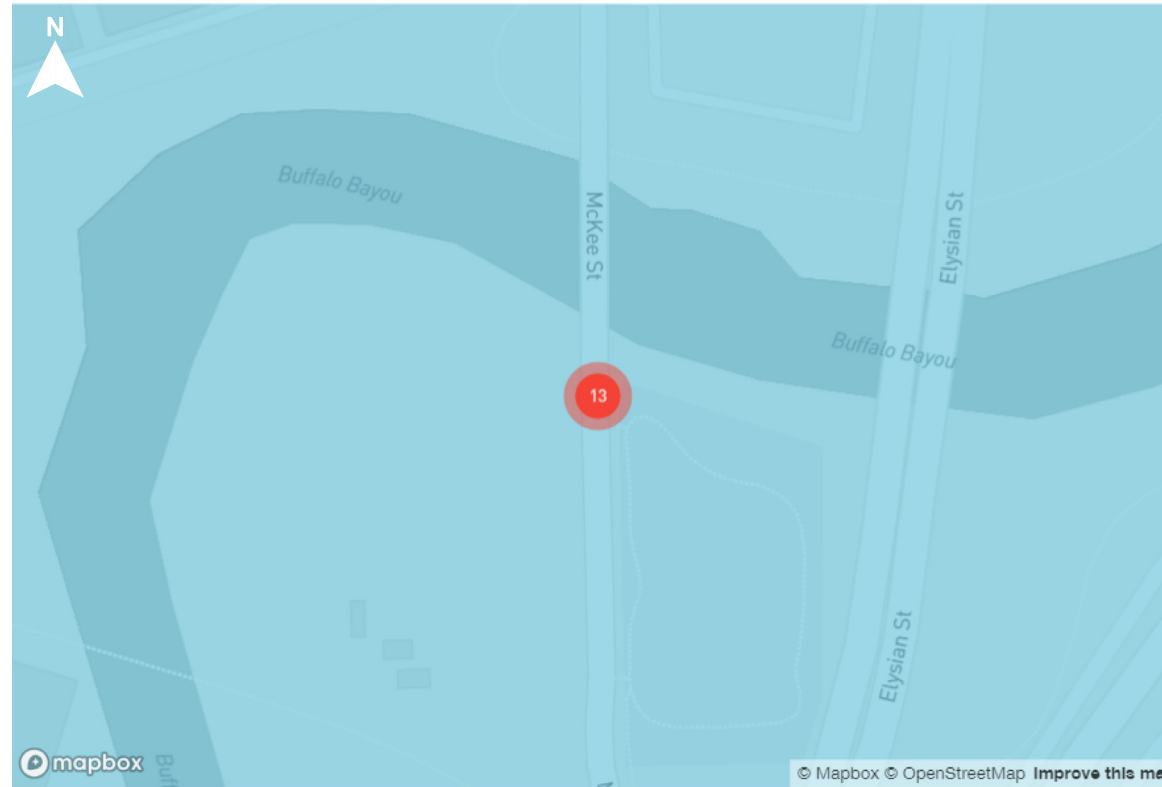
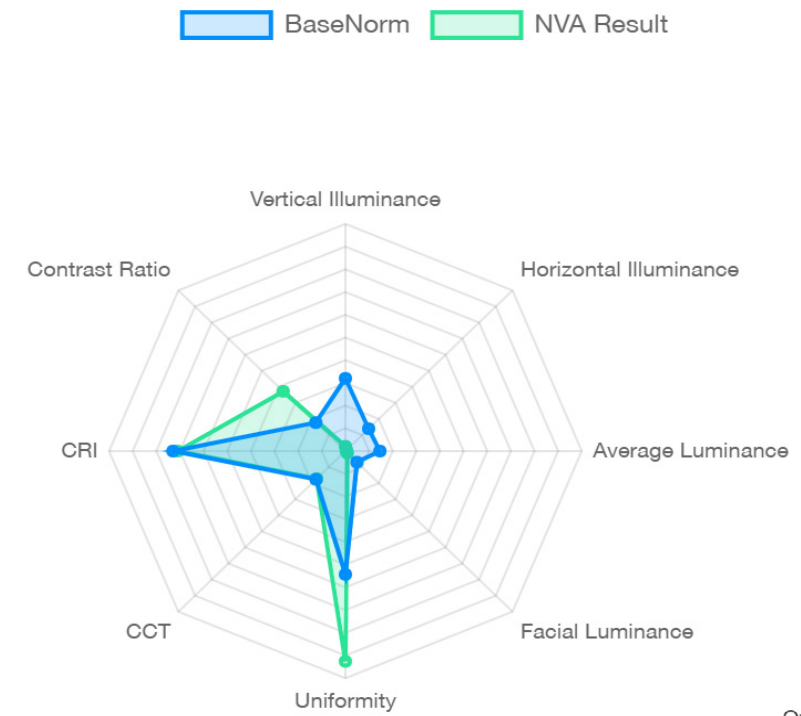
# James Bute Park

This NVA location site felt the most unsafe across all 24 sites. The dark park creates an oppressive void, where you are unable to see anyone moving. The bridge creates a connection point to the rest of the Warehouse District, but has high glare fixtures and these cause a harsh spotlighting effect when users are on the bridge. Across this bridge, users can see the construction sites to the north. Increasing the lighting across the park to reduce the darkness will allow users to feel safer moving through the space.

- Reduce darkness across public parks

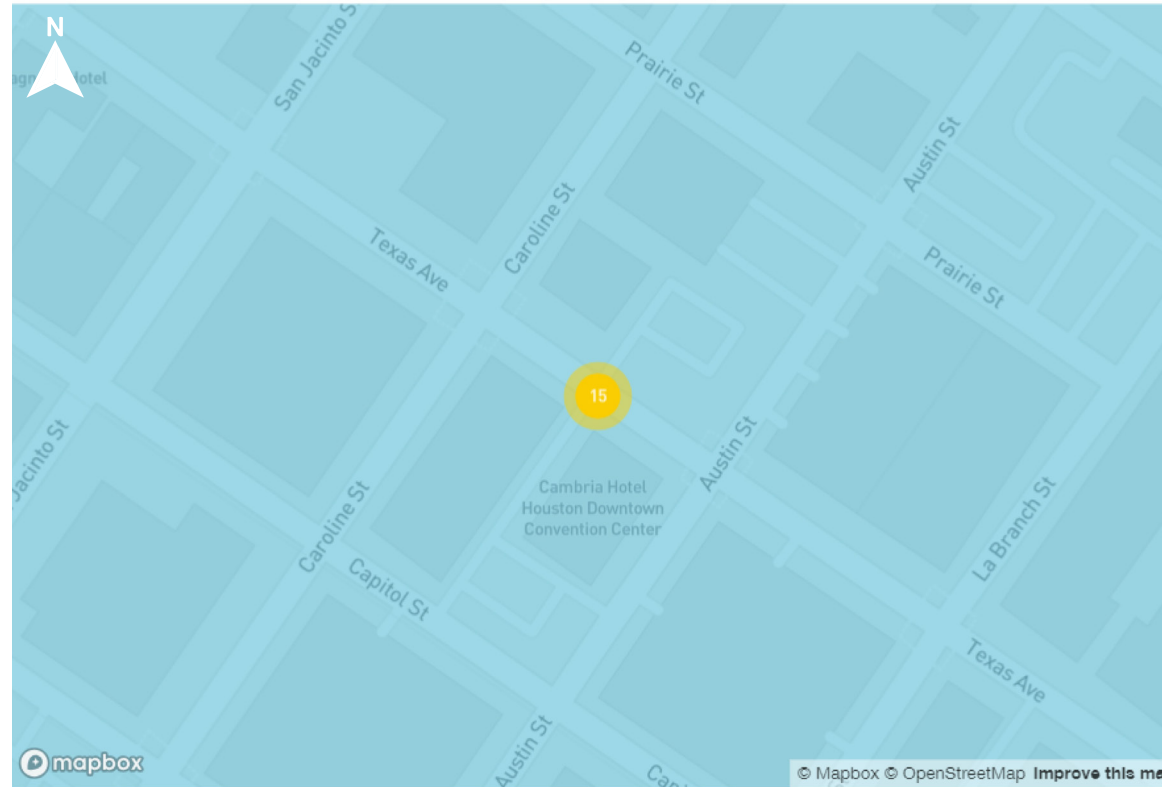
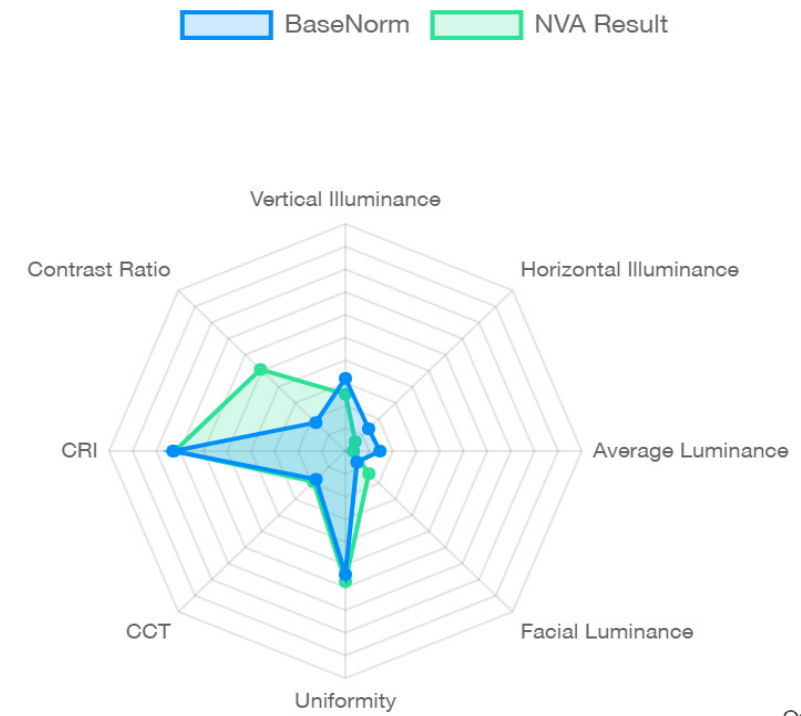
# Texas / Caroline

This location is missing human scale elements - there is a flat, dark parking lot which contrasts with the large lit façade of the prison. This contrast in scale and surface reflectance raises the vulnerability score, tipping it over into the medium score. As with a range of locations across Downtown, many of the trees have grown over the street lighting, making the sidewalks much darker than they were originally designed to be. Introducing activation of the parking lot at night, and bringing more lighting into the trees will improve the feeling of this area.

- Illuminate foliage
- Activate empty parking lots

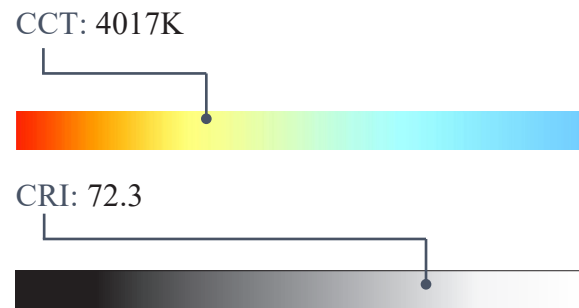
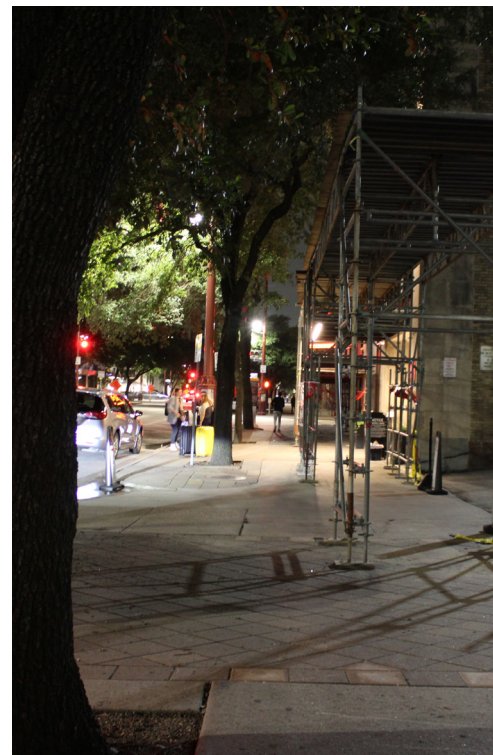
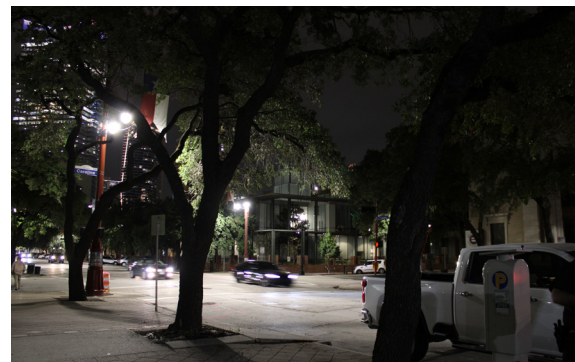
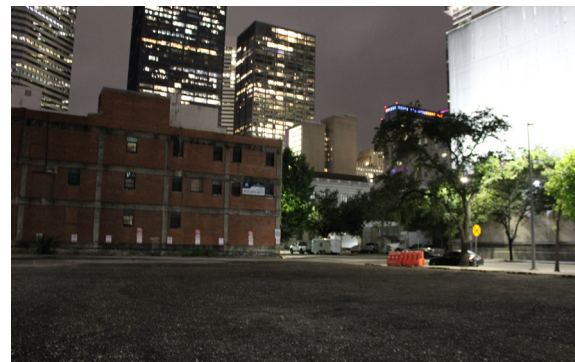
# Main / Preston

Lots of people, lights and music along this part of Main Street, with lots of layers of light. This area felt the most comfortable due to the human scale of lighting, and range of different types of light. It was noted that it's not iconically lit though - no district or feeling.

Main Street is an area that will have opportunities realized through the More Space Main Street 2.0 Project.

- Illuminate foliage
- Activate retail lighting

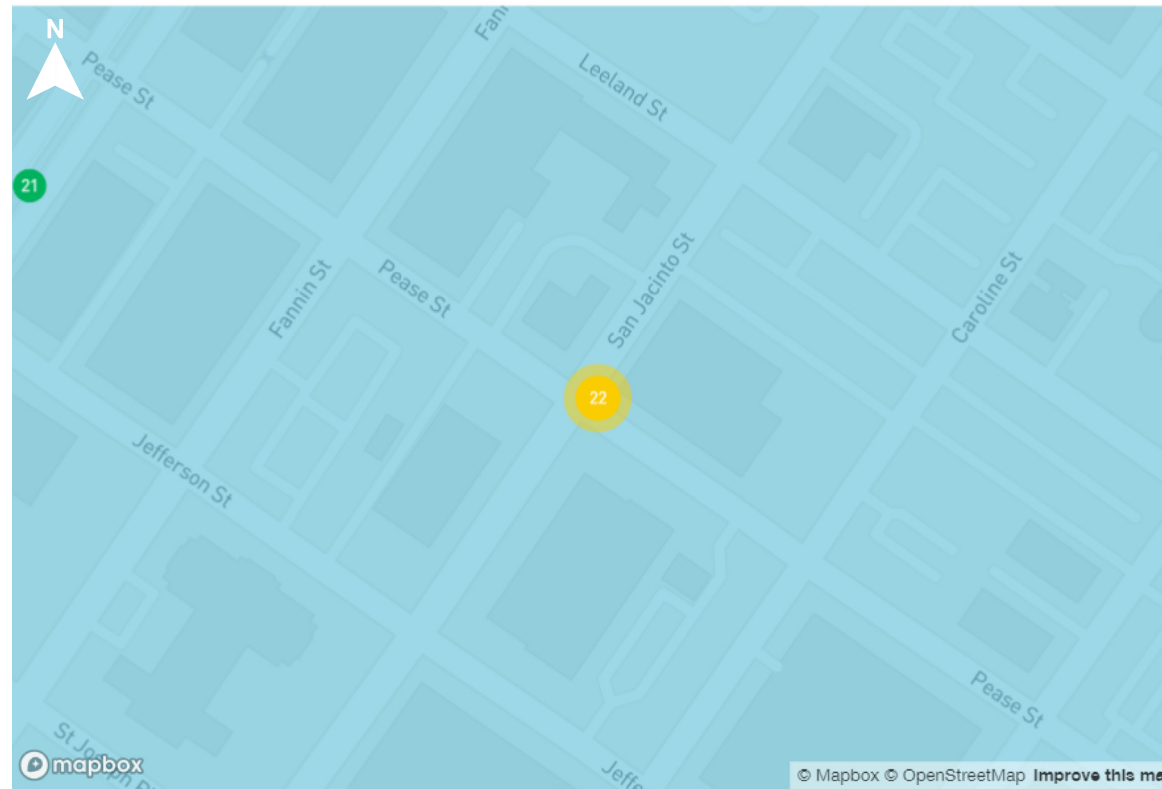
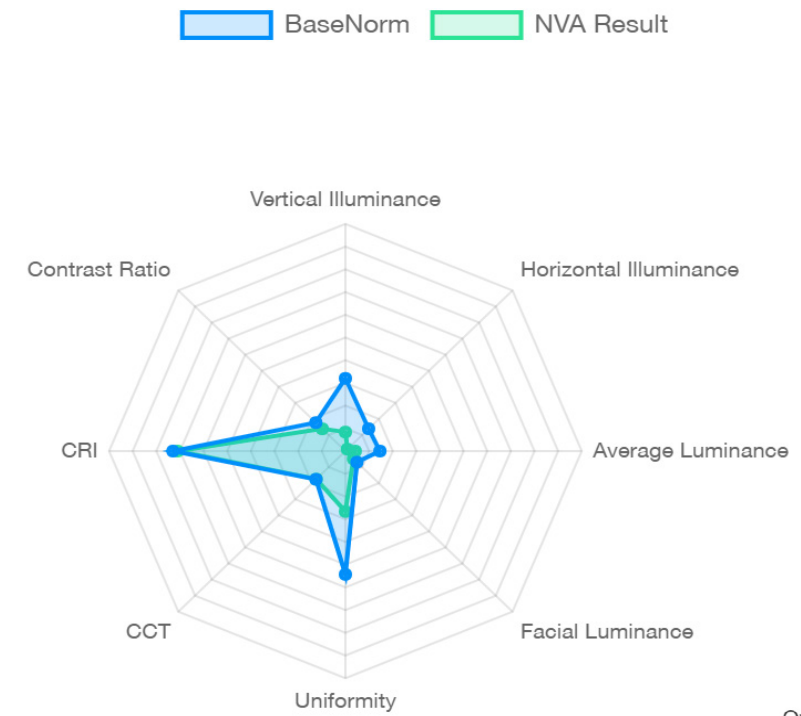
# Pease / San Jacinto

A lot of traffic and car noise, but no foot traffic. A lot of dark walls that make the space feel enclosed with broken sidewalks. It looks and feels disconnected from Downtown.

61 / 100

- Illuminate foliage

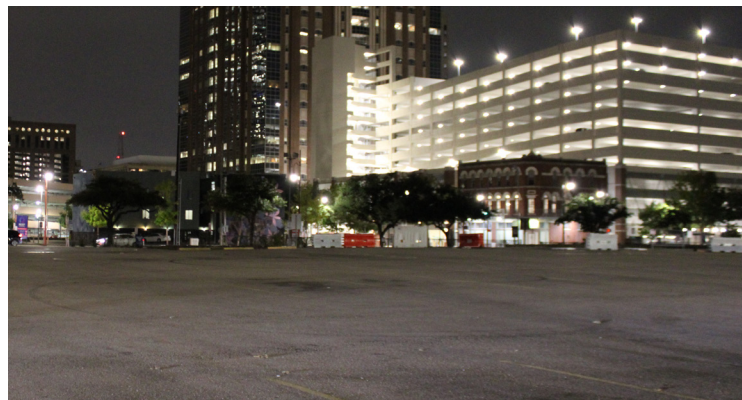
## Activate Parking lots

Dark and empty surface parking lots contrast to the highly lit and often glary high rise parking lots. This disconnect creates empty pockets of Downtown.

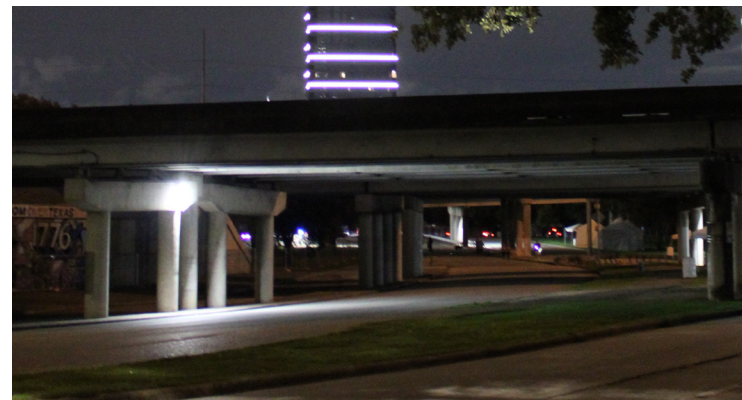
## Activate Underpasses

The underpass creates a bright spotlight for those standing within it. Activating these at night will make them more of an entrance to Downtown.

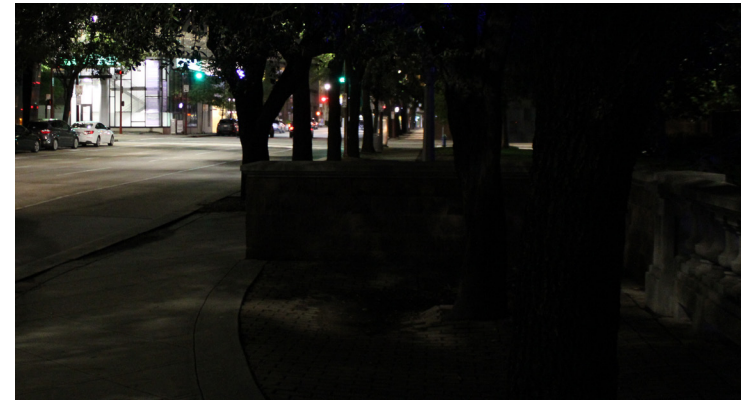
## Illuminate Foliage

Many of the walkways have low uniformity and dark light levels due to foliage growing over the street lighting,

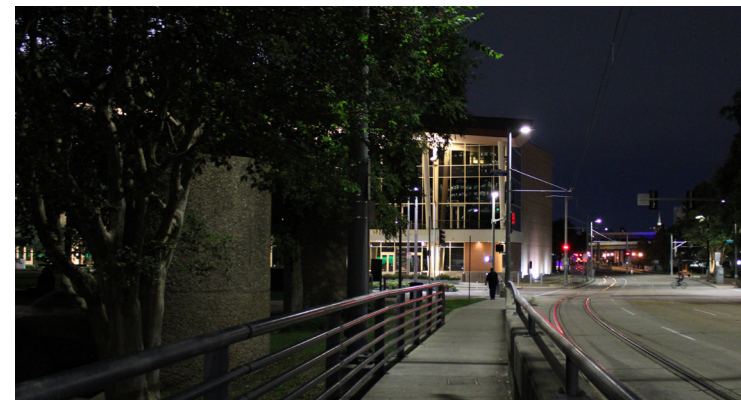
## Increase Public Park Lighting

Many parks are not illuminated and creates a dark void where it is hard for users to see who is coming.
