THE STITCH
EXISTING UTILITIES EXHIBIT
 Overhead Hanging Utilities with Existing Development

DaVinci
 Development Collaborative, LLC
 Central Atlanta Progress
 Atlanta Downtown Improvement District

THE STITCH
Photograph Sheet

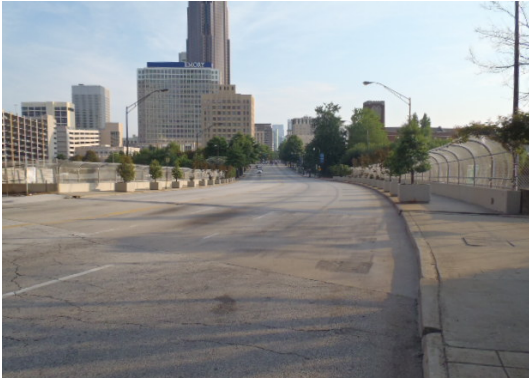
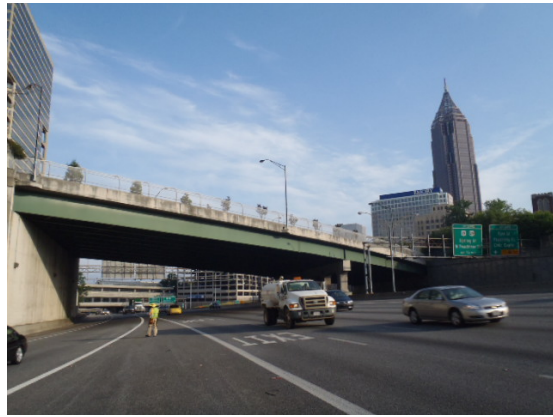
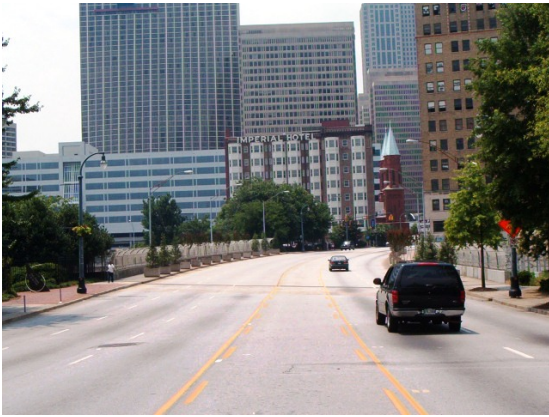
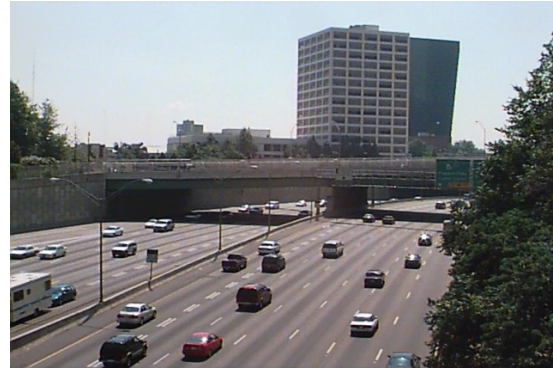
EXISTING UTILITIES IN BRIDGE STRUCTURE

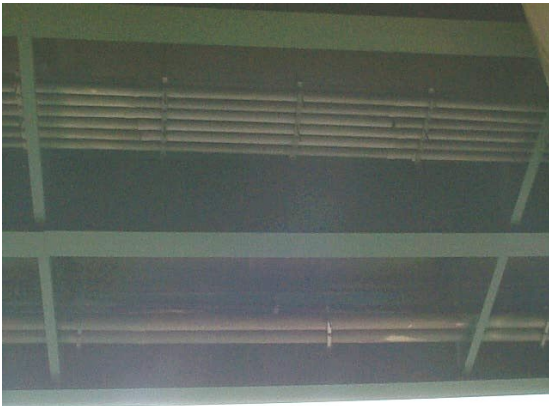
ELECTRIC

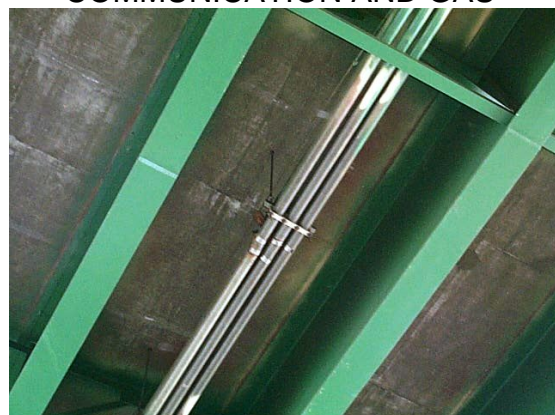
COMMUNICATION

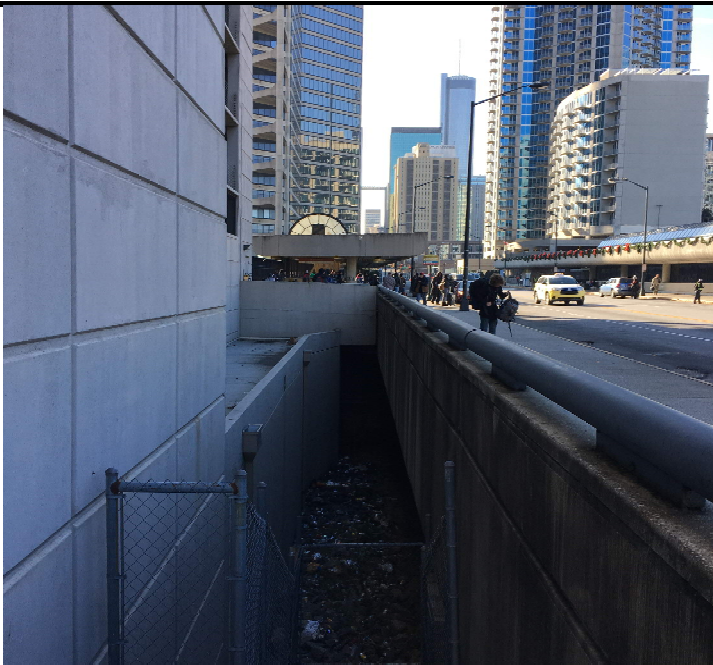
Photo No. 1

Remarks: CIVIC CENTER MARTA STATION
WEST PEACHTREE STREET LOOKING SOUTH

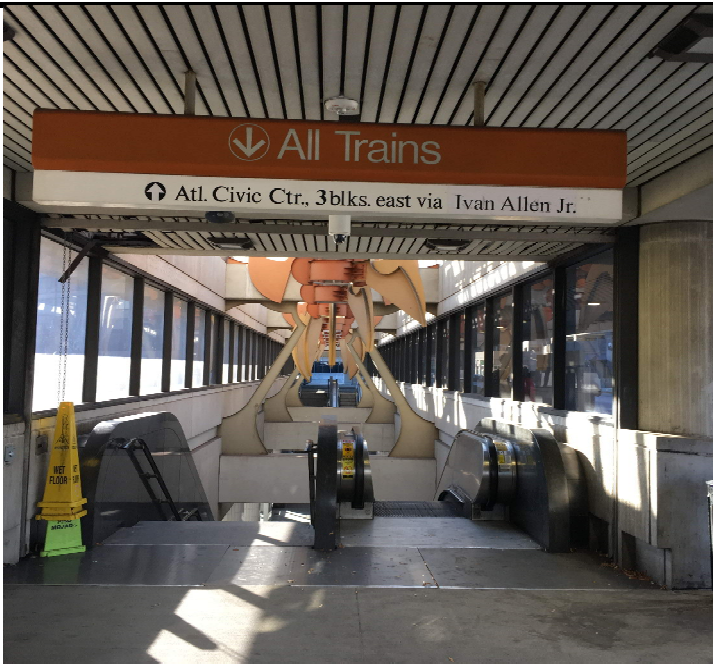
Photo No. 2

Remarks: CIVIC CENTER MARTA STATION

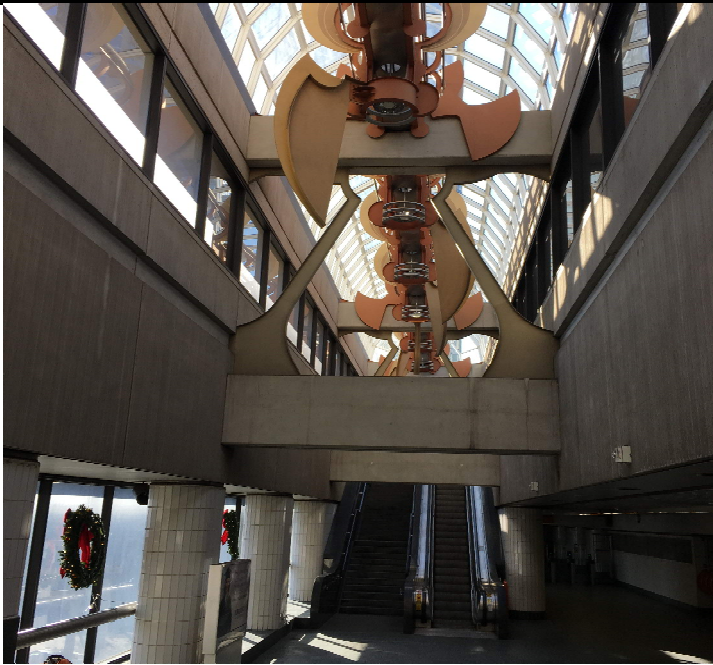
Photo No. 3

Remarks: CIVIC CENTER MARTA STATION

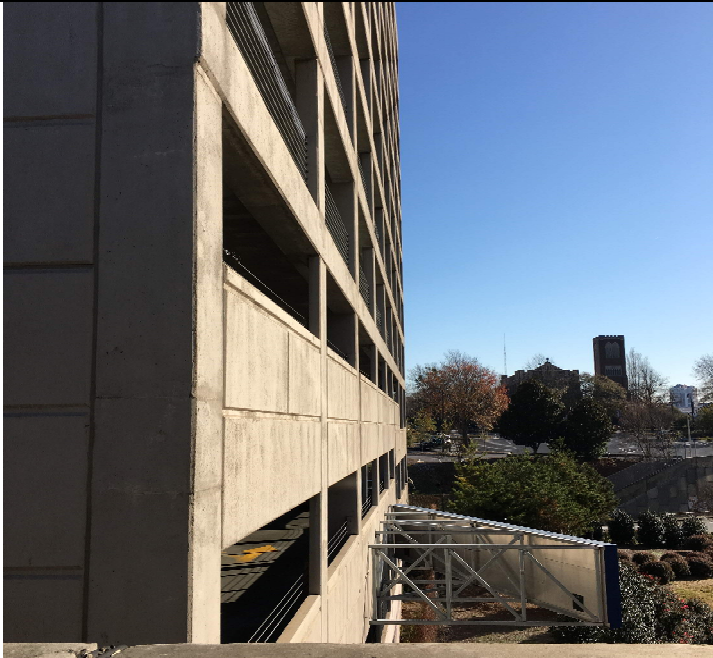
Photo No. 5

Remarks: GSA PARKING DECK

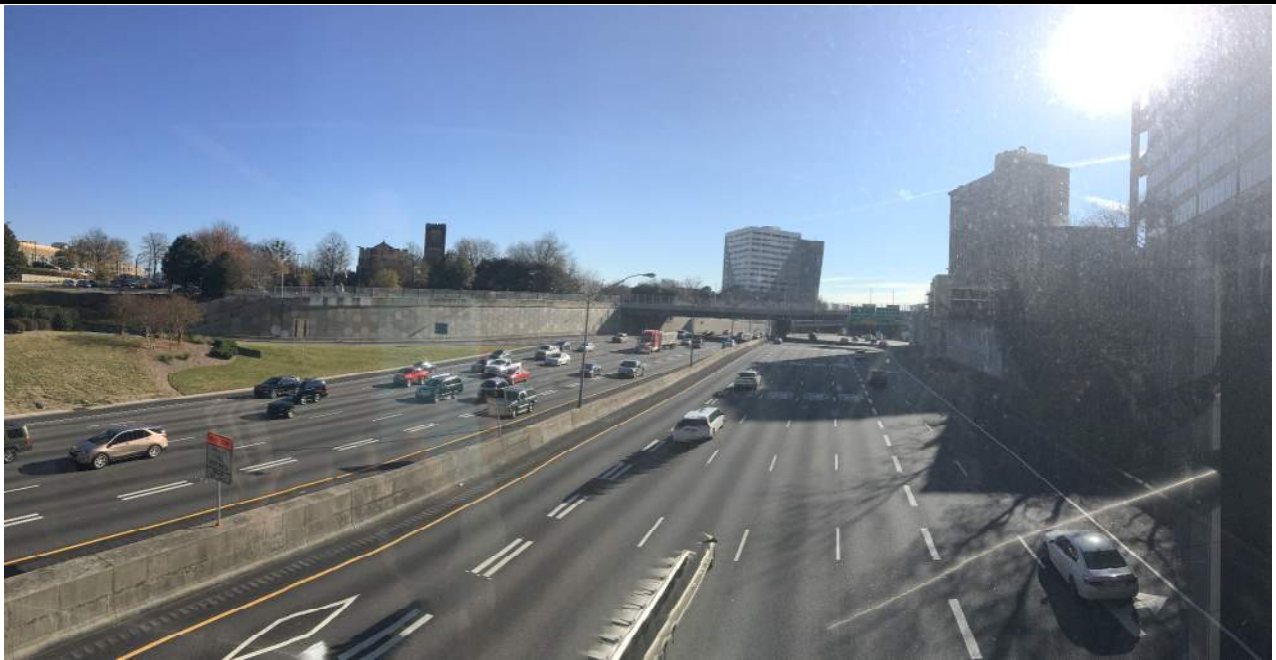
Photo No. 6

Remarks: DOWNTOWN CONNECTOR VIEW FROM CIVIC CENTER MARTA STATION, FACING SOUTHBOUND

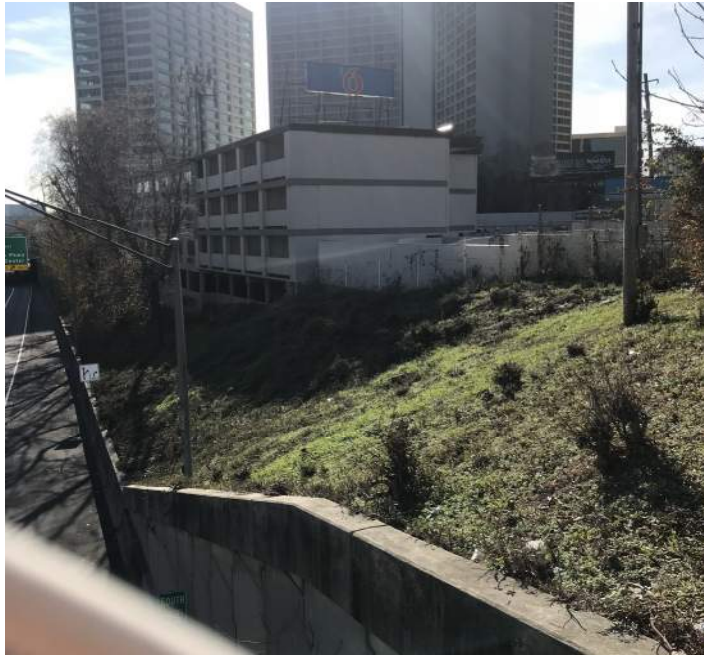
Photo No. 7

Remarks: MOTEL 6 AND WEST PEACHTREE LANDSCAPED SLOPE AND WALL

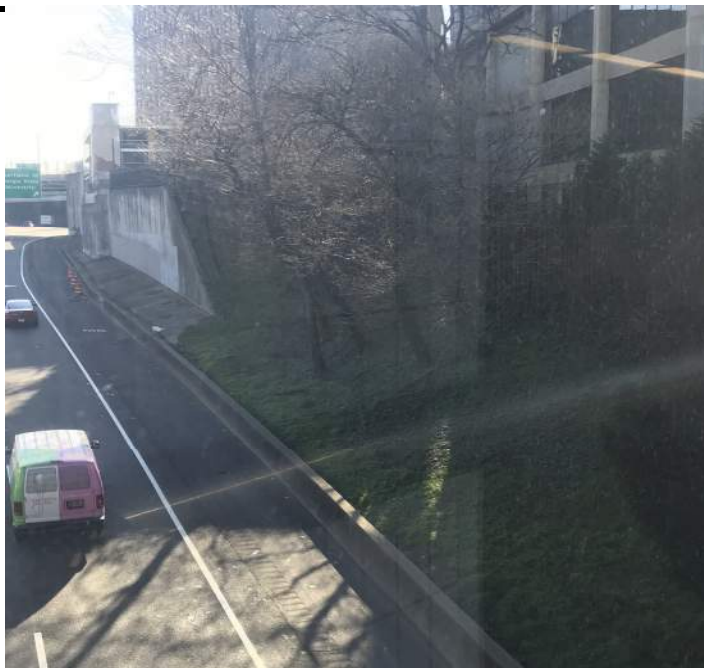
Photo No. 8

Remarks: SOUTHBOUND DOWNTOWN CONNECTOR APPROACHING COURTLAND STREET EXIT RAMP

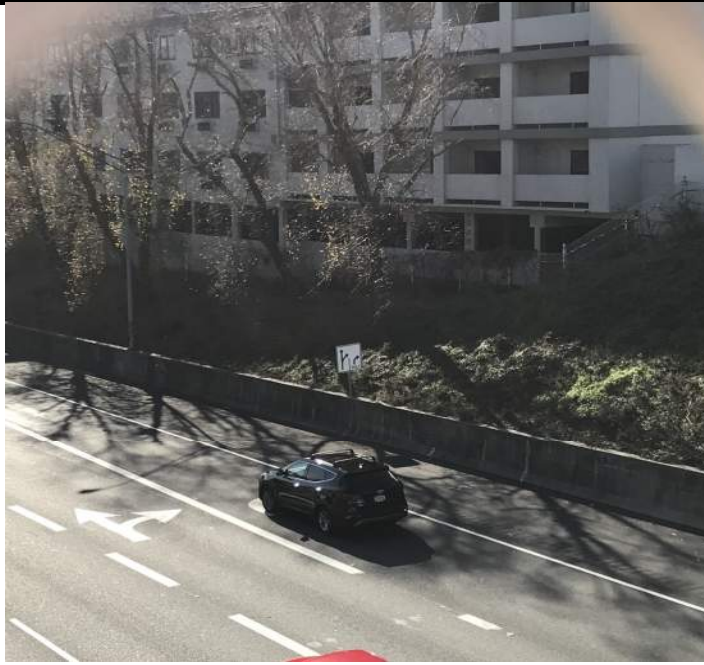
Photo No. 9

Remarks: MOTEL 6

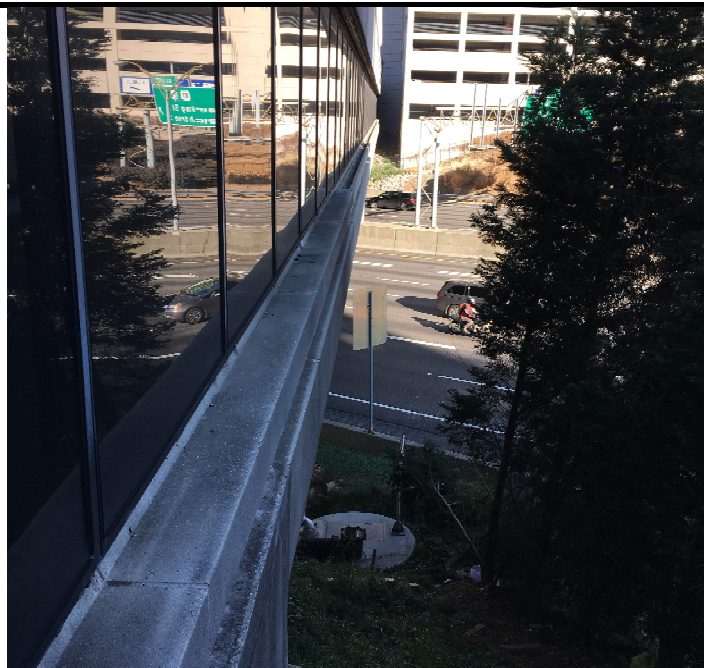
Photo No. 10

Remarks: MARTA CIVIC CENTER STATION LOOKING NORTH

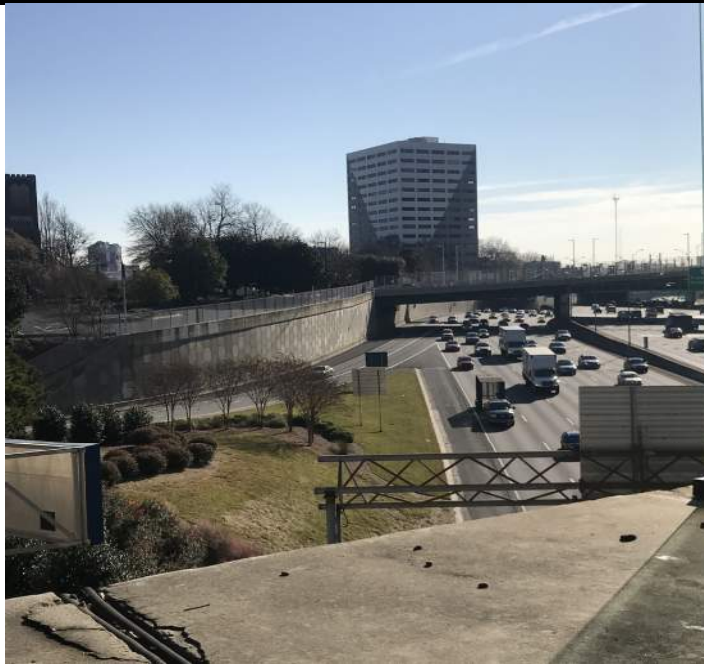
Photo No. 11

Remarks: PINE STREET EXIT RAMP

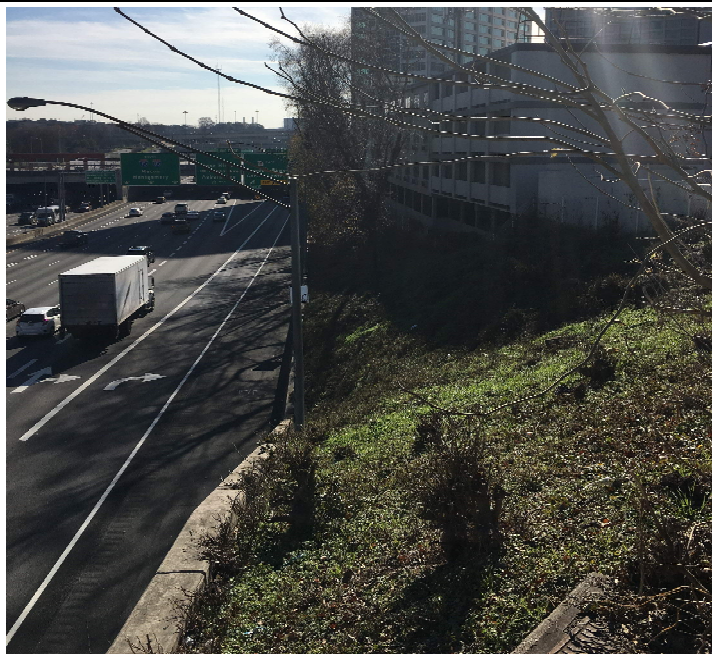
Photo No. 12

Remarks: MOTEL 6

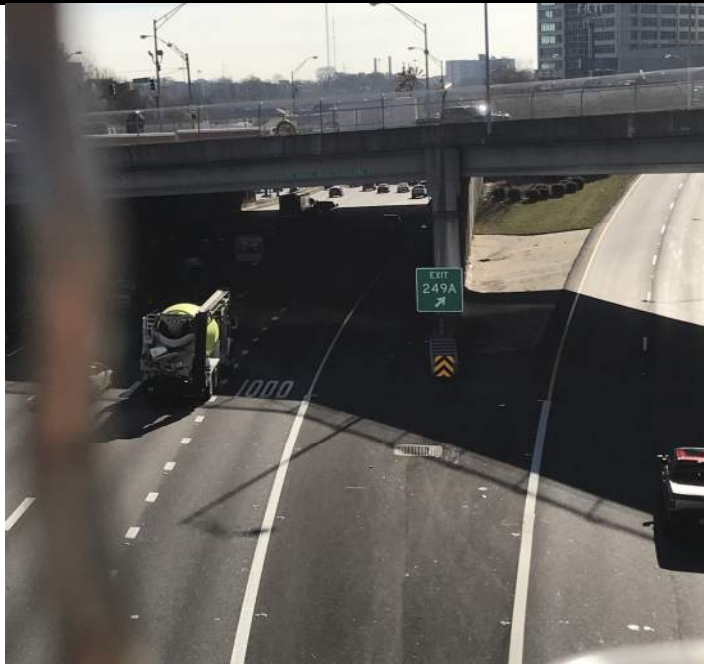
Photo No. 13

Remarks: COURTLAND STREET EXIT RAMP

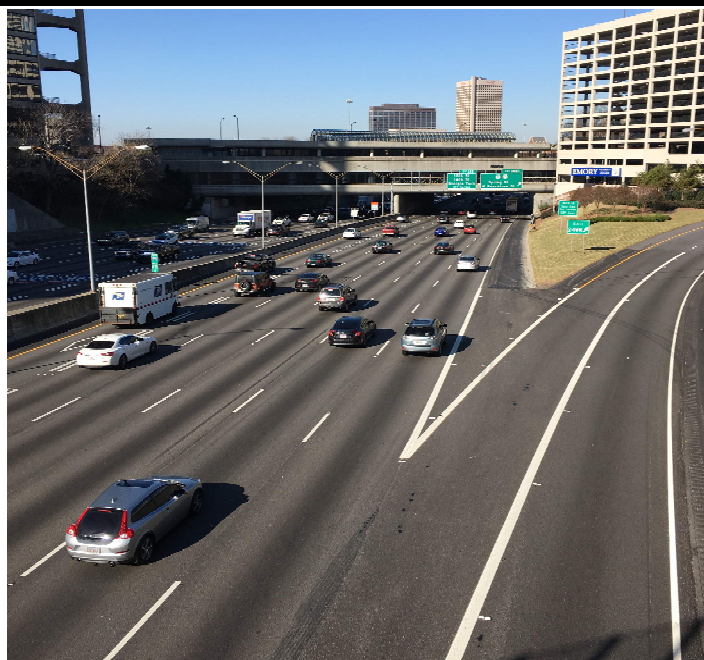
Photo No. 14

Remarks: PINE STREET EXIT RAMP

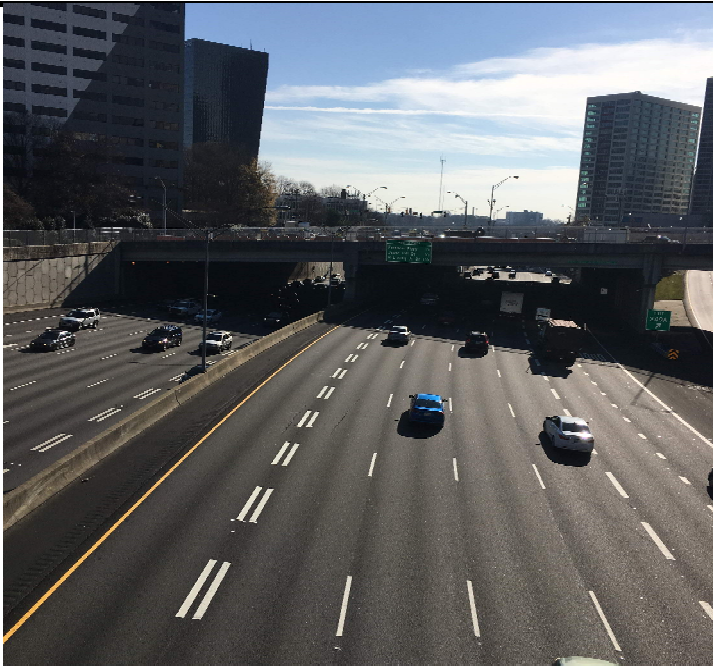
Photo No. 15

Remarks: COURTLAND STREET EXIT RAMP

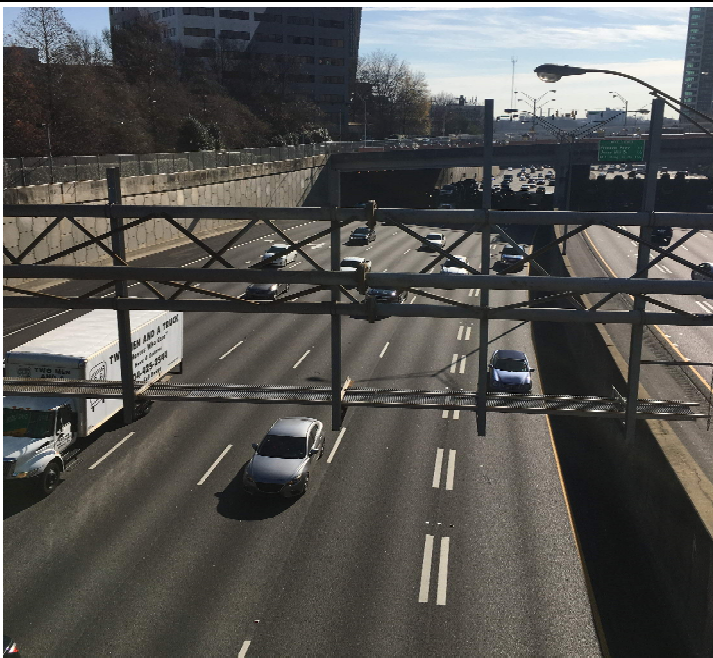
Photo No. 16

Remarks: NORTHBOUND DOWNTON CONNECTOR FROM PEACHTREE STREET BRIDGE LOOKING TOWARD:
COURTLAND STREET-RALPH MCGILL BLVD BRIDGE

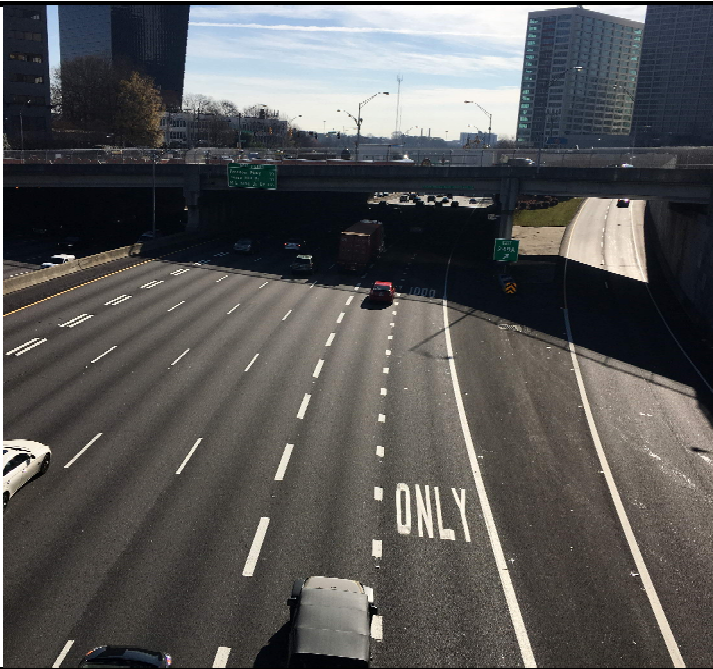
Photo No. 17

Remarks: COURTLAND STREET EXIT RAMP

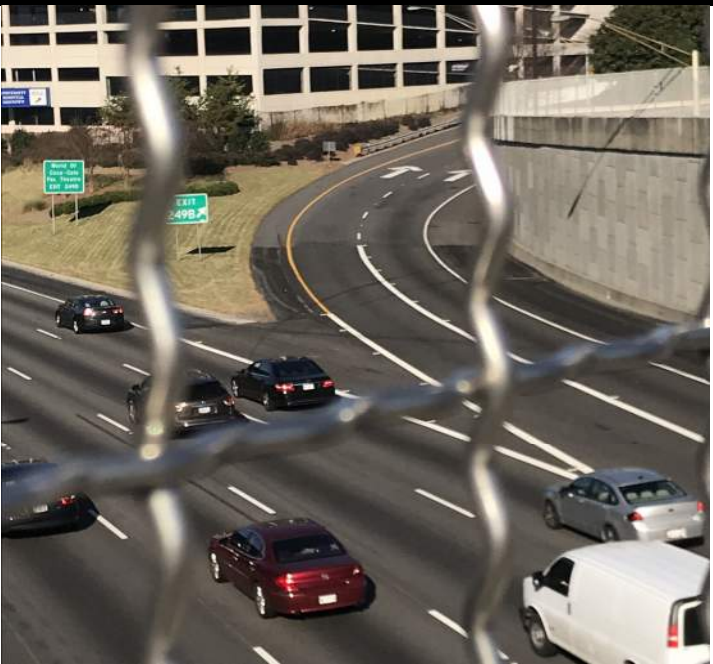
Photo No. 18

Remarks: PINE STREET EXIT RAMP

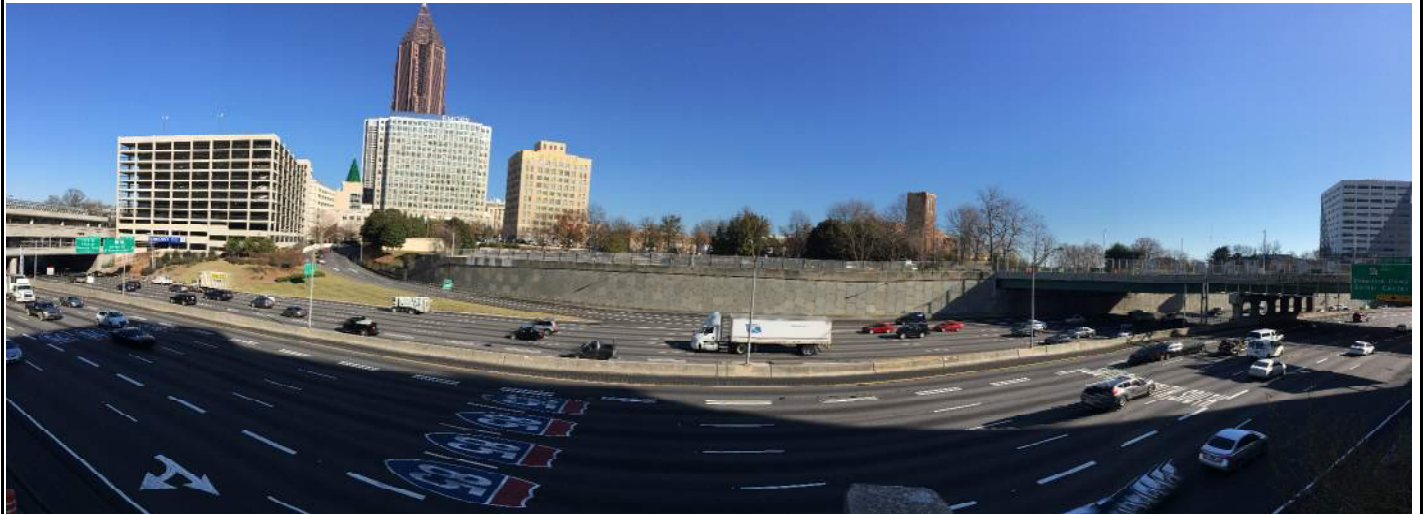
Photo No. 19

Remarks: DOWNTOWN CONNECTOR BETWEEN WEST PEACHTREE AND PEACHTREE STREETS
LOOKING NORTH

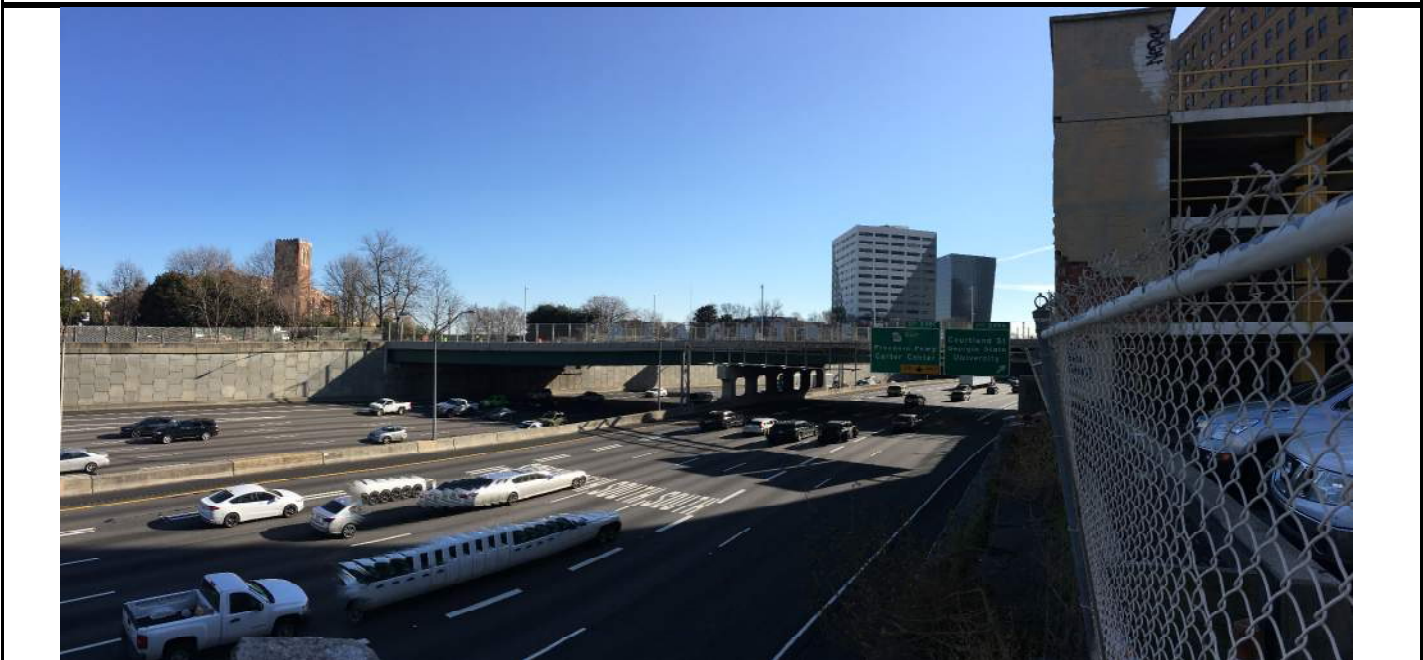
Photo No. 20

Remarks: PEACHTREE STREET BRIDGE

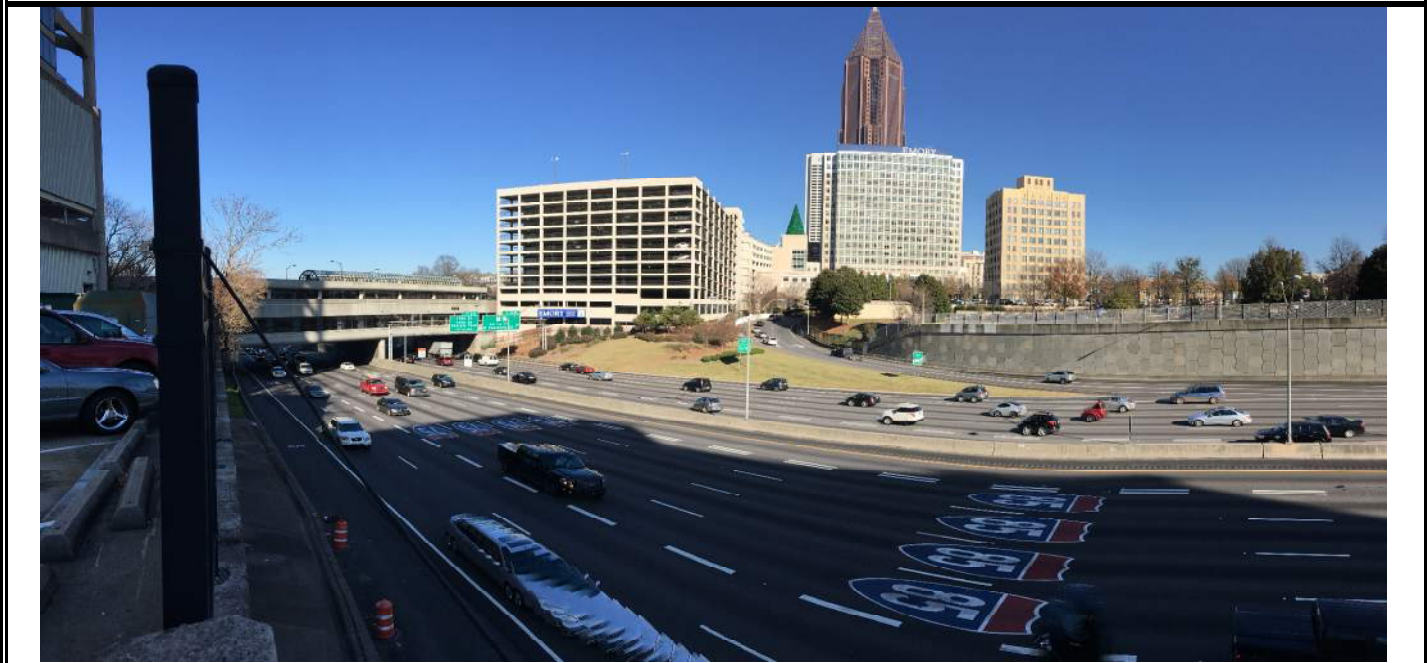
Photo No. 21

Remarks: PINE STREET EXIT RAMP

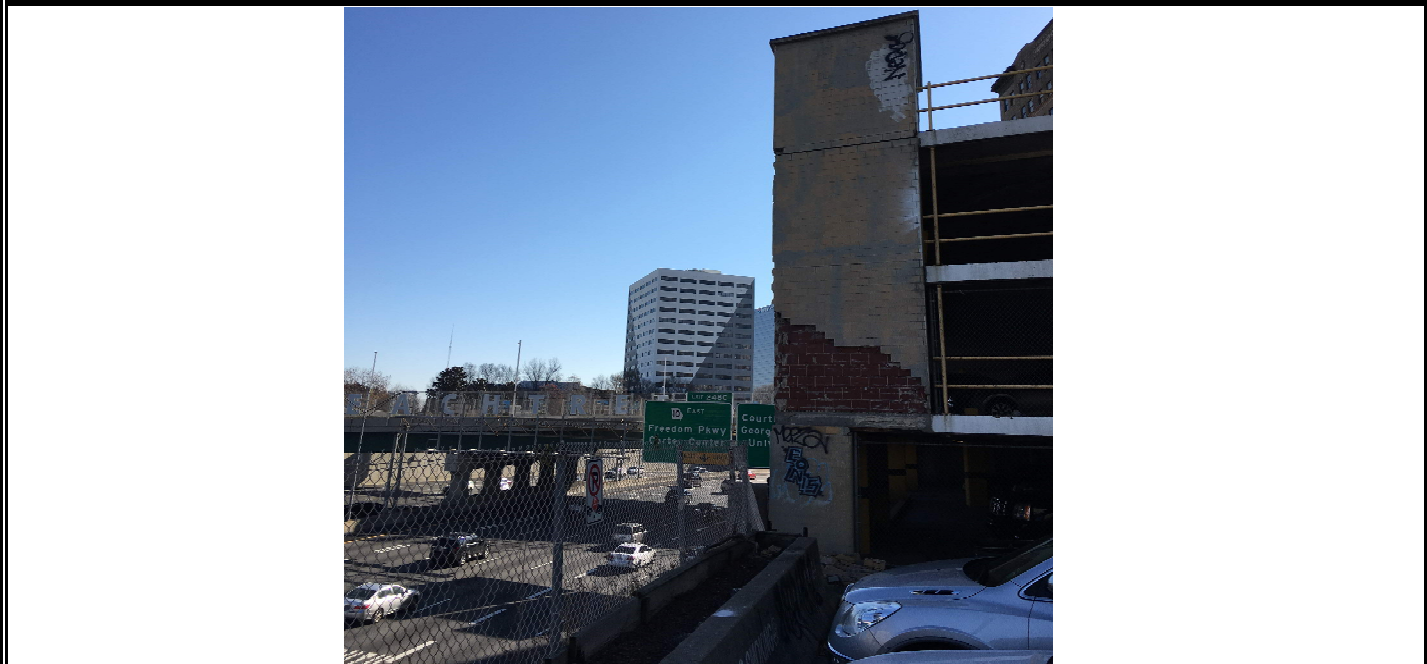
Photo No. 22

Remarks: PEACHTREE STREET BRIDGE FROM ALEXANDER STREET AND MEDICAL ARTS PARKING DECK

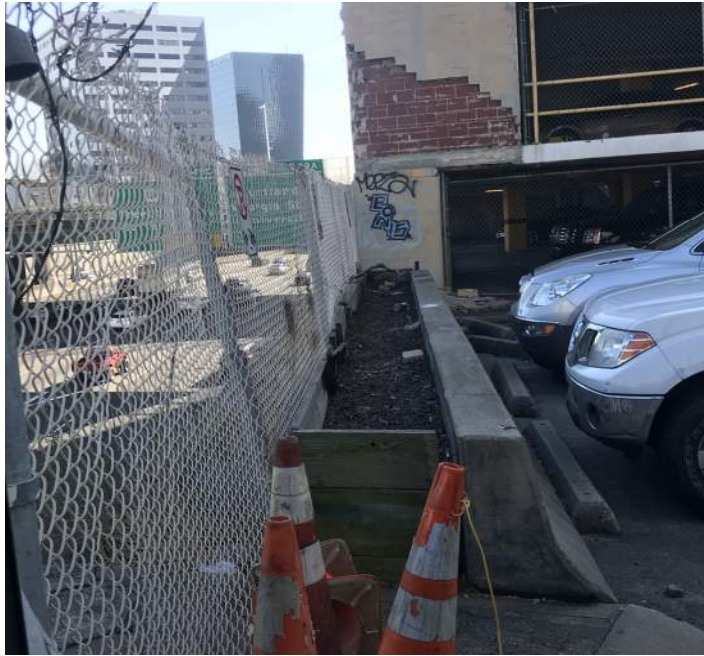
Photo No. 23

Remarks: ALEXANDER STREET AND MEDICAL ARTS PARKING DECK

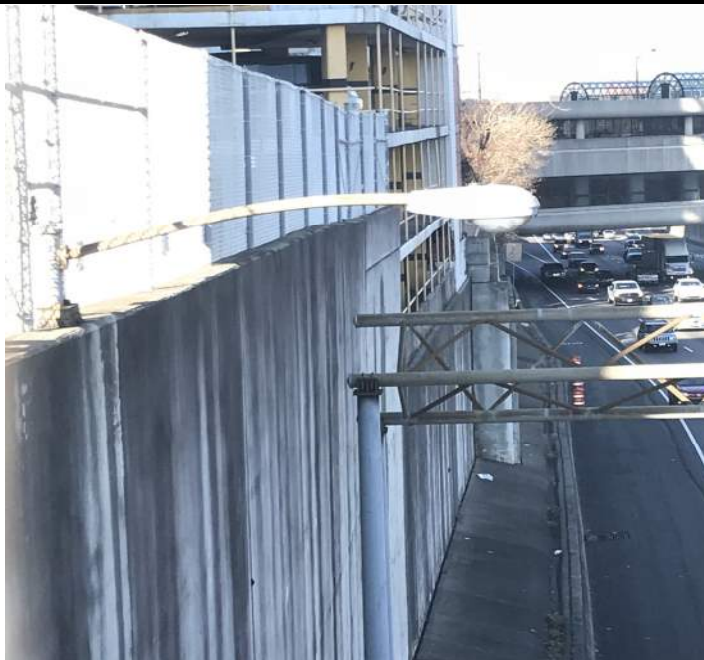
Photo No. 24

Remarks: ALEXANDER STREET ABUTMENT

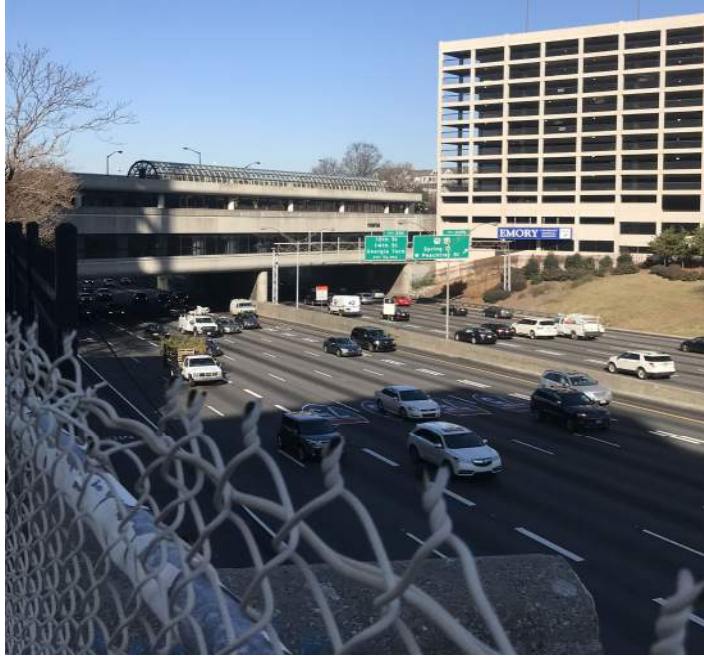
Photo No. 25

Remarks: CIVIC CENTER MARTA STATION AND GSA PARKING DECK VIEW FROM ALEXANDER STREET

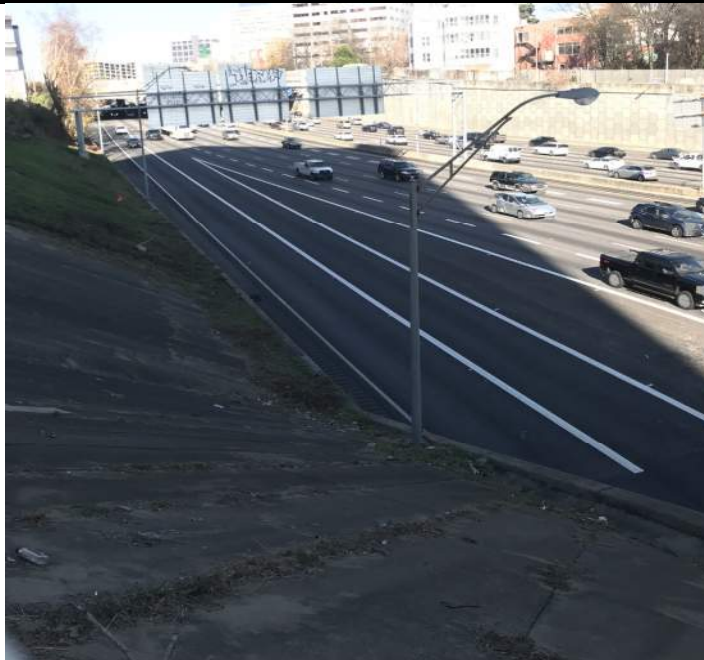
Photo No. 26

Remarks: CONCRETE AND LANDSCAPED SLOPE UP TO BAKER-HIGHLAND CONNECTOR

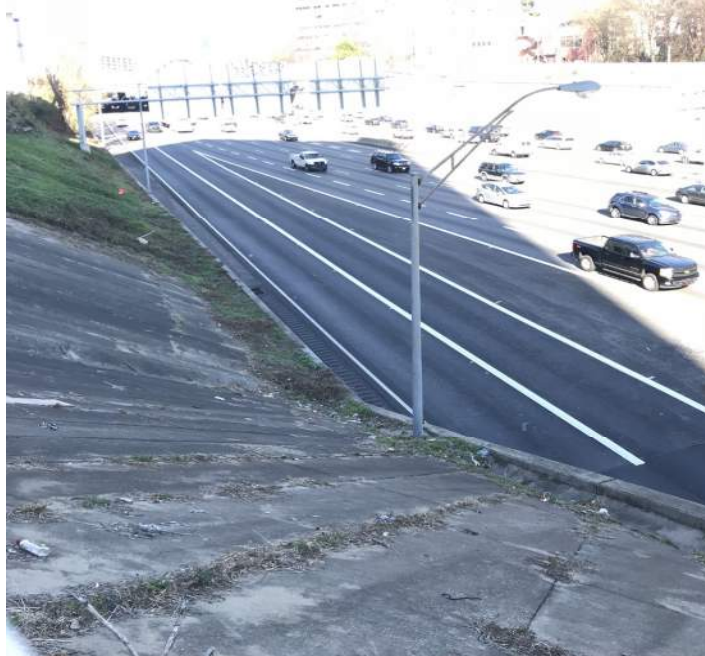
Photo No. 27

Remarks: CONCRETE AND LANDSCAPED SLOPE UP TO BAKER-HIGHLAND CONNECTOR

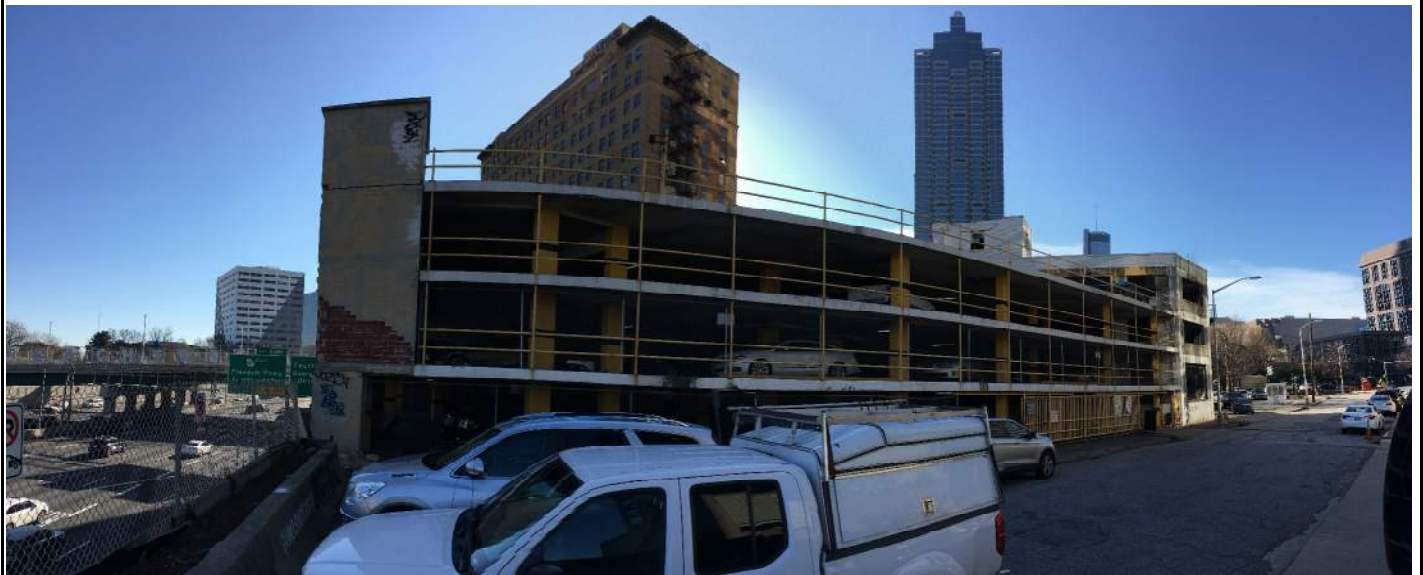
Photo No. 28

Remarks: MEDICAL CENTER PARKING DECK

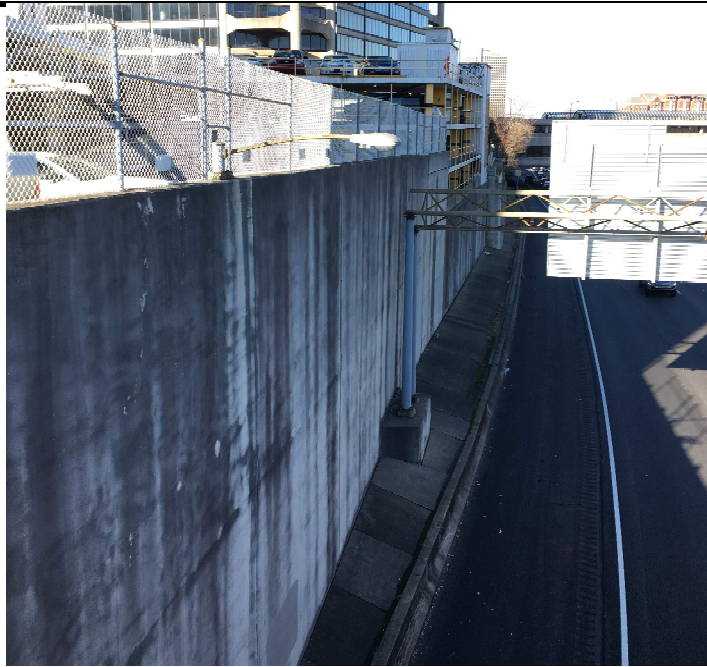
Photo No. 29

Remarks: ALEXANDER STREET ABUTTMENT

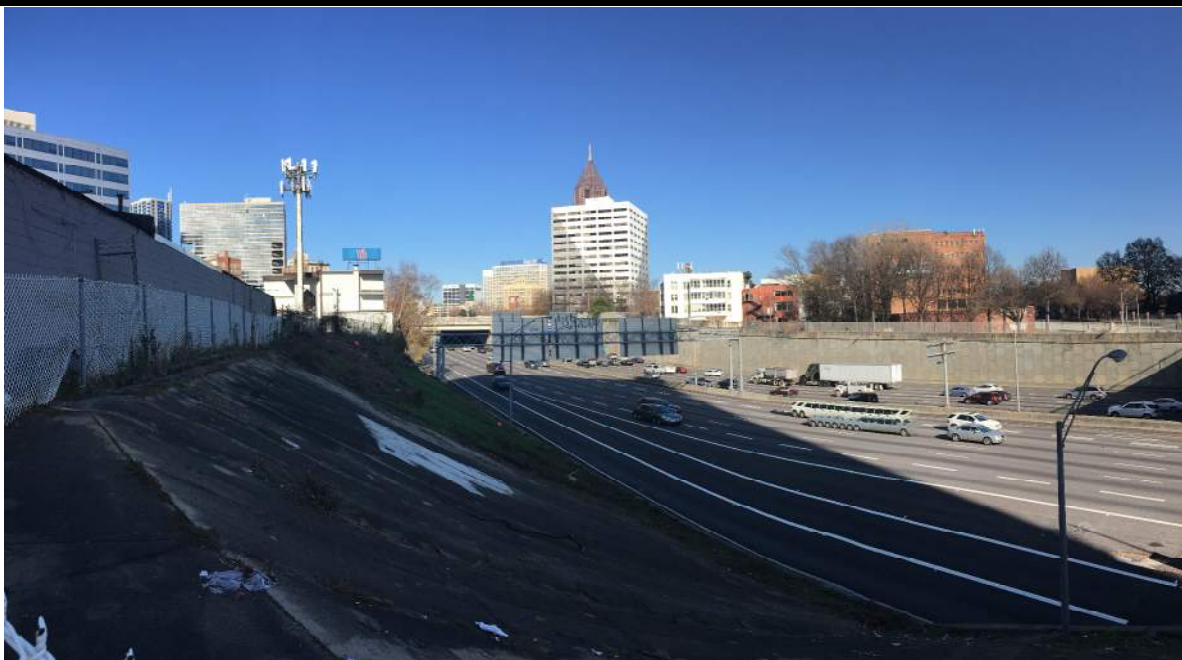
Photo No. 30

Remarks: CONCRETE AND LANDSCAPED SLOPE UP TO BAKER-HIGHLAND CONNECTOR

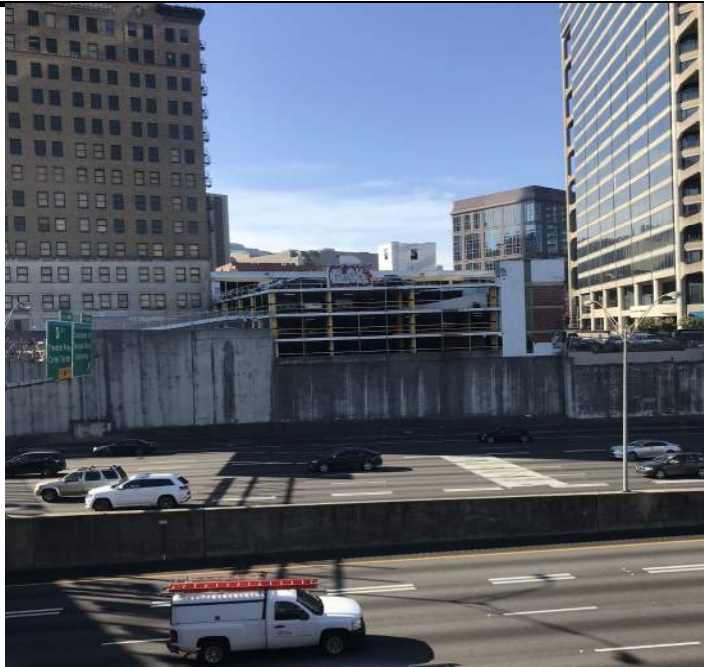
Photo No. 31

Remarks: ALEXANDER STREET ABUTTMENT AND MEDICAL ARTS PARKING DECK

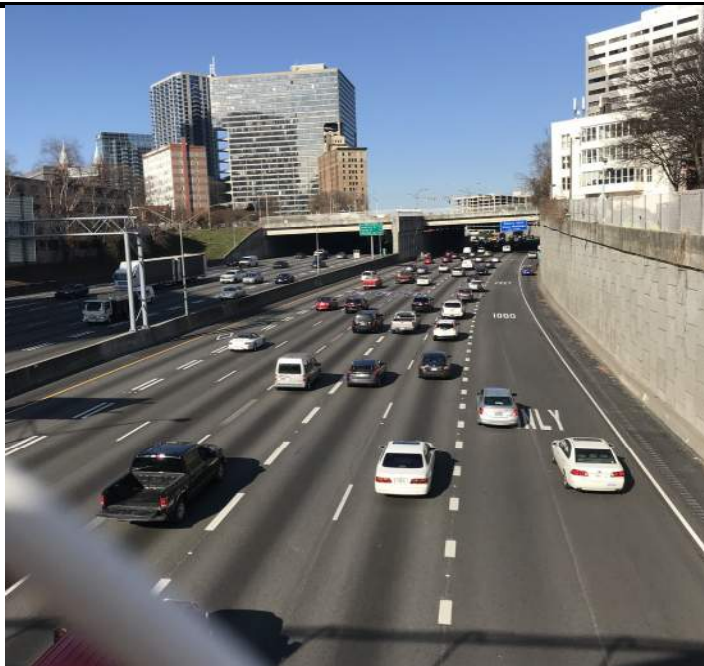
Photo No. 32

Remarks: NORTHBOUND DOWNTON CONNECTOR FROM BAKER-HIGHLAND CONNECTOR

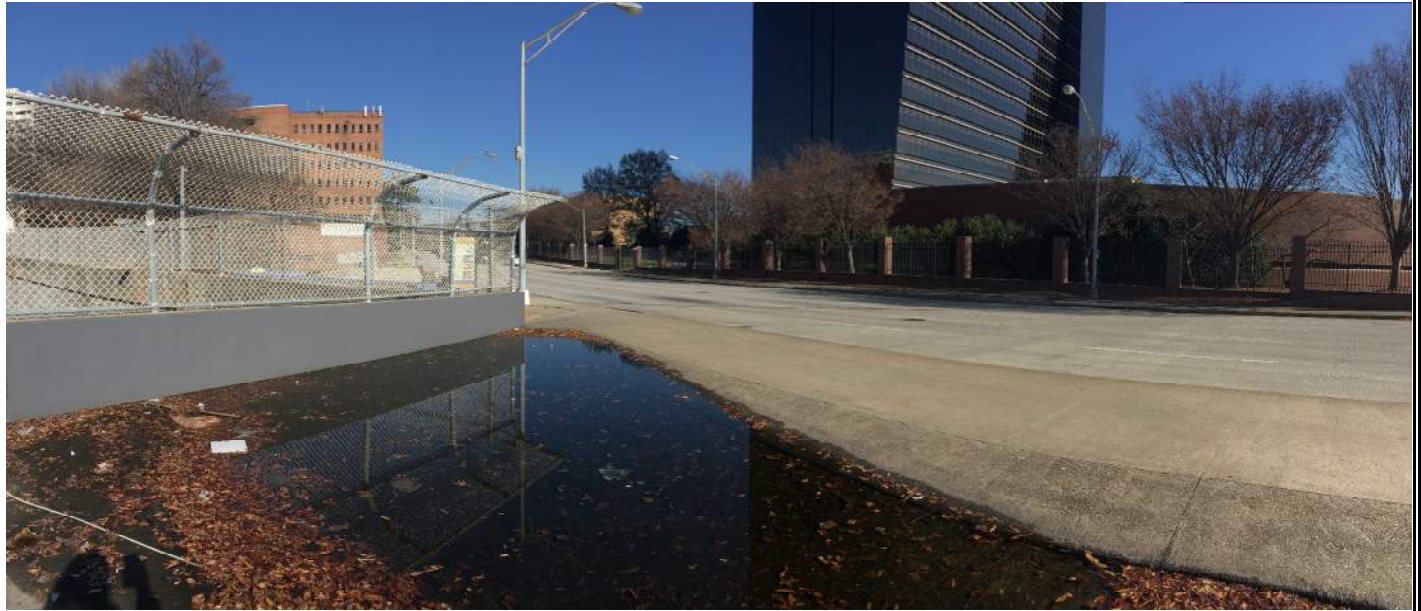
Photo No. 43

Remarks: PONDING AT BAKER-HIGHLAND CONNECTOR

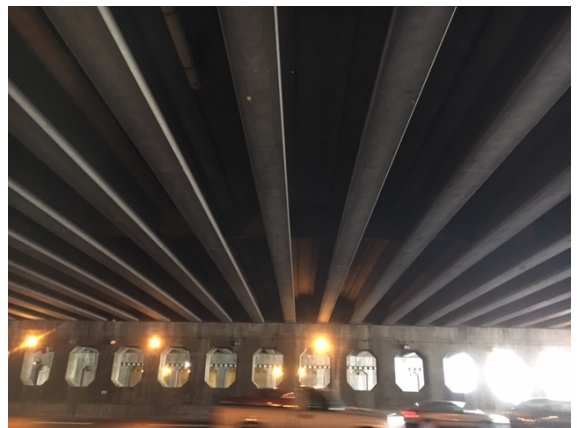
121-0667-0_superstructure_2017-5-15.jpg

NBIS Condition 8 - Very Good Condition **Material:** O. Concrete **Year Painted:** 0000
Paint Type : 0- Not Applicable **Temperature (F):**
 Three span pre stressed concrete I-beams on neoprene bearings.

Superstructure

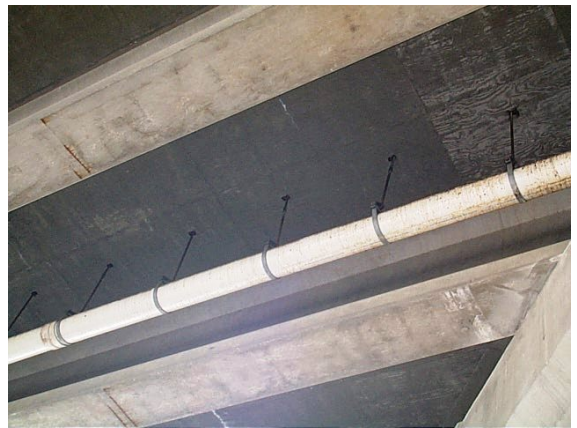
121-0667-0-5.JPG

Electric.

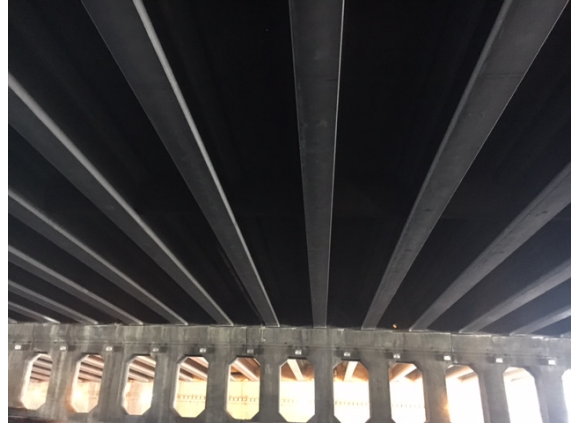
121-0664-0_superstructure_2017-5-15.jpg

Span 1, bays 1 through 17 has cracking with efflorescence.

Span 2, bays 4 through 15 has cracking with efflorescence.

superstructure

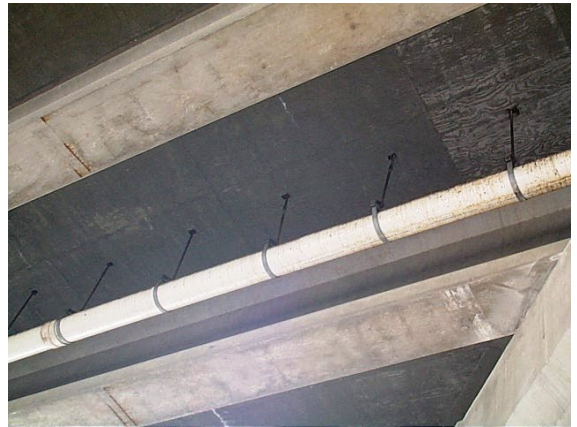
121-0664-0-6.JPG

Electric.

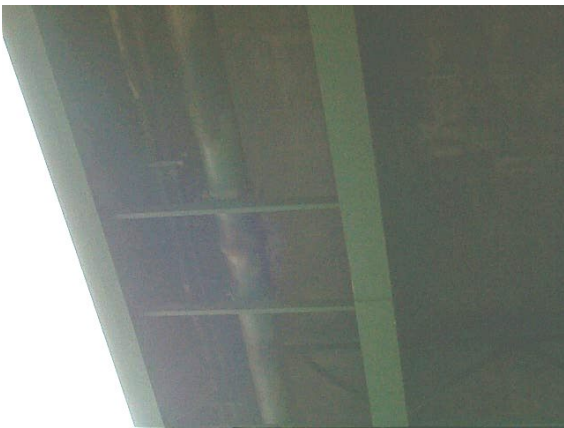
121-0644-0-6.JPG

18" Water & phone.

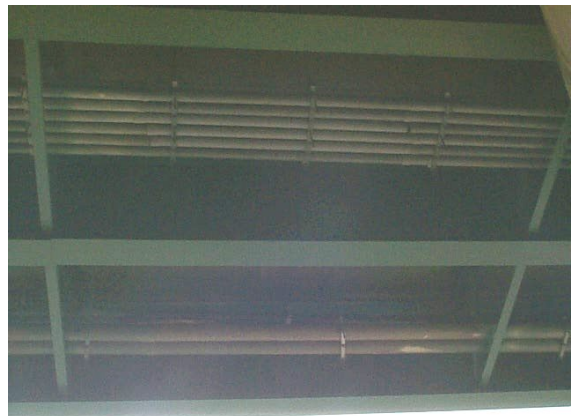
121-0644-0-9.JPG

Electric

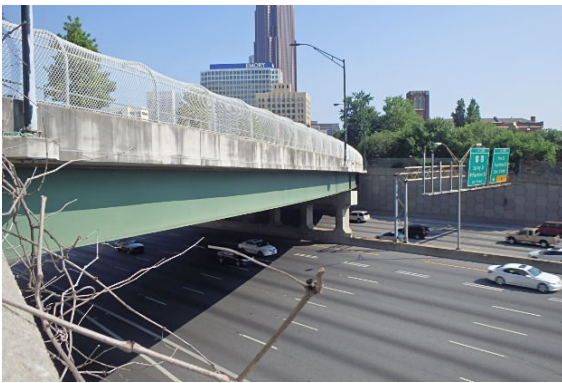
121-0644-0-2.JPG

Deck spall span #1bottom

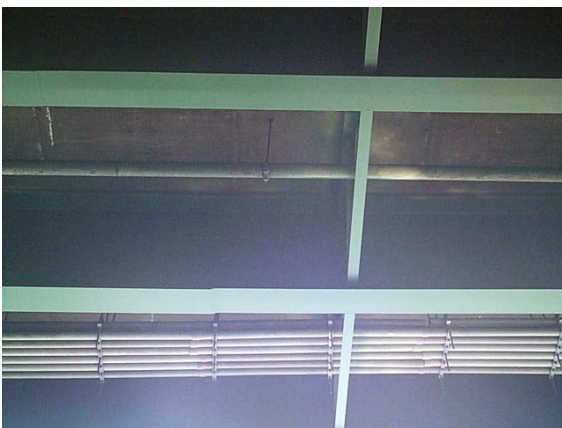
121-0644-0-8.JPG

12 phone & gas.

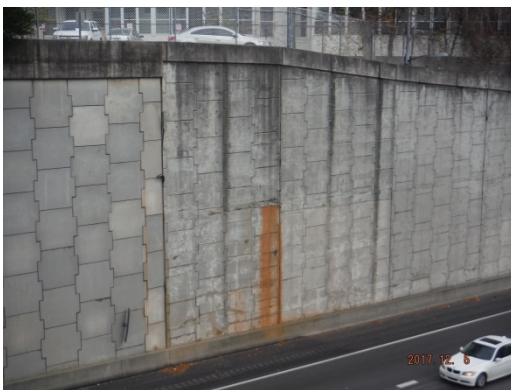
Figure A-5: Wall N to Wall M Transition
